CK-2361

KOOKIPI SEVEN 4.9km

2017 Inspection

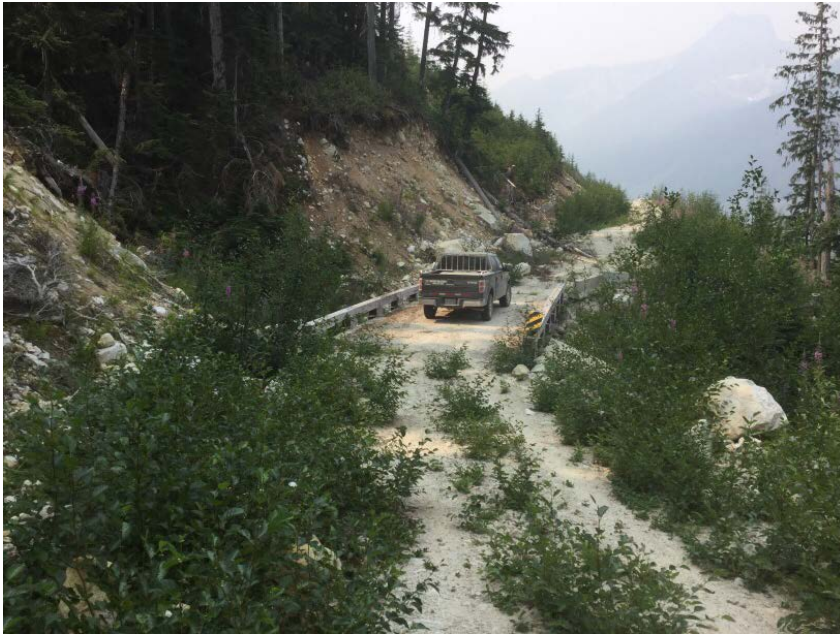
Approach from Right Bank when facing downstream

Road Surface Poor

Semi deactivated and brushed in

| 2 | Medium | Brush and grade approaches and post bridge ahead signs |

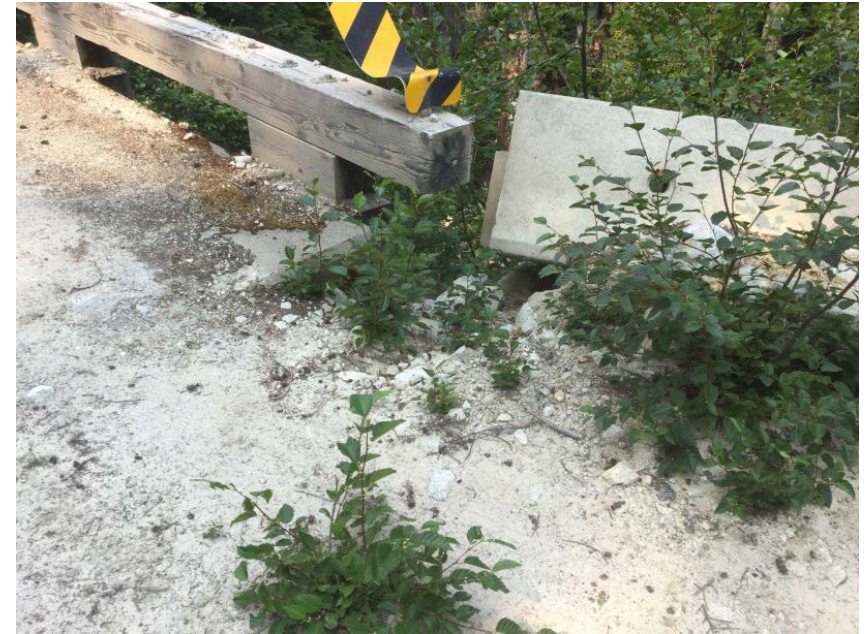
Downstream right approach fill

Fill Fair

Failing at approaches

| 3 | Medium | Replace failing fill on downstream approaches and repair failing cutslope approaches |

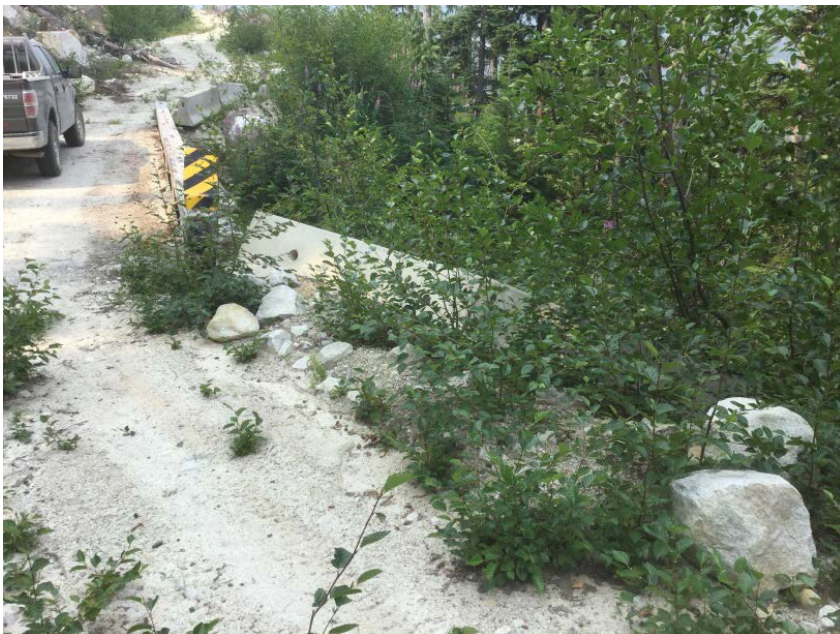
Downstream right approach barriers

Fender Condition Poor

Concrete no posts not aligned and falling from road surface

| 1 | Medium | Replace guardrail, risers and blocks |

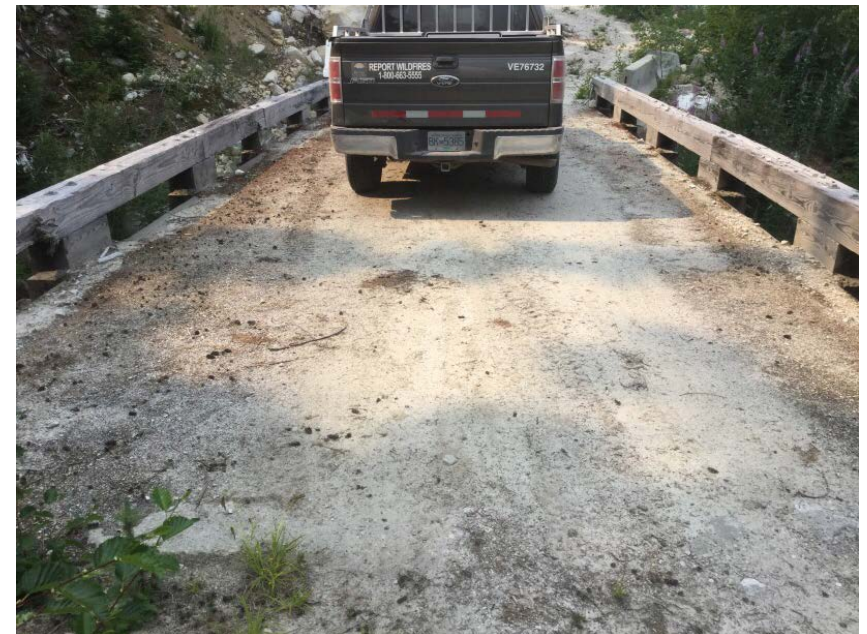
| Curb Rail/Blocks/Posts | Poor | Rotting |

| Hardware | Poor | Loose rail bolts |

| Overall Deck Condition | Poor | Due to rail condition |
