CK-2364

CONNOR CREEK 0.05km

2017 Inspection

| Structure Class | Major Culvert |

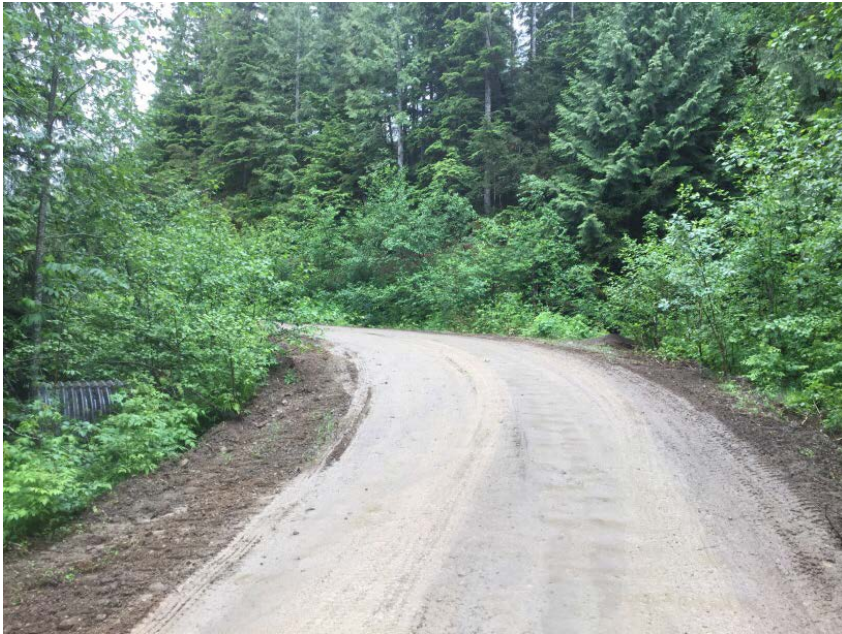
Approach from Left Bank when facing downstream

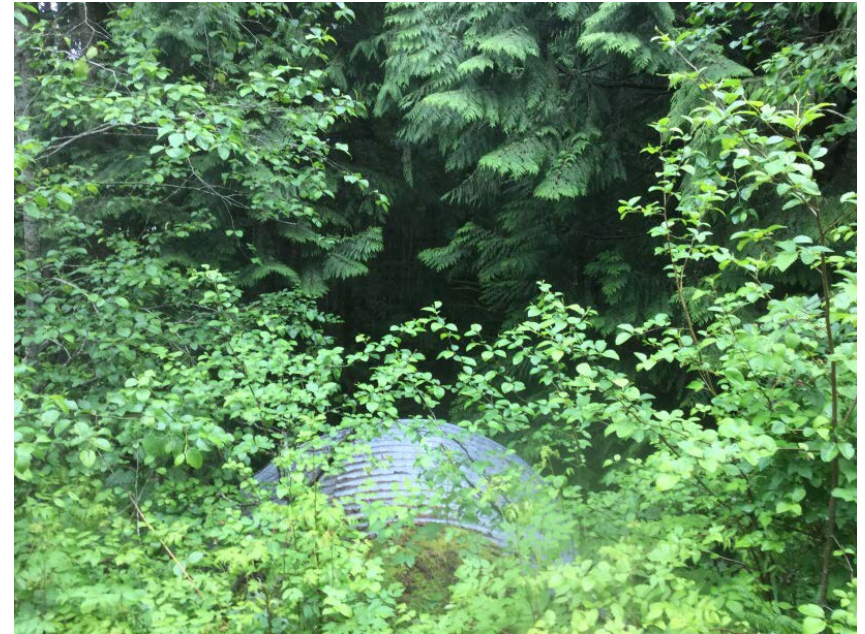
Looking downstream from road

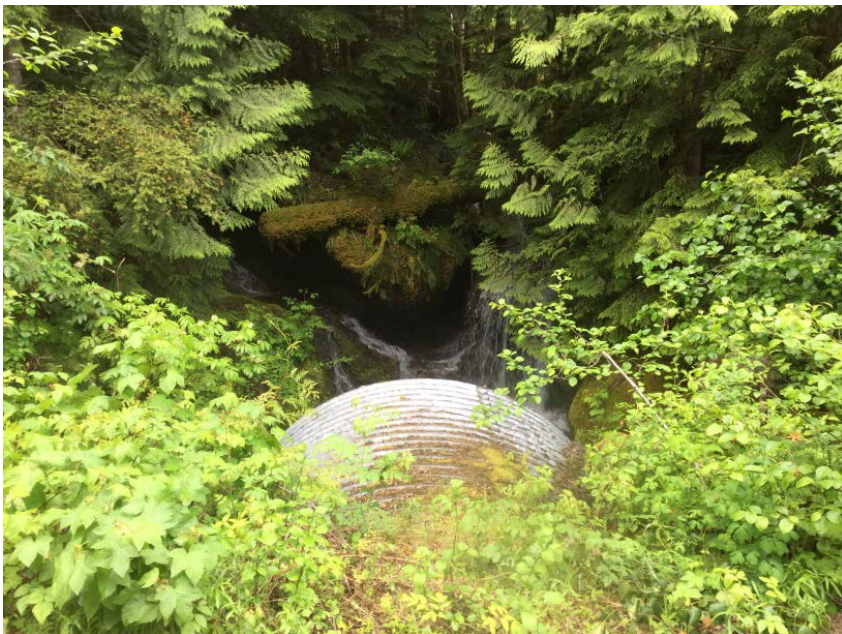
Looking upstream from road

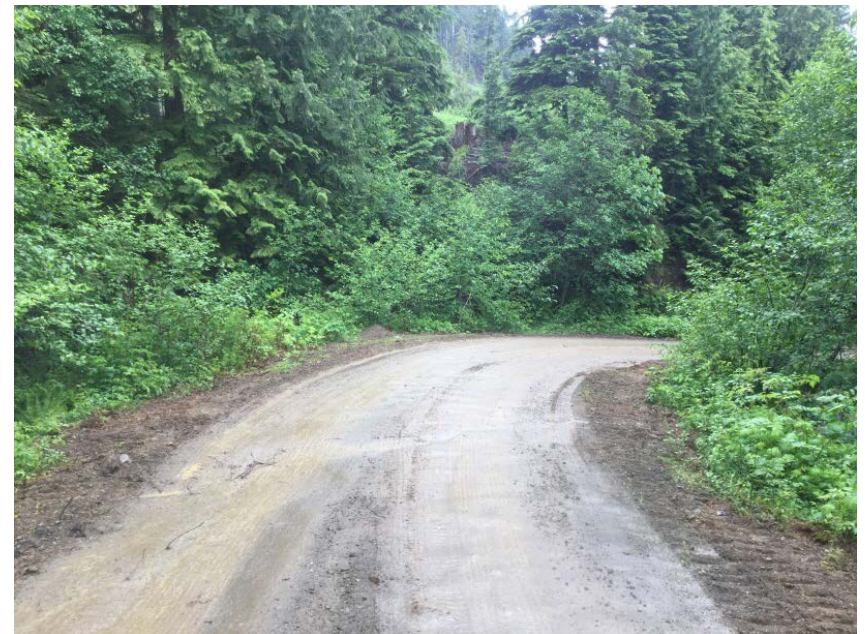
Approach from Right Bank when facing downstream

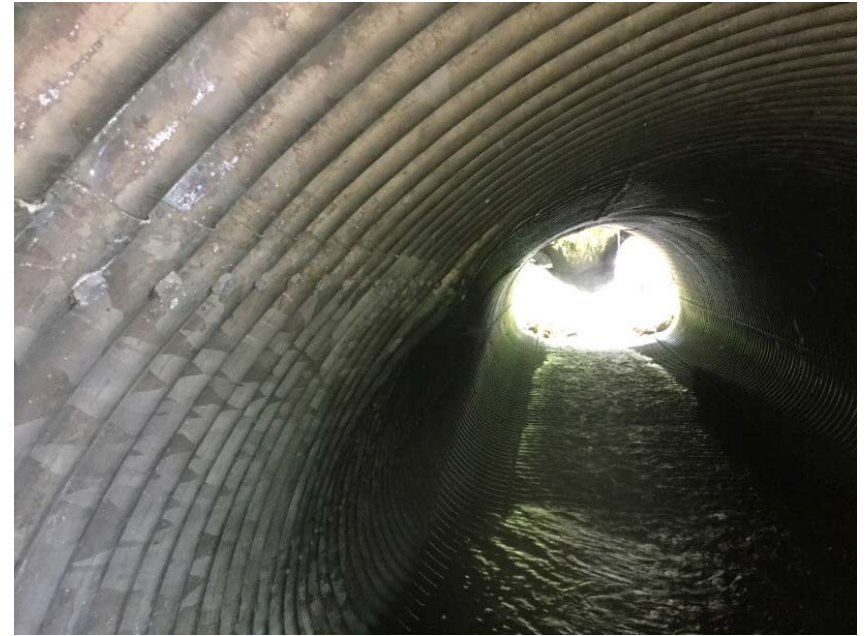
Minor damage noted near outlet

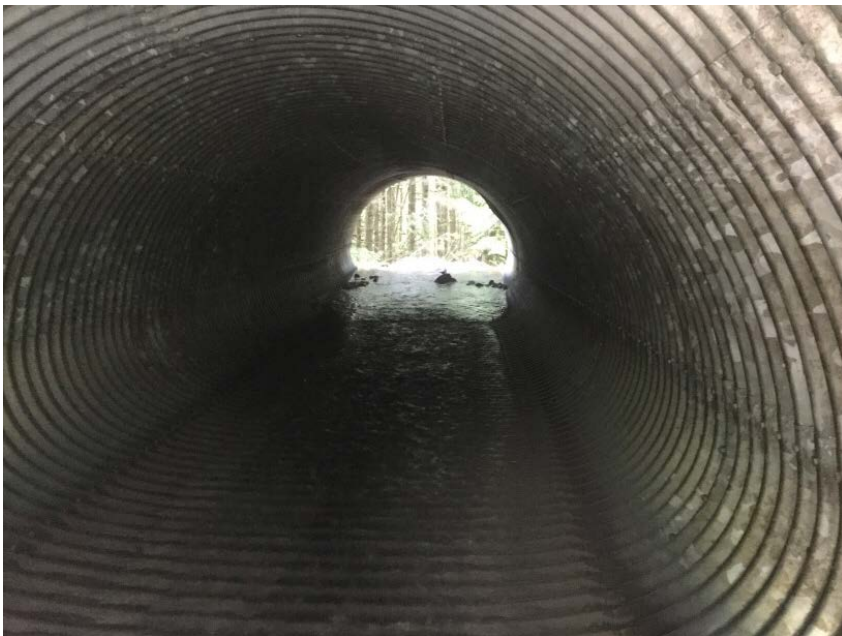
Looking through culvert
