CK-2366

STAVE RIVER 15.6km

2017 Inspection

| Structure Class | Major Culvert |

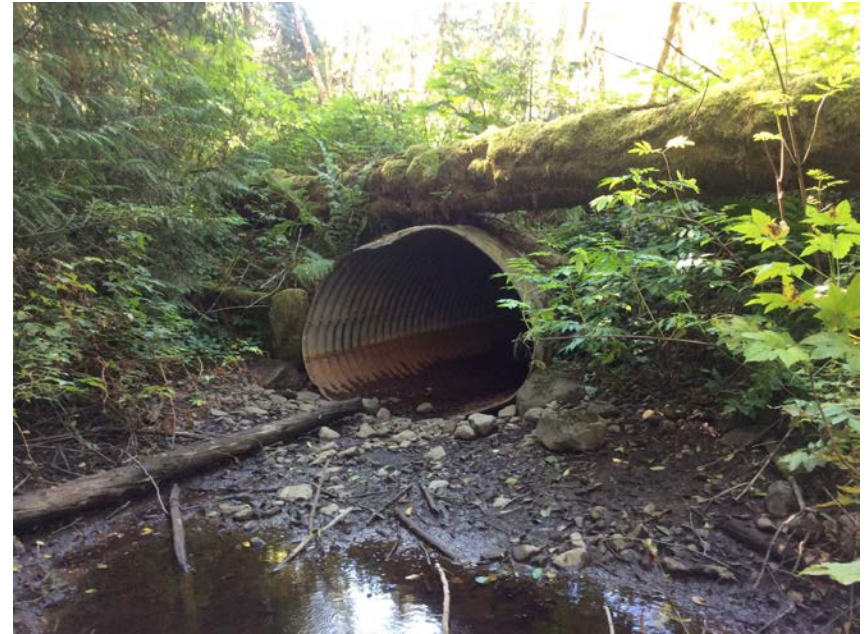
Inlet Good

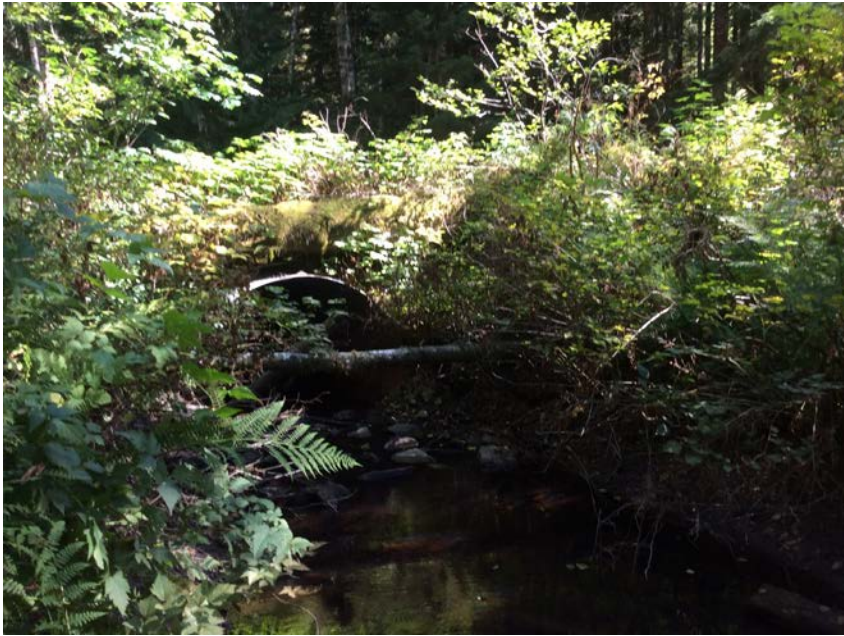
Outlet Good
