CK-2367

STAVE RIVER 19.1km

2017 Inspection

| Structure Class | Major Culvert |

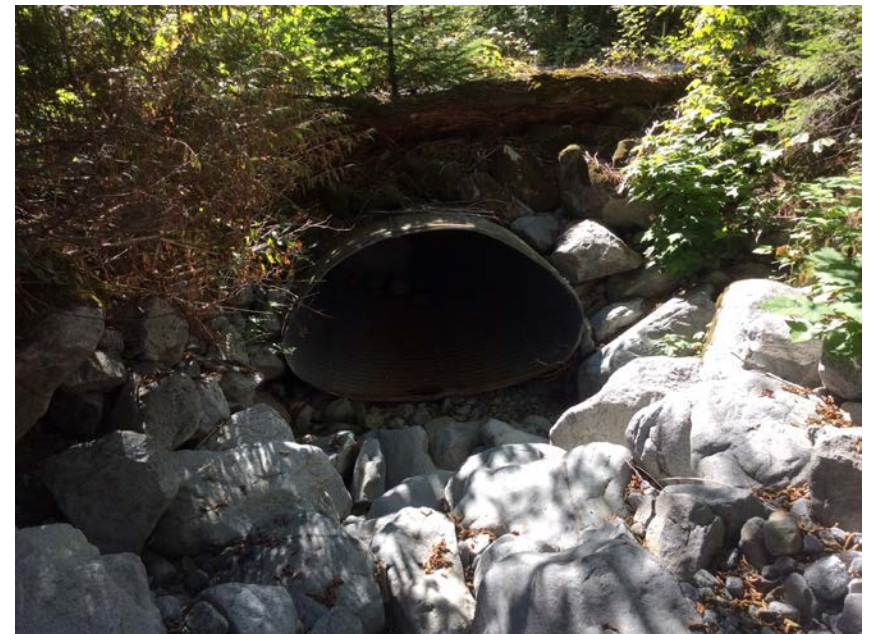
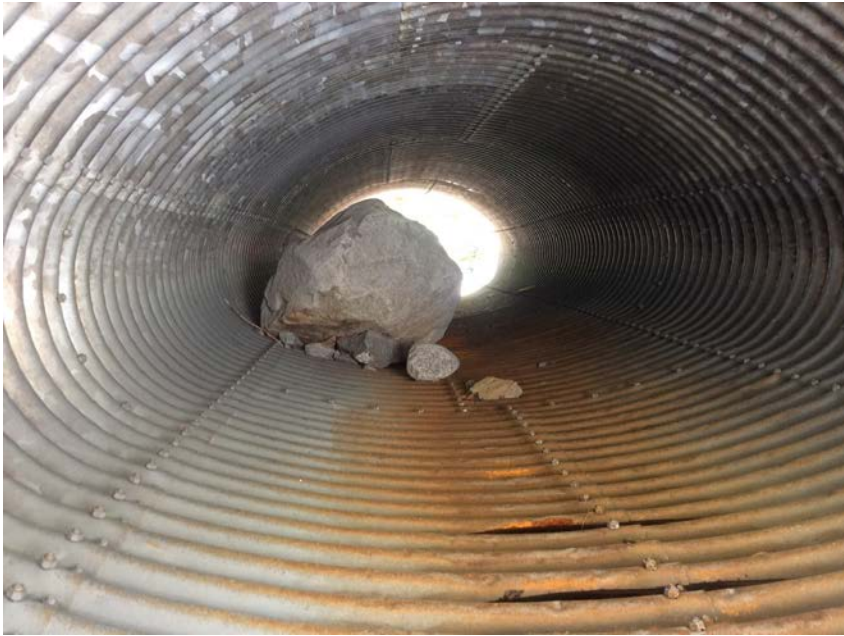
Inlet Good

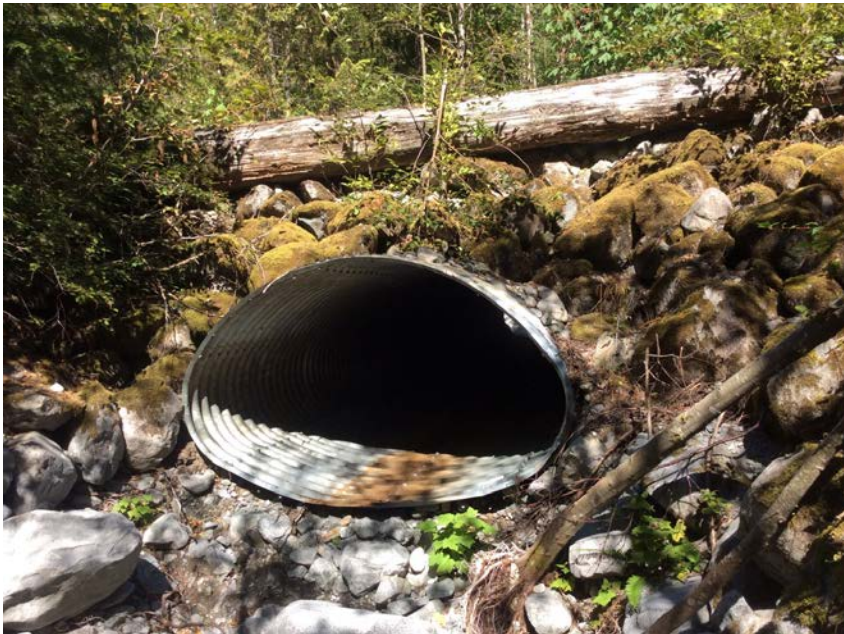
Outlet Good
