CK-2368

KAREN CREEK 0.2km

2017 Inspection

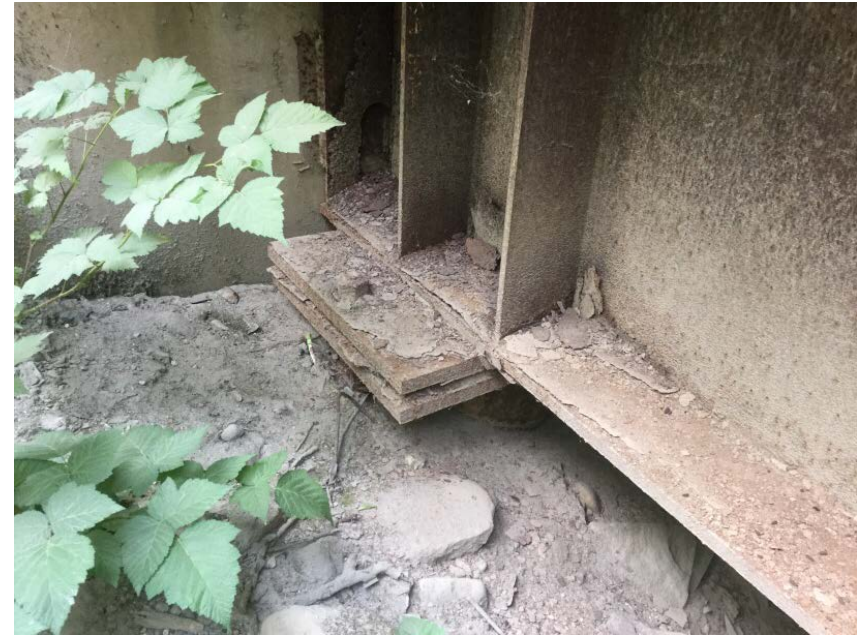
Minor steel delamination at the left approach abutment noted

Minor steel delamination at left abutment

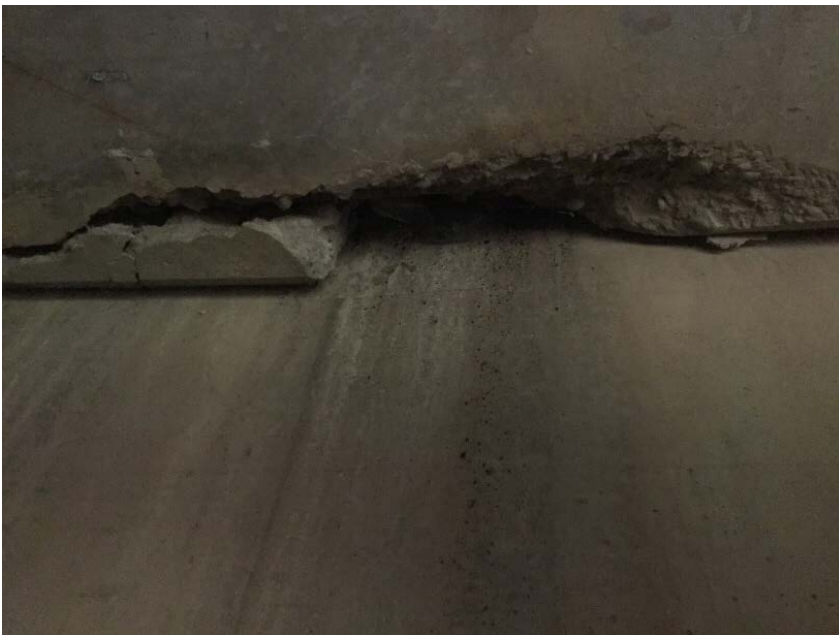
Running Surface      **Good**      Small damage noted on the underside of panel 1, on the right abutment.

Damage to panel 1 on right approach

Replace missing delineator and post bridge ahead signs. Repair the damage to the underside of deck panel 1, on the right abutment. Present load rating of L75 or 68 tonnes to continue.

| Repair Item | Priority | Repair Description |
|---|---|---|
| 2 | Medium | Repair damage to panel 1 on right approach (underneath) |

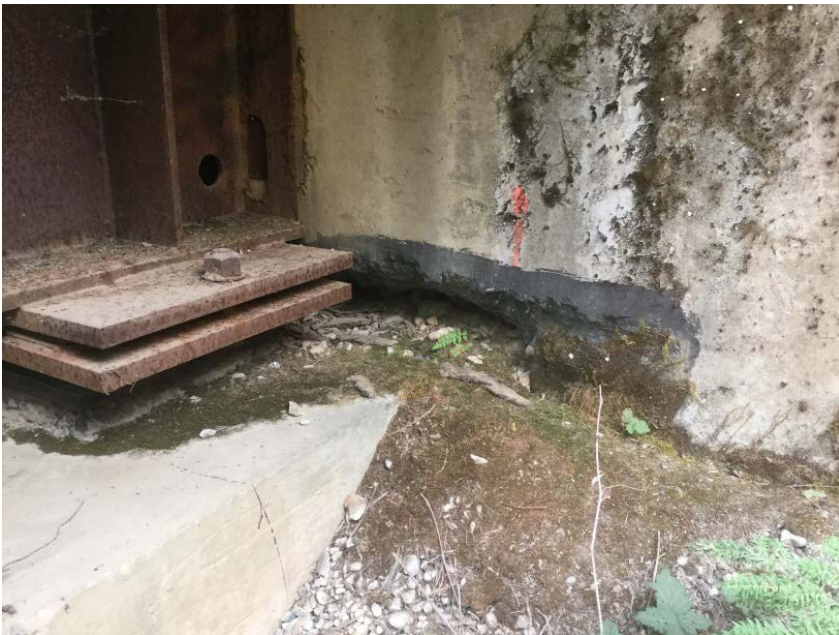
Upstream right wall was cut for field fit, exposed concrete was treated

Ballast Wall at upstream right bank
