CK-2372

SOWERBY CREEK 1.6km

2017 Inspection

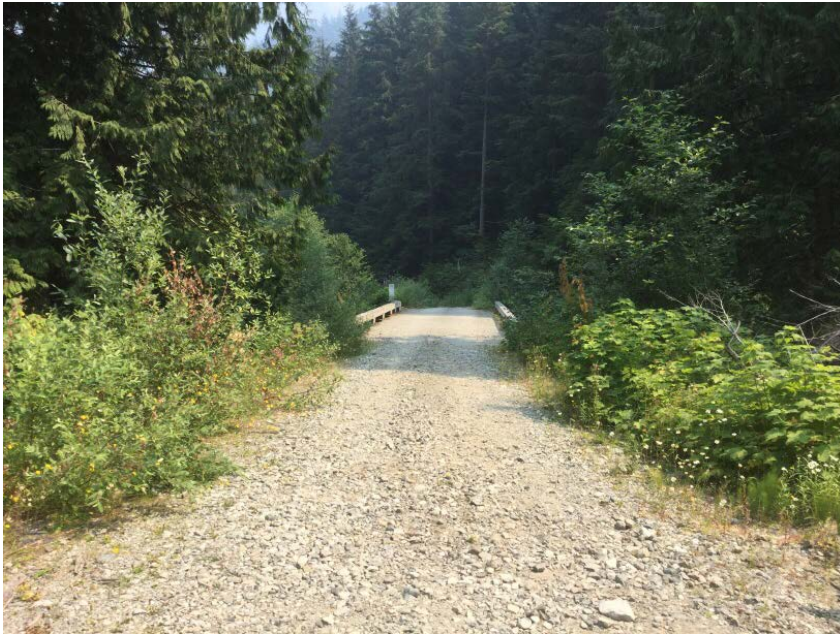
Approach from Left Bank when facing downstream

HC both approaches

Wilderness road, requires grading

| Repair | | Repair Description |
|---|---|---|
| 1 | Medium | Brush, grade approaches and place fenders |

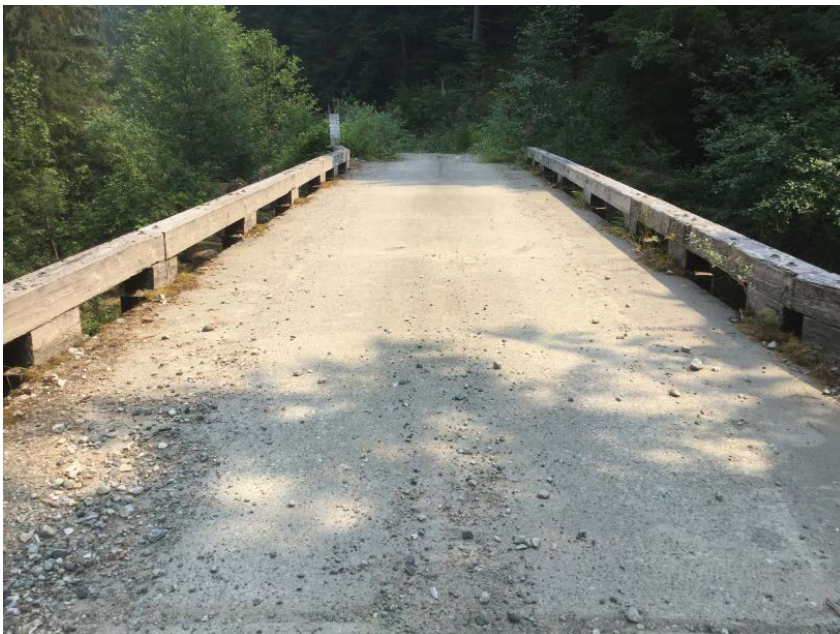
| Curb Rail/Blocks/Posts | Poor | Rotten |

| Hardware | Poor | Loose rail |

| Overall Deck Condition | Poor | Due to rail condition |

| Repair | | Repair Description |
|---|---|---|
| 2 | Medium | Replace guardrail, risers and blocks |

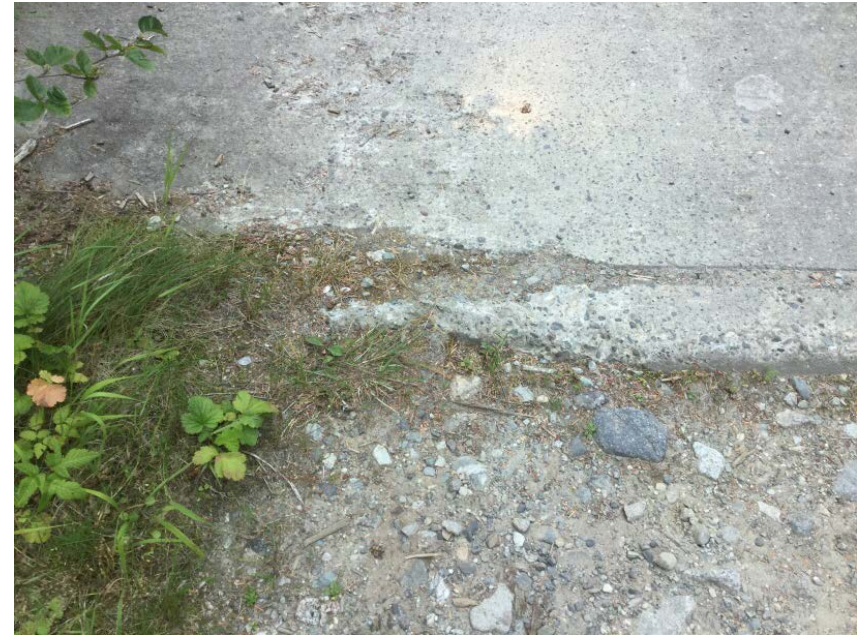
Ballast Wall Fair

Damage to both walls at road surface

Ballast wall damage at right approach

| Repair | | Repair Description |
|---|---|---|
| 3 | Medium | Repair damage to ballast walls |
