CK-2378

STAVE RIVER 7.7km

2017 Inspection

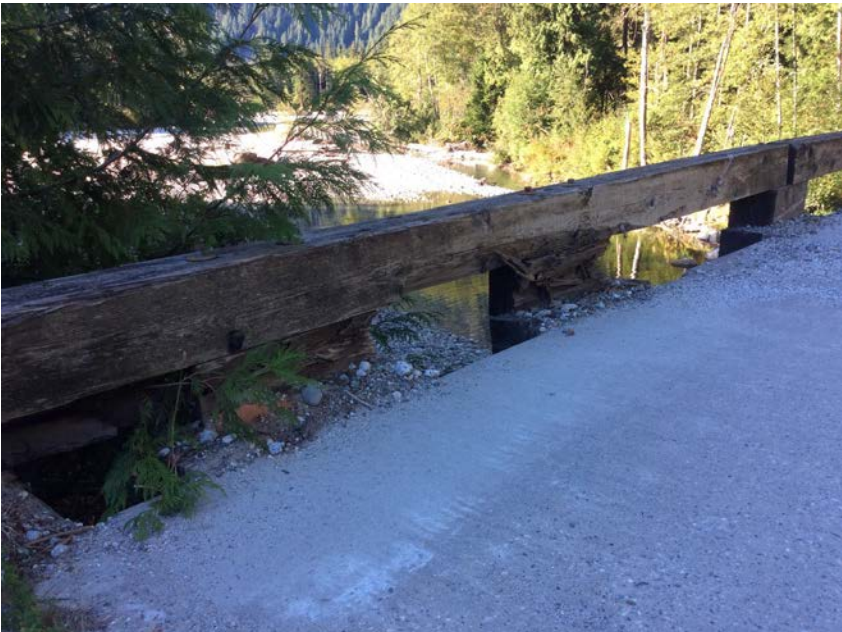
| Curb Rail/Blocks/Posts | Poor | Damaged and rotten. Replace before industrial use |

Guard Rail

| Repair Item | Priority | Repair Description |
|---|---|---|
| 2 | Medium | Replace all guardrail, risers and blocks and add road support and realign all concrete barriers. |

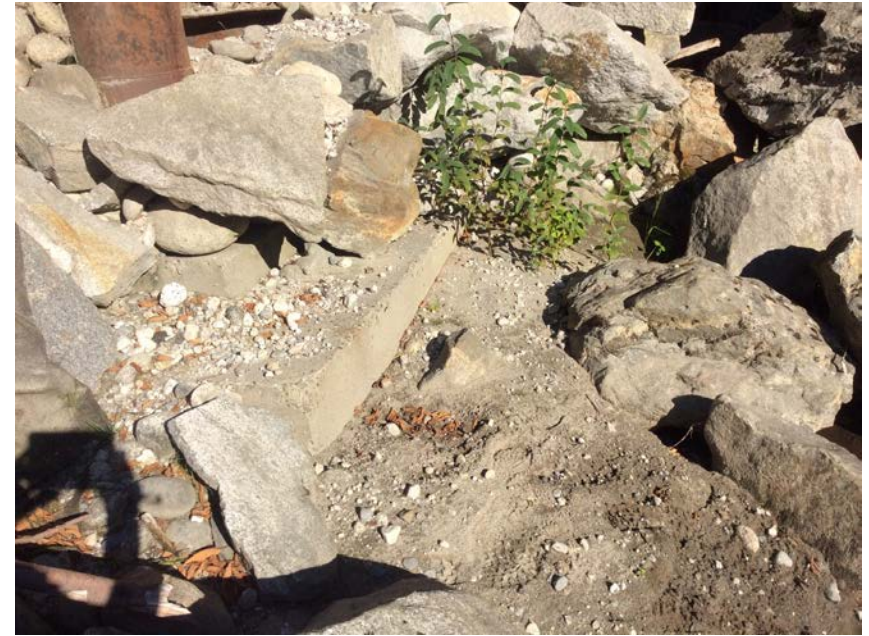
Right downstream footing is exposed due to undermined riprap. Requires repair.

Exposed footing

| Repair Item | Priority | Repair Description |
|---|---|---|
| 1 | High | Repair right side riprap or footing will be undermined by next storm event. |
| 1 | Riprap scour and footing erosion at downstream right bank | Annual |

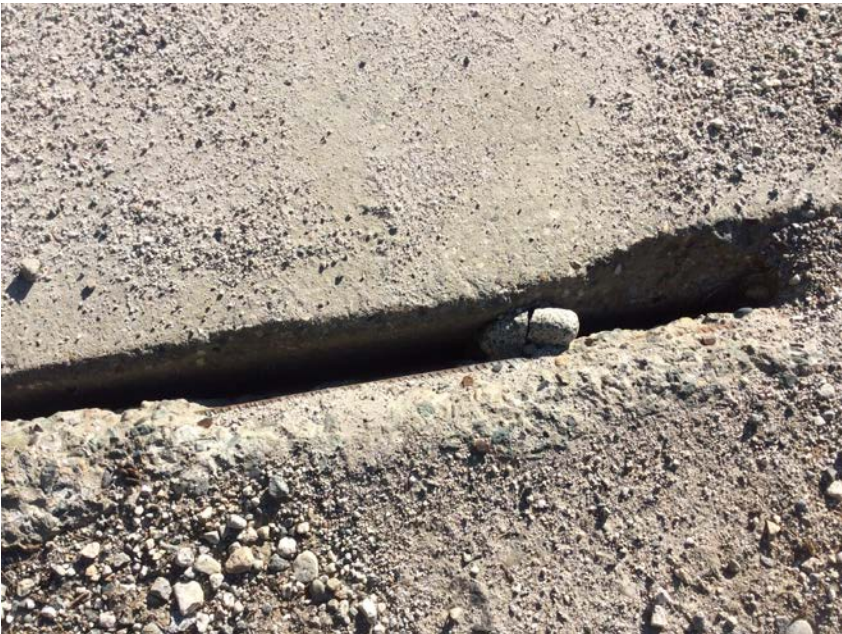
Exposed rebar

| Repair Item | Priority | Repair Description |
|---|---|---|
| 3 | Medium | Repair damage to ballast wall and replace all compression seals |

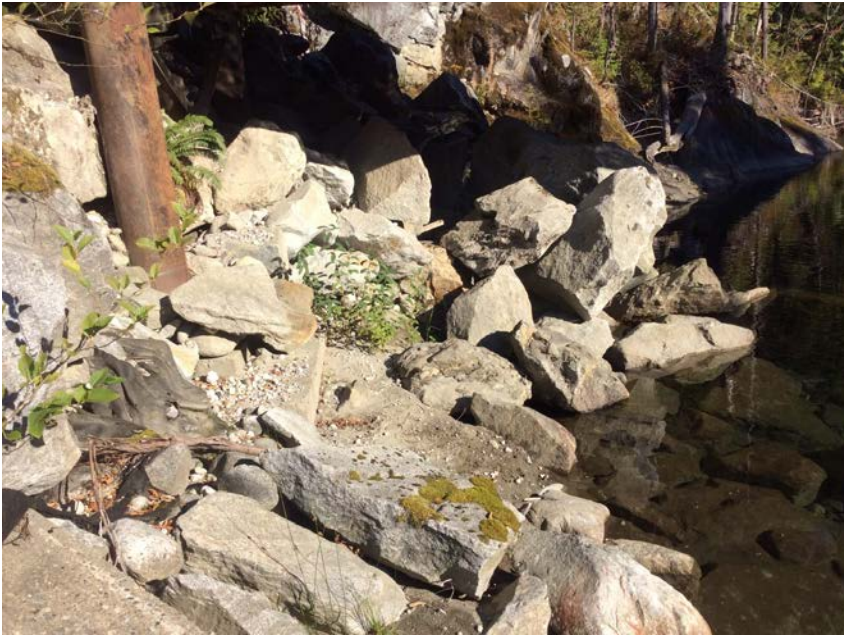
Riprap Poor

Eroded riprap
