CK-2386

CENTRE CREEK 5.1km

2017 Inspection

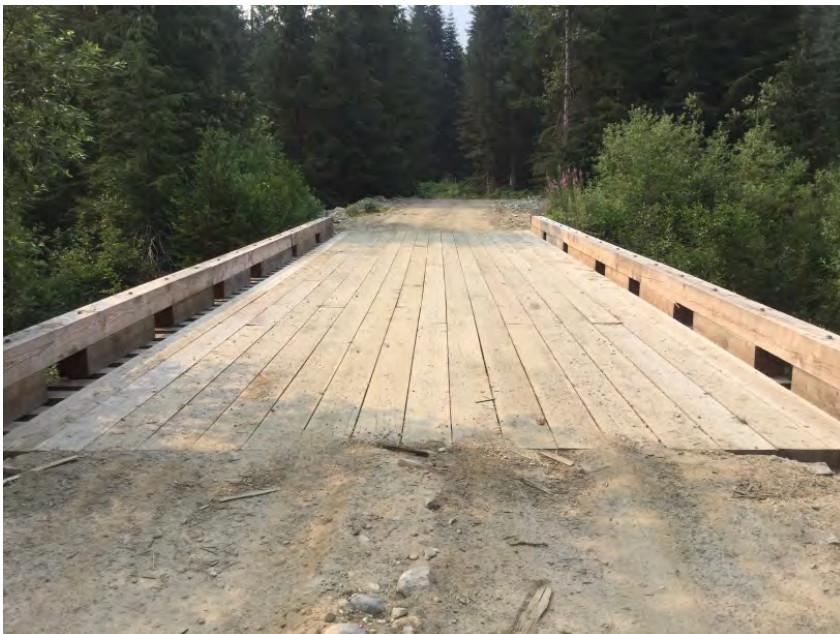
16.0 m span  
New deck on existing super and sub structure

Overall Deck Condition      **Good**

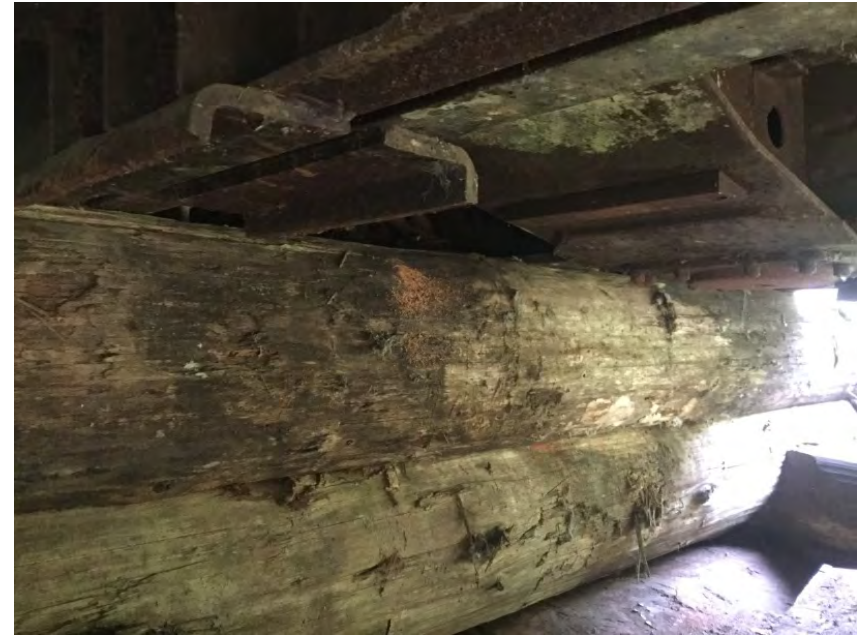
Right bank bearing

Log/Timber Cribbs Fair Old rotting crib on right bank in front of bearing crib behind - bearing cribs in fair condition

Caps or Sills Fair Sill logs loosely lashed to top crib face log with up to 30mm sap rot - no crushing evident

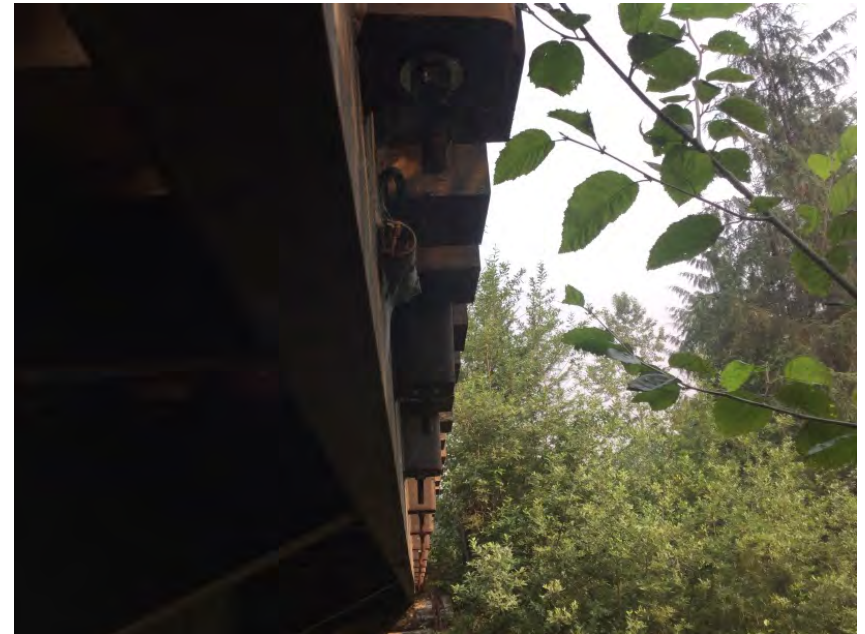
Deck fasteners

Hardware      **Fair**      Loose lashing

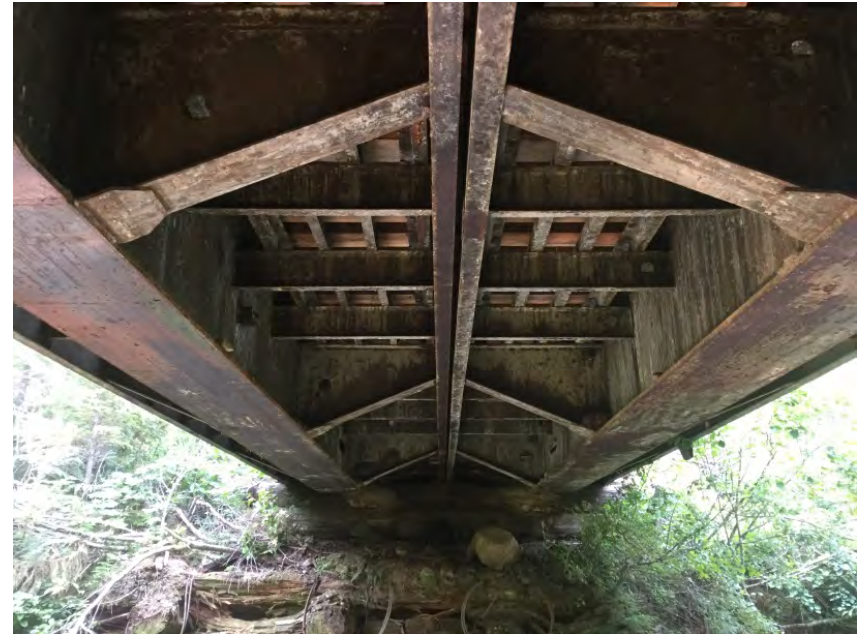
Superstructure

The FERIC Technical Report SR98 indicates BC Railcars are classified as "temporary" with an estimated service life of 10 years, subject to regular inspections. The Ministry does not have any information on when this structure was installed and as such needs to be monitored, especially while in use. According to SR98 when spanning 16 meters, the live load rating is L75 (68,040 kgs); however given the condition of the cribs I recommend reducing the load capacity by 5% and the load rating of L60 or 54 tonnes be assigned. Install log fenders at both approaches, place bridge ahead signs, and post the load rating.

Girders Fair
