## Permanent Bridge Inspection Report

| Structure #: | CK-2395 | Site #: | CK-2395 | Road Name: | ENGLISH CREEK | Inspection Date: | 2017/08/01 |
| KM: | 0.30 | User km: | 0.30 | Crossing Name: | Big Silver River | Next Inspection Date: | 2020/08/01 |

2017 Inspection

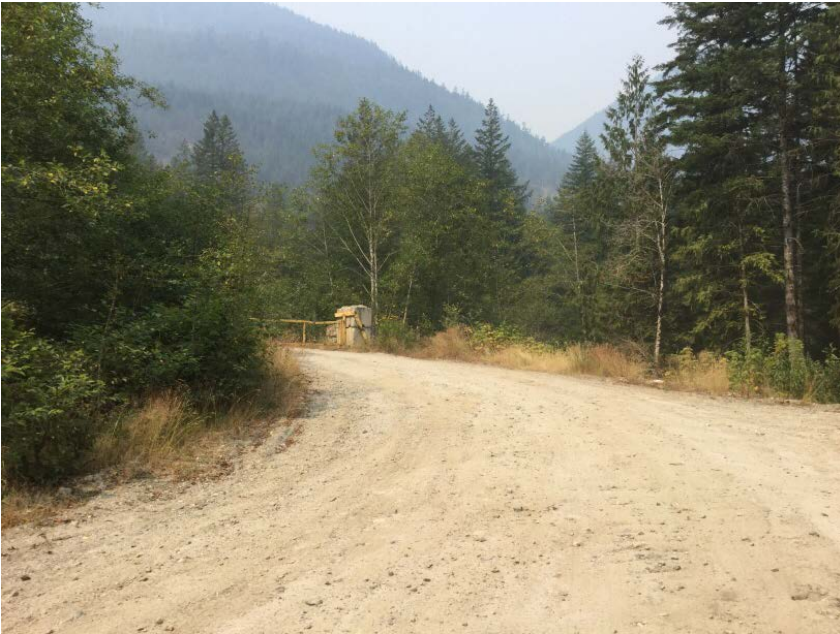
Approach from Left Bank when facing downstream

| Alignment | Fair | HC both approaches |

| | 1 | Required | Medium | \$5,000.00 | brush and grade both approaches | | | |

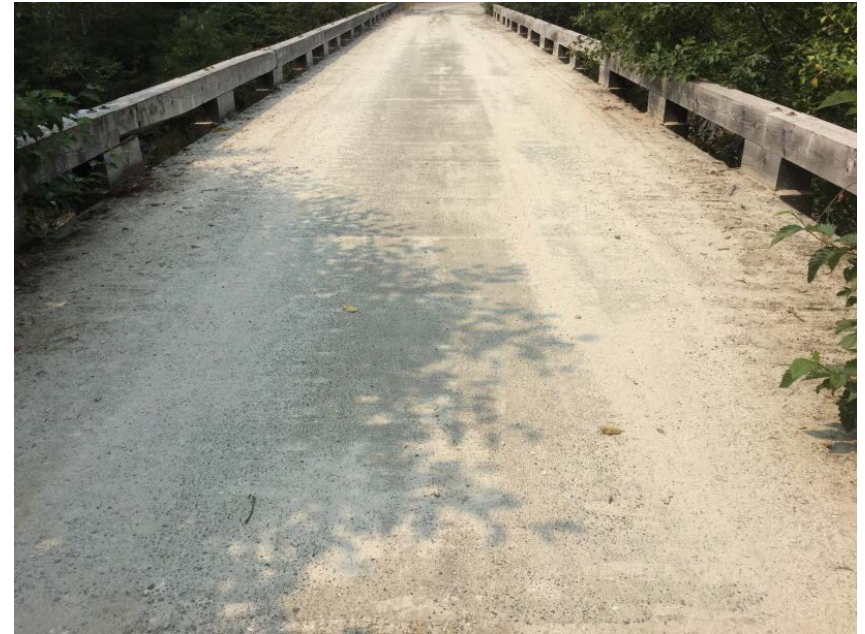
| Overall Deck Condition | Fair | | | | | | | | | |
| Running Surface | Fair | debris on deck | | | | | | | | |

| | 2 | Required | Medium | \$1,000.00 | clean sediment off deck | | | |

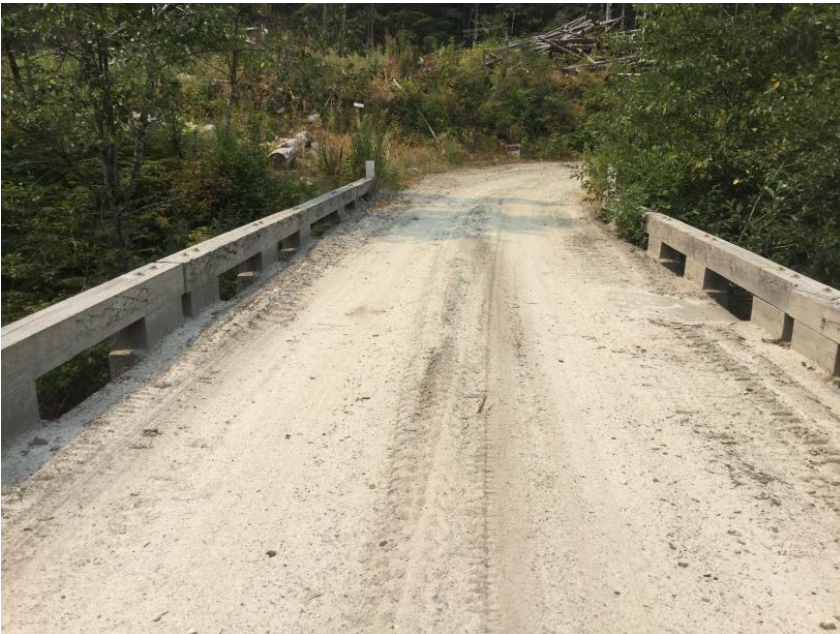
Sediment on deck at right approach
