CK-2400

NESAKWATCH LAKE 1.07km

2017 Inspection

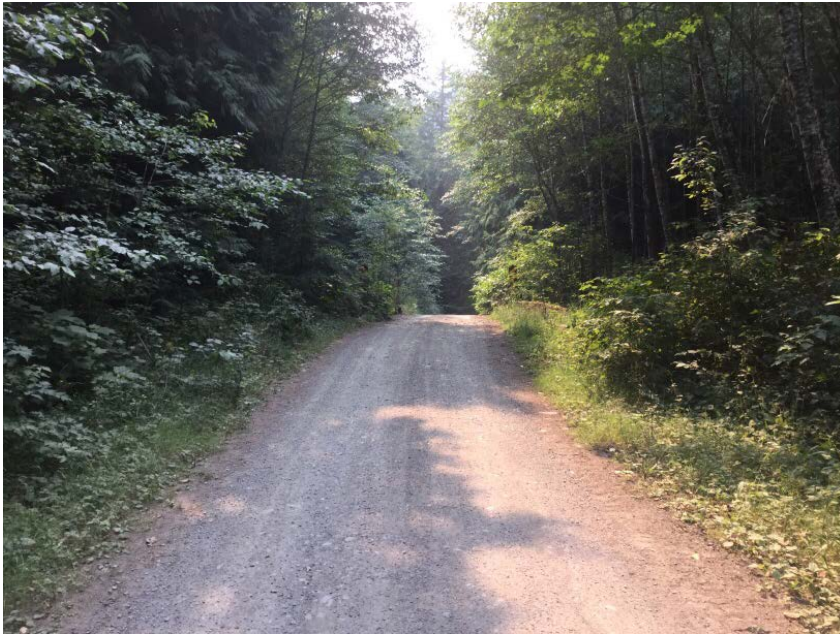
Approach from Left Bank when facing downstream

Post bridge ahead signs. Brush and grade approaches. Monitor deformation along wheel path of deck. Current load rating of L75 or 68 tonnes to continue.

| 1 | Medium | Brush and grade approaches |

| 2 | Medium | Post bridge ahead signs |

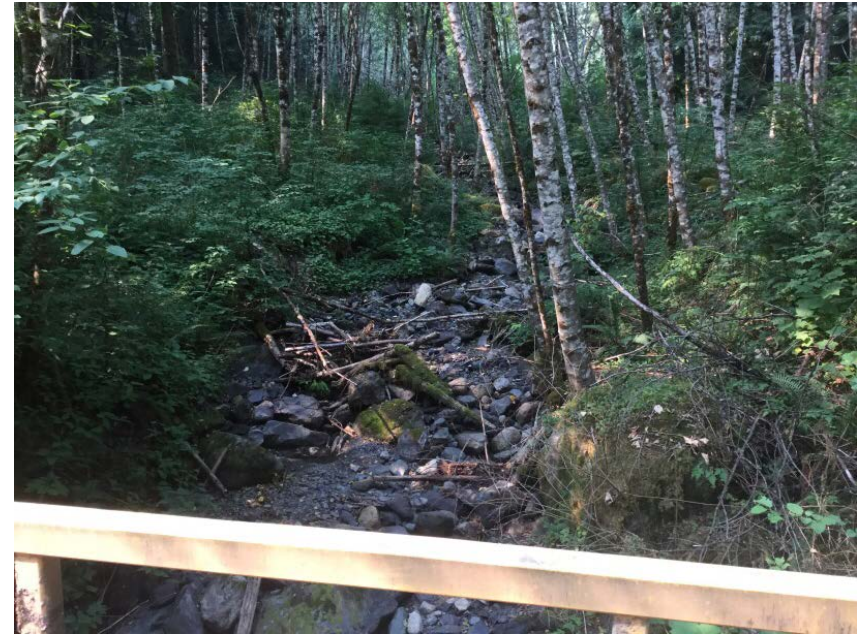
Looking upstream from deck

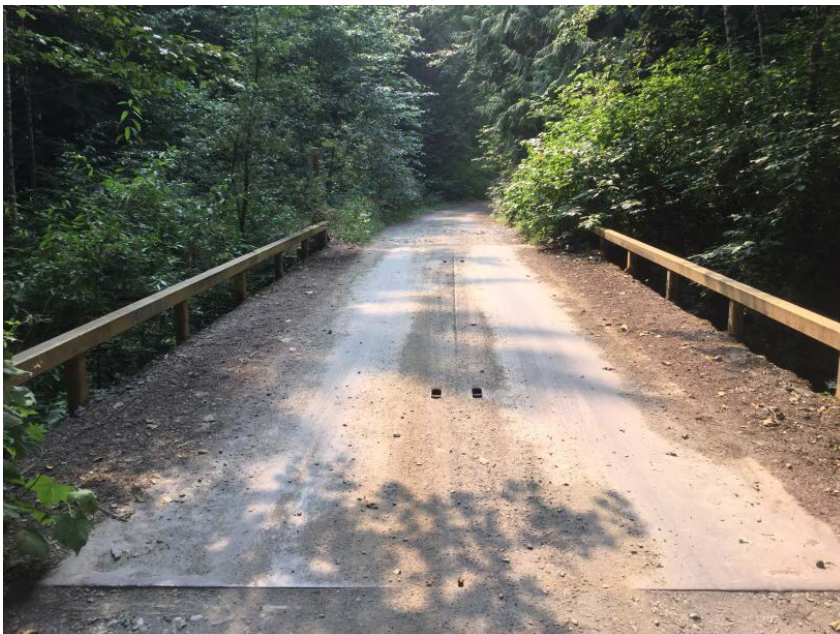
Steel Deck Plate      Fair      Some deformation along wheel path

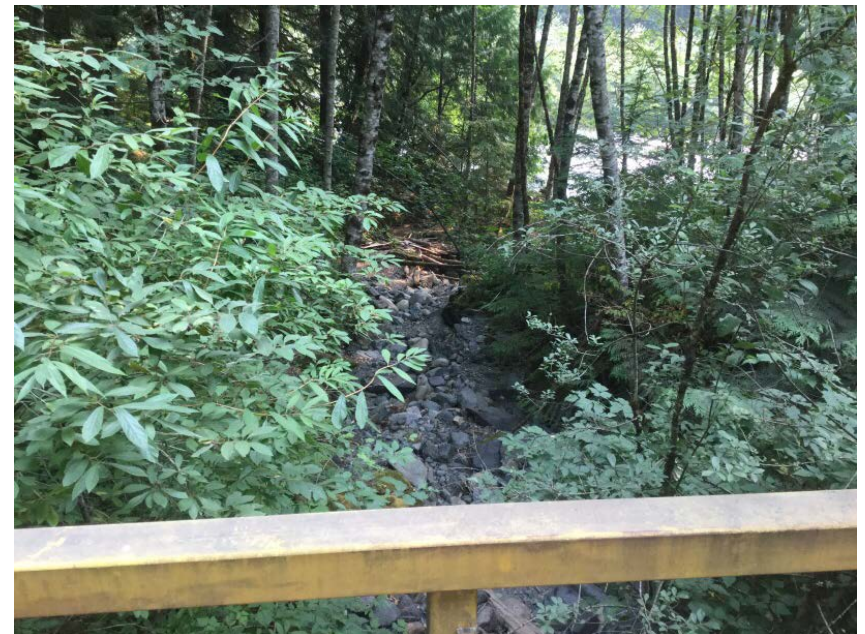
Looking downstream from deck

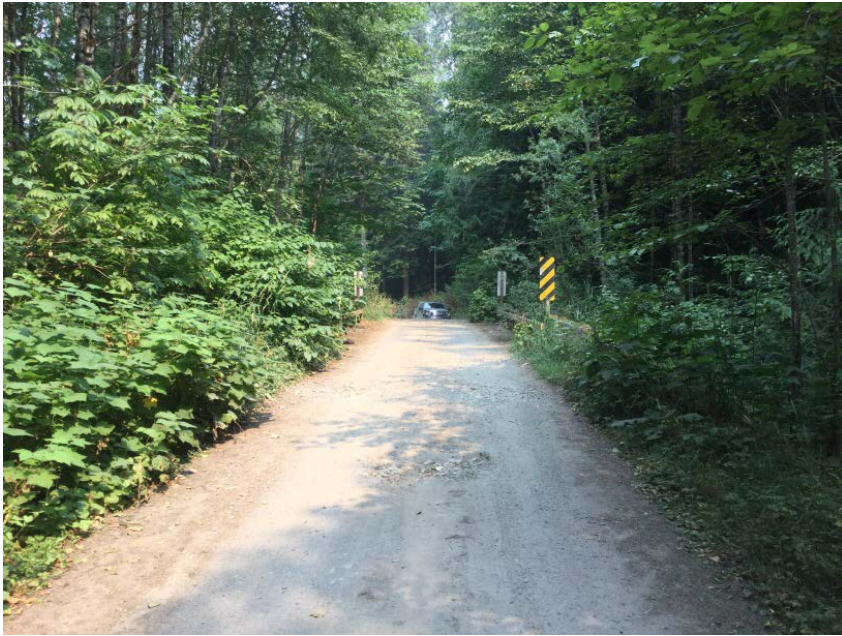
Approach from Right Bank when facing downstream

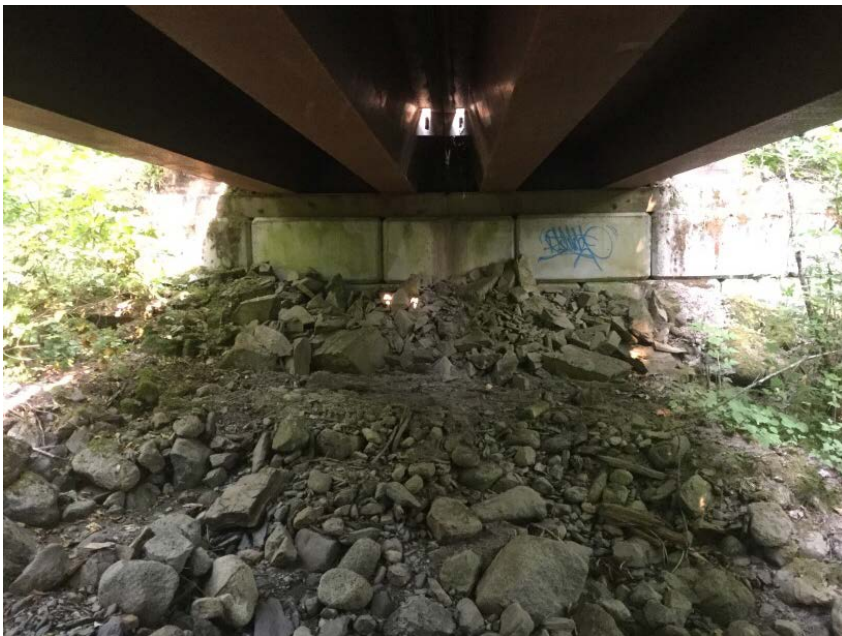
Left Bank Abutment when facing downstream

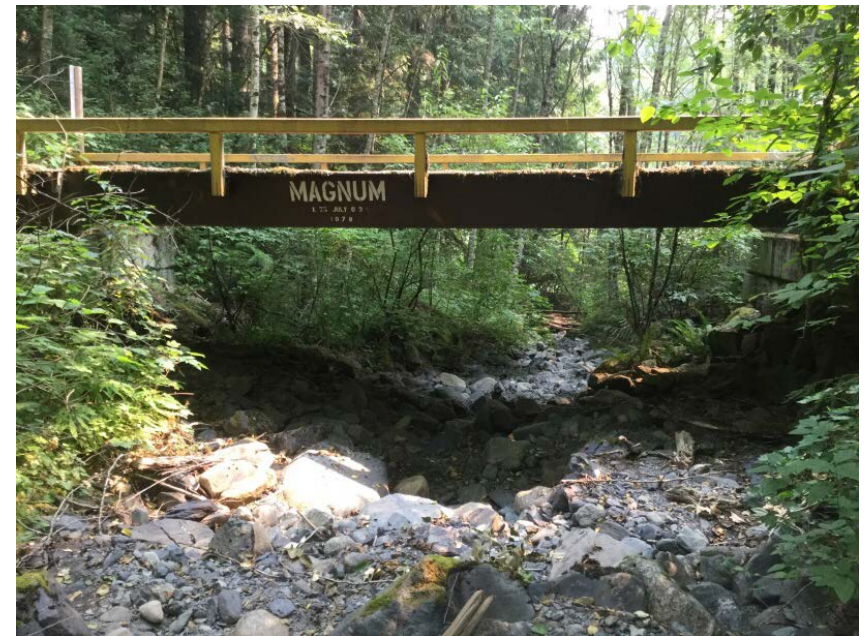
Upstream Profile

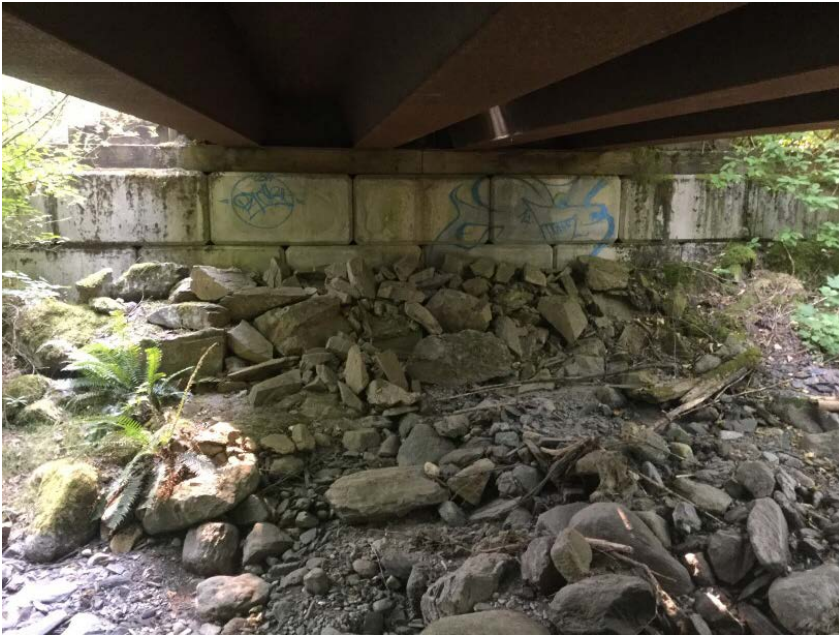
Right Bank Abutment when facing downstream

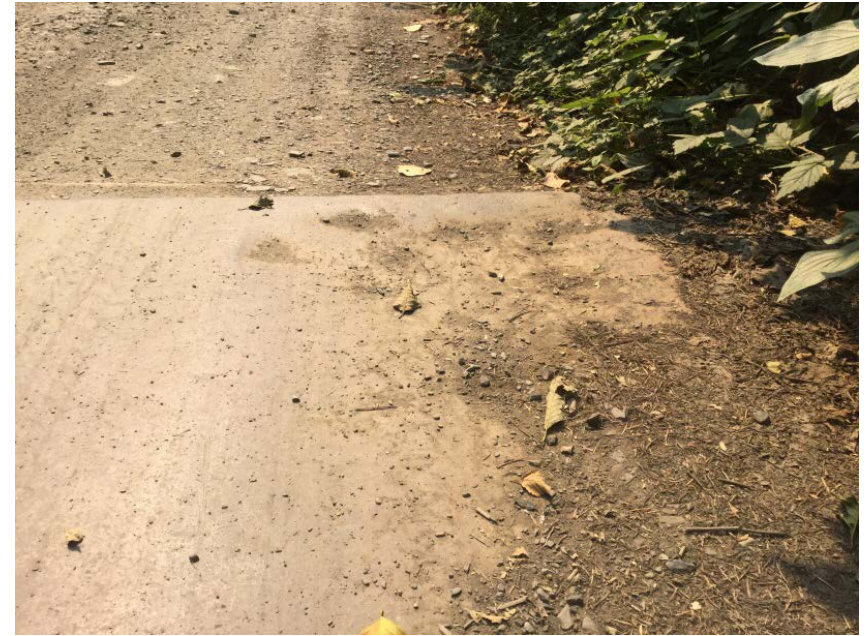
Steel deck plate deformation, up to 25mm deformation in locations
