CK-2406

PITT RIVER 18.5km

2017 Inspection

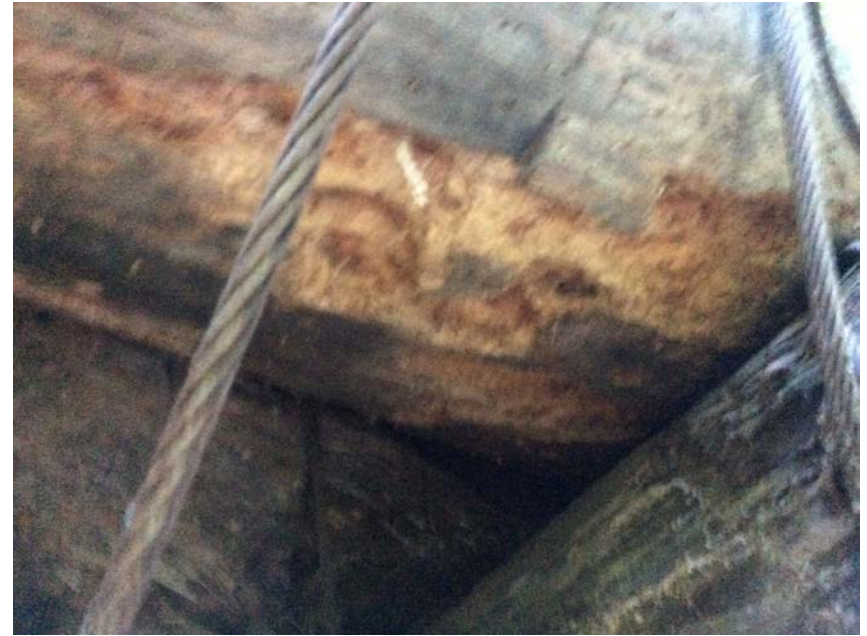
Stringers

Appears to be good bridge. stringer 1 has woodpecker damage and should be replaced. Other stringers were cored without issue.

| Item | Priority | Repair Description |
|---|---|---|
| 1 | Medium | Stringer 1 shows woodpecker damage due to rot. Replace |

L100 or 91 tonnes load rating. Update load rating sign. Replace stringer 1.
