CK-2417

STAVE RIVER 13.1km

2017 Inspection

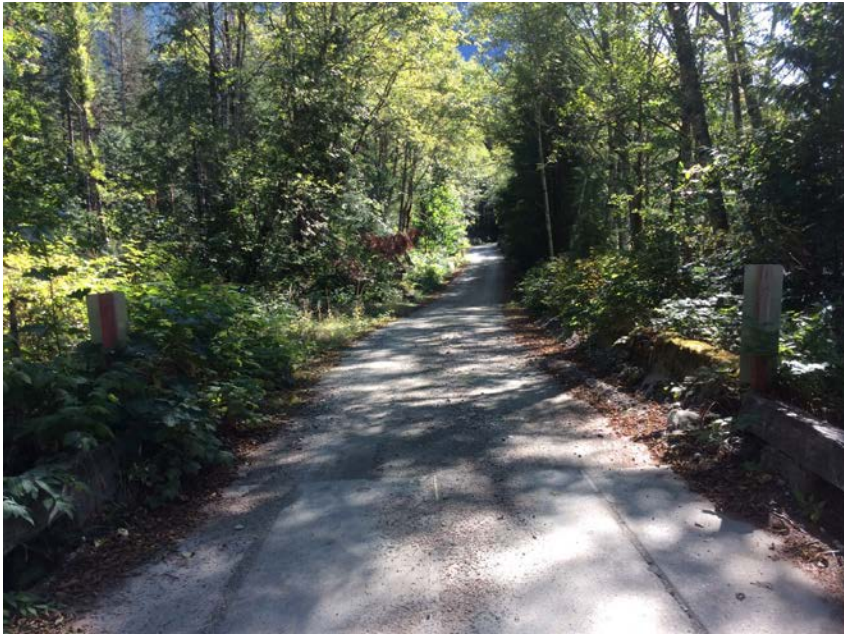
Left approach viewed from bridge

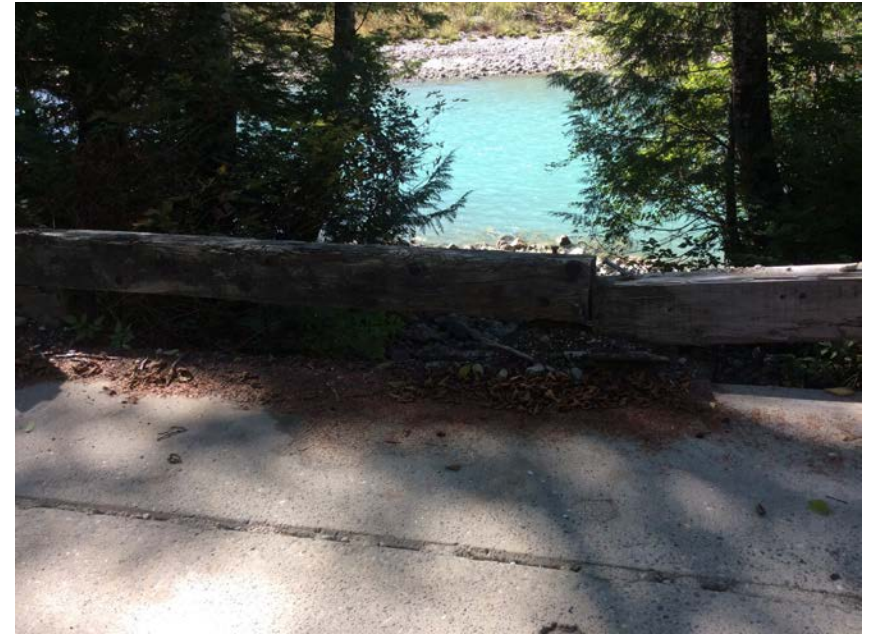
| Curb Rail/Blocks/Posts | Poor | Missing and damaged risers, rotten guardrails |

Guard Rail

Replace guardrail, risers and blocks. Replace the joint seals between each concrete slab. Present load rating of 30 tonnes to continue - post load rating sign.

| Repair Item | Priority | Repair Description |
|---|---|---|
| 1 | Medium | Replace guardrails for industrial use |

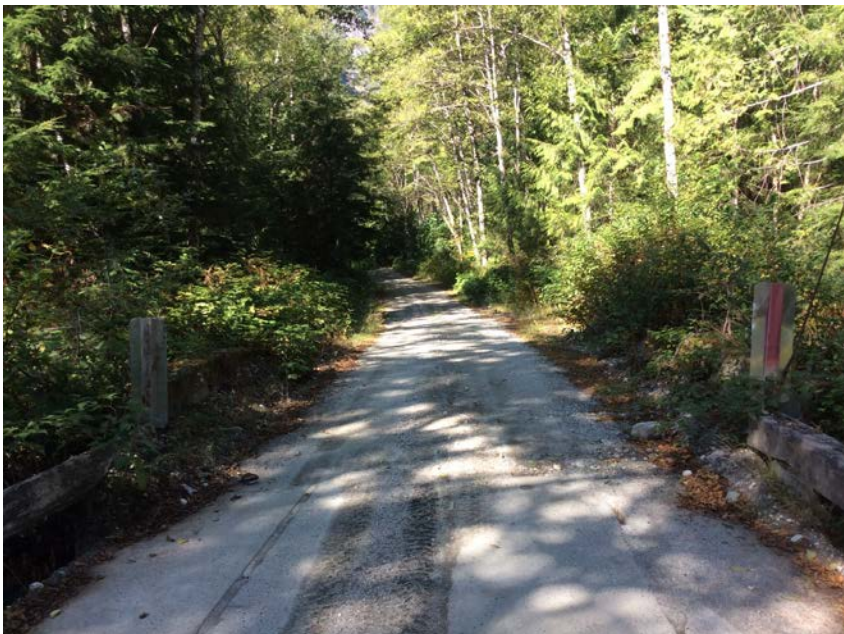
Right approach viewed from bridge

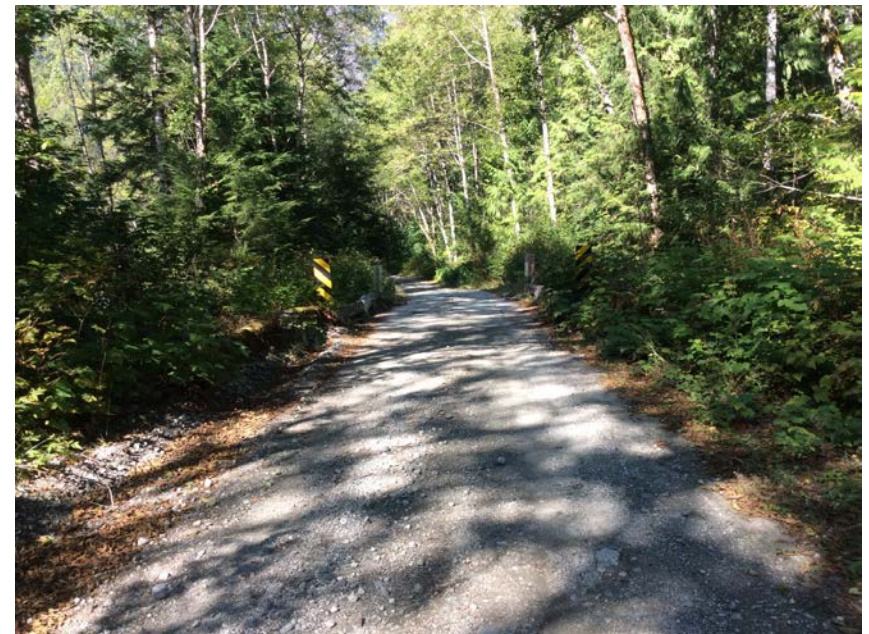
Approach from Left Bank when facing downstream

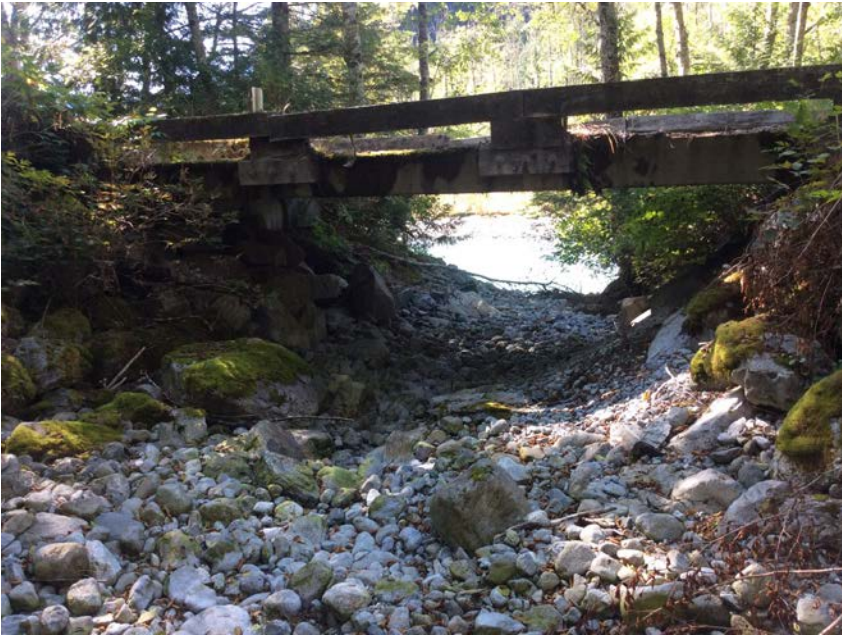
Upstream Profile

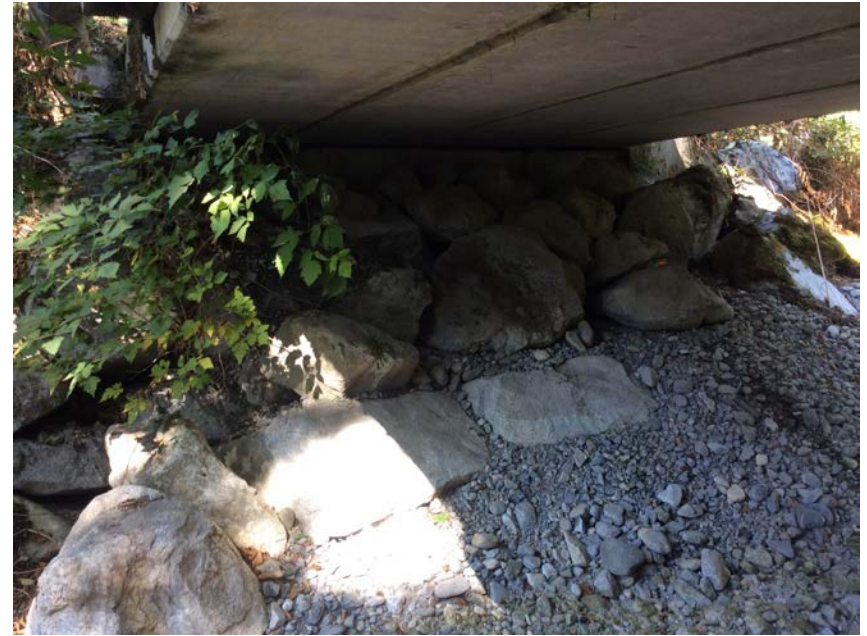
Right Bank Abutment when facing downstream

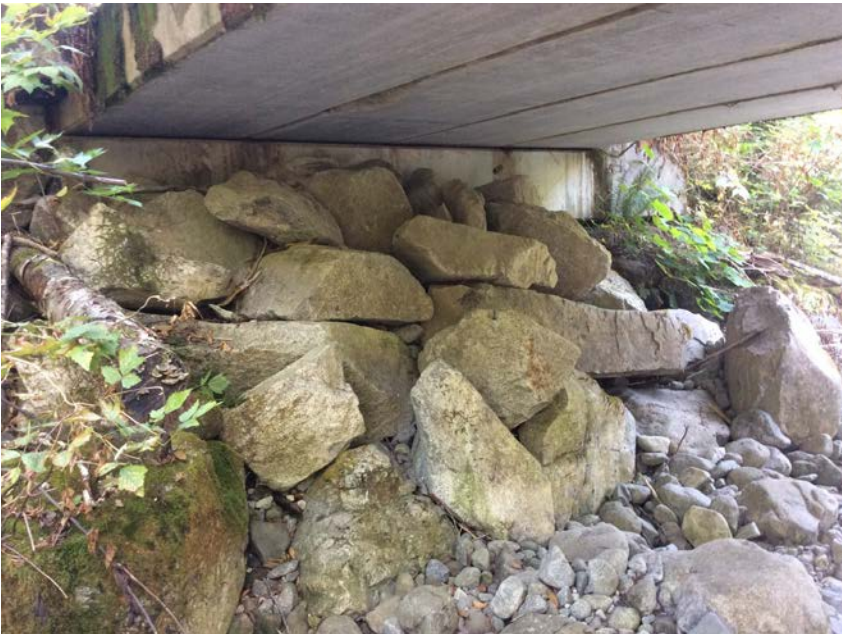
Left Bank Abutment when facing downstream

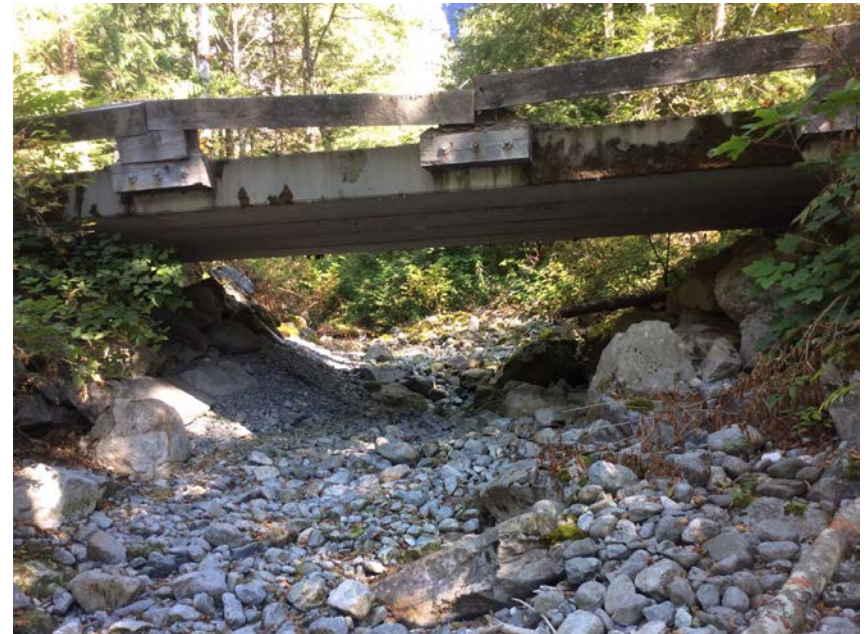
Downstream Profile

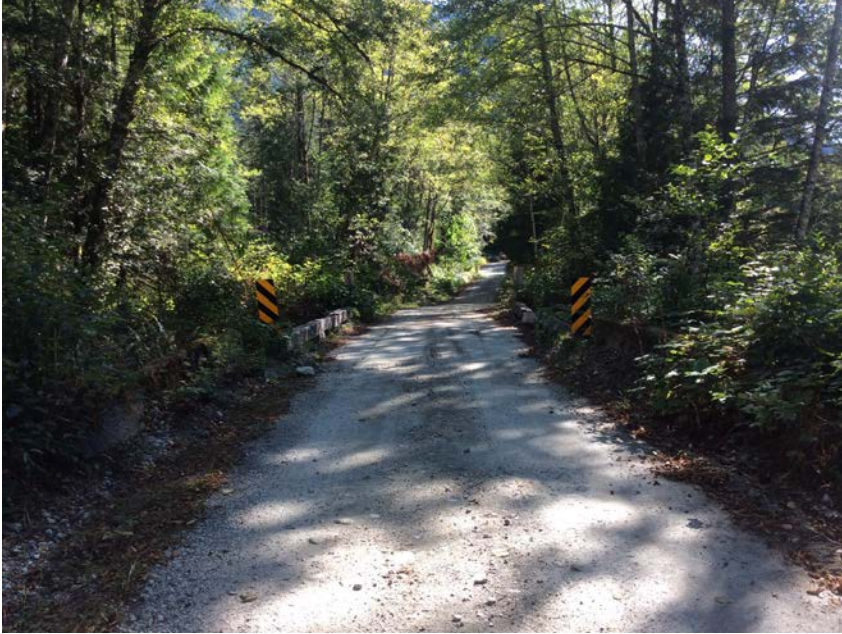
Approach from Right Bank when facing downstream
