CK-2441

DEWDNEY WEST 1.5km

2017 Inspection

| Crossing Name | Fifteen Mile Creek |

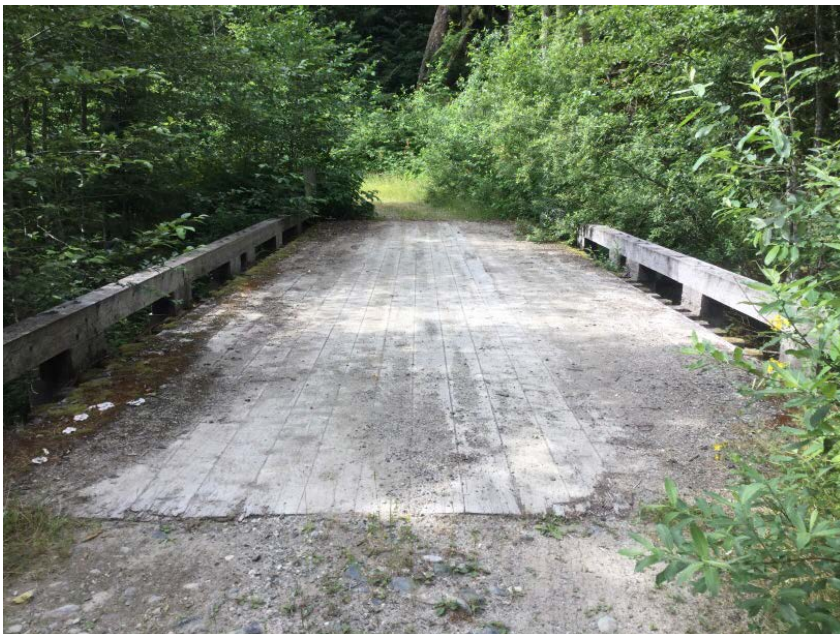
Deck

Check age of structure as deck is now starting to show signs of decay and should be replaced prior to industrial use

Running Planks      Fair      Wearing on wheel path at both ends

Ties      Fair      Starting to show signs of decay

| Item | Priority | Repair Description |
|---|---|---|
| 3 | Medium | Replace ties, planks, guardrail and risers prior to industrial use |

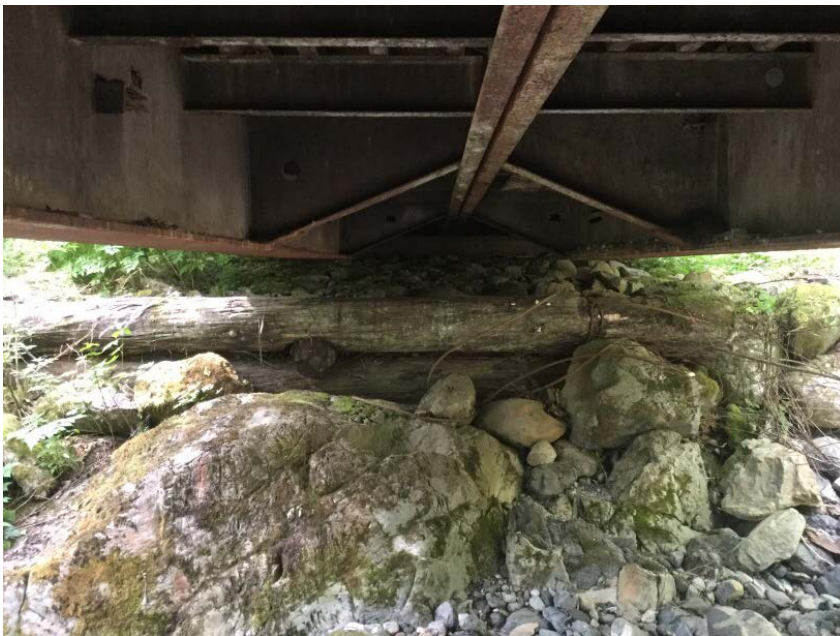
Right Bank Abutment when facing downstream

Lock blocks (5) each abutment

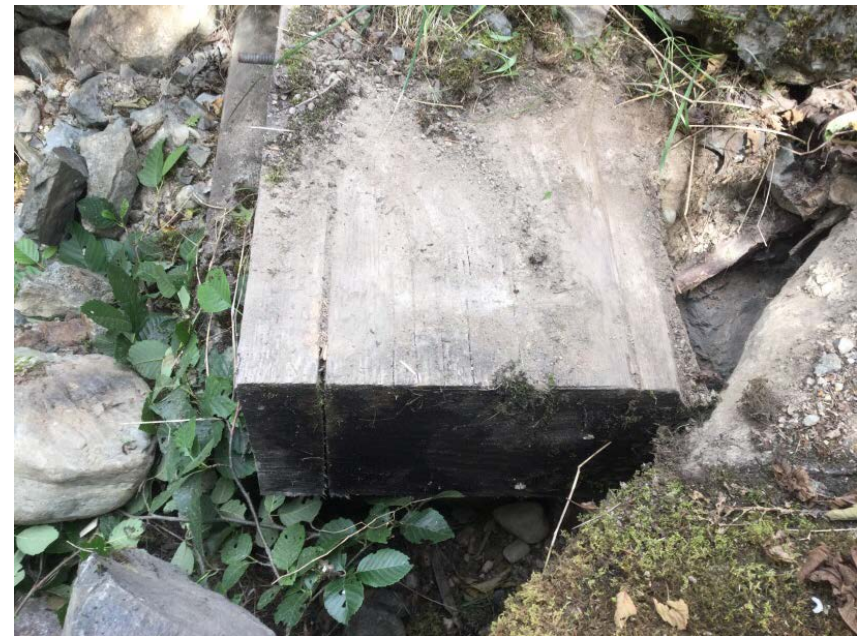
Timber sill

Caps or Sills Fair

Timber - 300mm x 300mm with a 75mm x 300mm attached to both faces
