CK-2442

AMERICAN EIGHT 0.15km

2017 Inspection

| Crossing Name | American Creek |

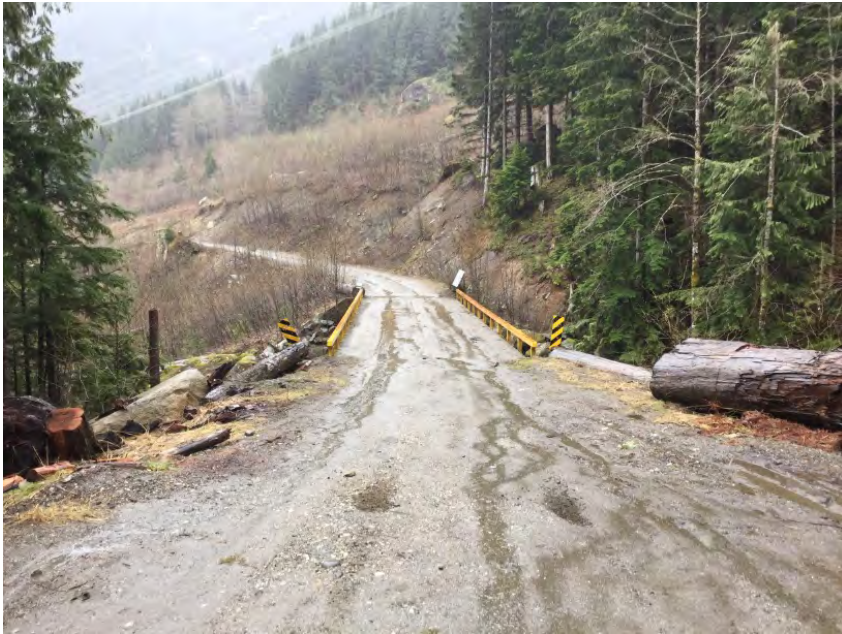
Approach from Left Bank when facing downstream

Fender Condition Fair Left downstream undersized and rolling off road

| Item | Priority | Repair Description |
|---|---|---|
| 3 | Medium | Replace fender log at left downstream approach when active |

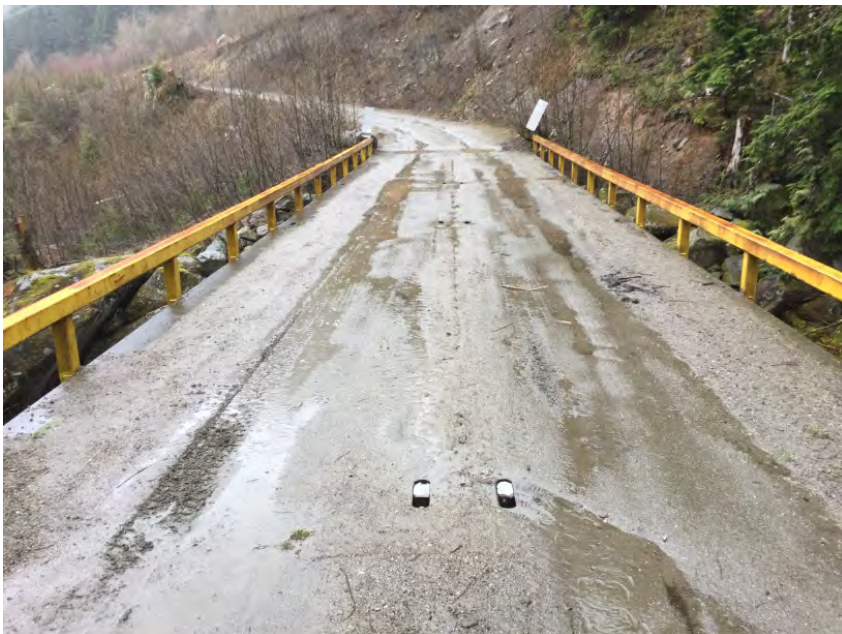
Running Surface      Fair

Steel Deck Plate      Fair

Overall Deck Condition      Fair

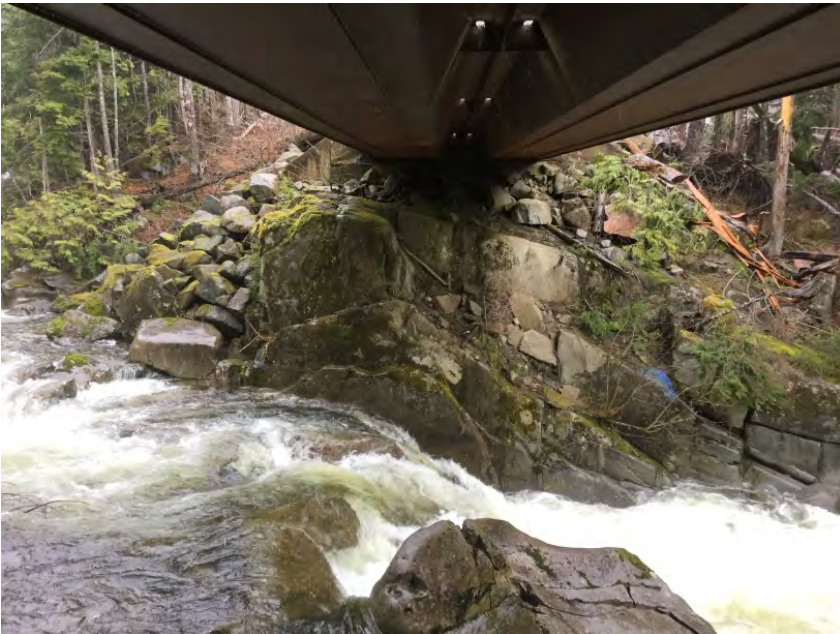
Left Bank Abutment when facing downstream

Concrete Good

Caps or Sills Good

Riprap Good BR left bank

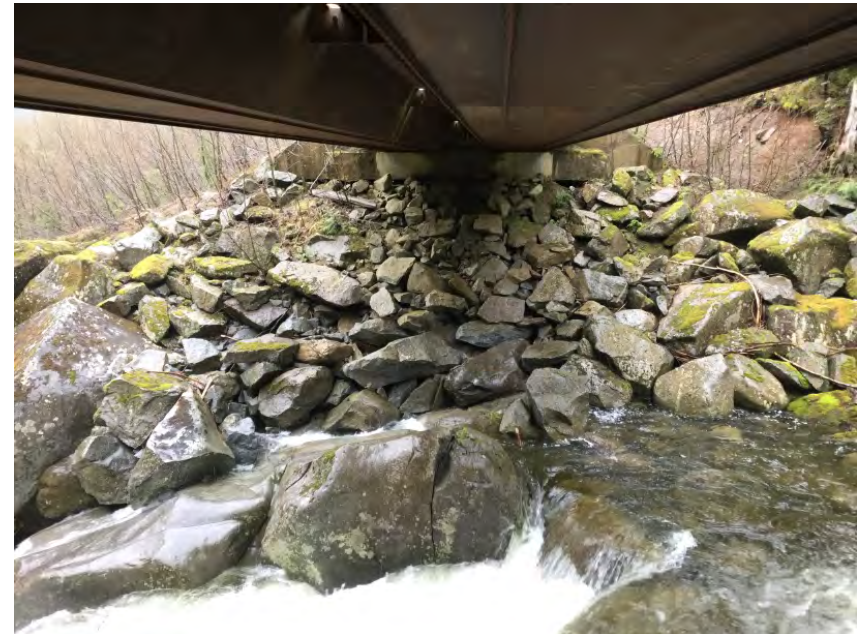
Right Bank Abutment when facing downstream

Piles or Posts Good
