CK-2446

NORRISH CREEK 16.3km

2017 Inspection

| Crossing Name | Tom Creek |

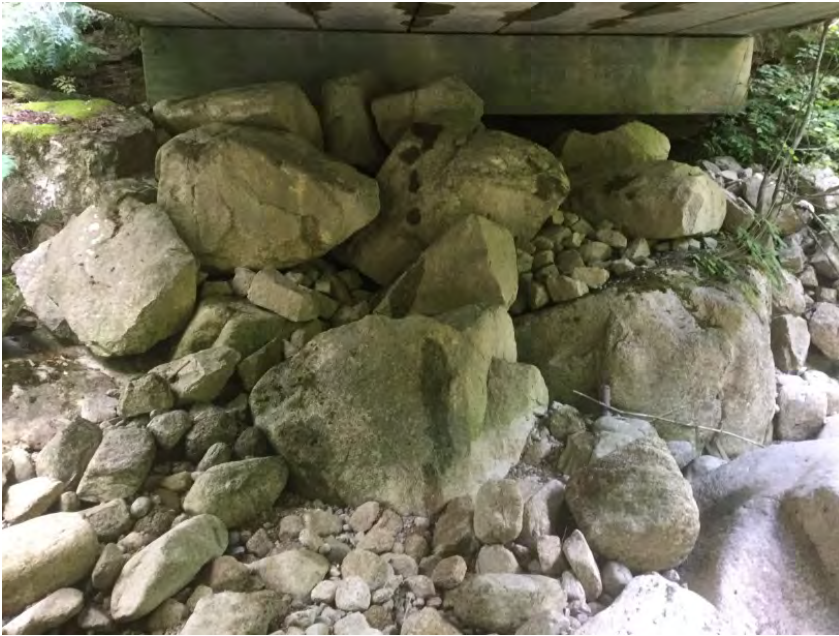
Left Bank Abutment when facing downstream

Precast footings are partially visible at left abutment, monitor fill under these pads

Monitor fill under left bank precast footings. Replace missing delineator, brush approaches.  
Current load rating of L165 or 150 tonnes to continue.
