CK-2450

NORRISH CREEK 5.1km

2017 Inspection

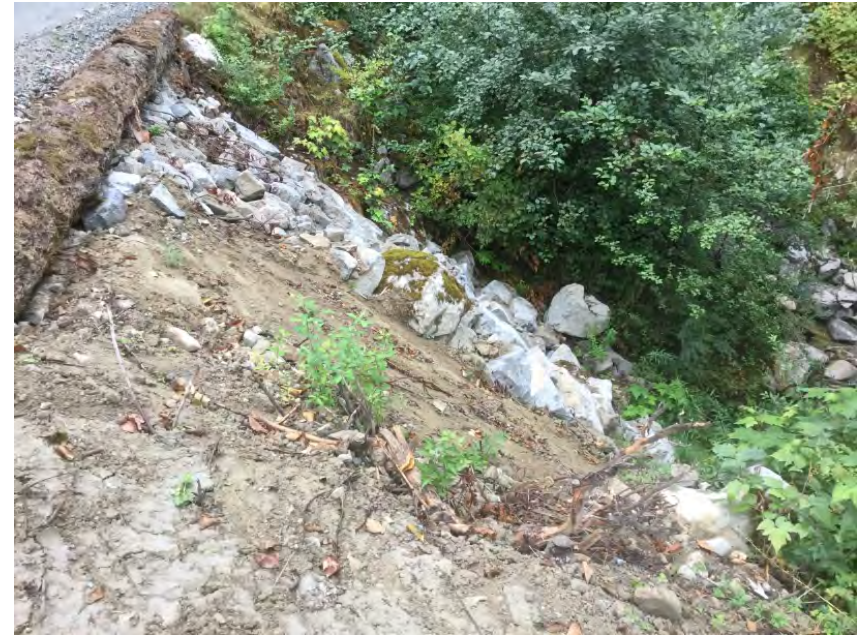
A recent fill slope failure occurred at the downstream right approach. The base of this repair is immediately above the location of the large log retaining fill. If that log moves there is risk that all the fill below culvert (and perhaps the road prism itself) will fail as well. Recommend replacing the large log before that happens

Downstream right approach fill slope repair

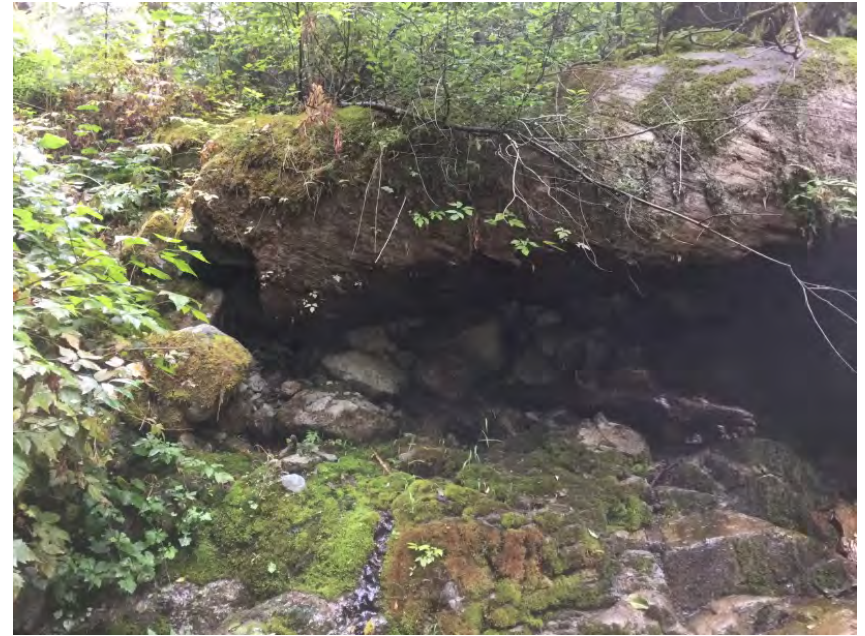
Fair to poor as fill slope below culvert is held in place by a large log on erodible materials

Log retaining fill not anchored on right bank

Monitor log retaining fill at outlet of culvert. Consider replacing log with permanent materials or replace the entire structure. Current load rating of BCL-625 or 63 tonnes to continue.

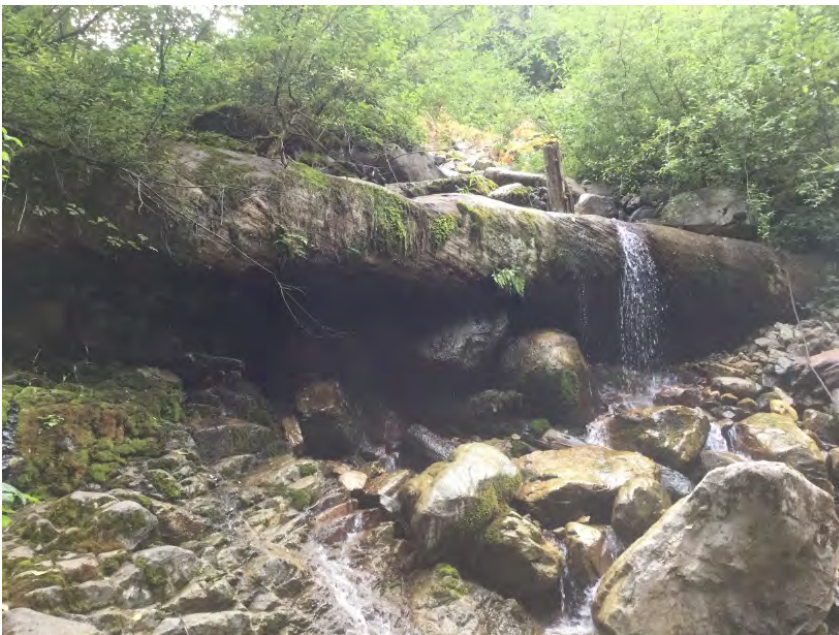
Log retaining much of the fill below culvert

| 1 | Large log retaining fill | Anually |

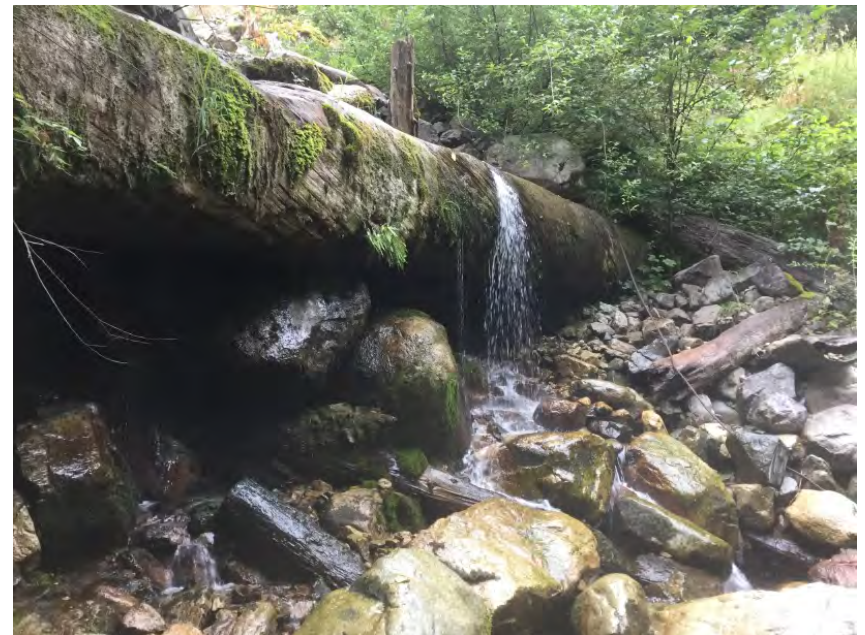
Log retaining fill anchored in middle (approx) and left bank

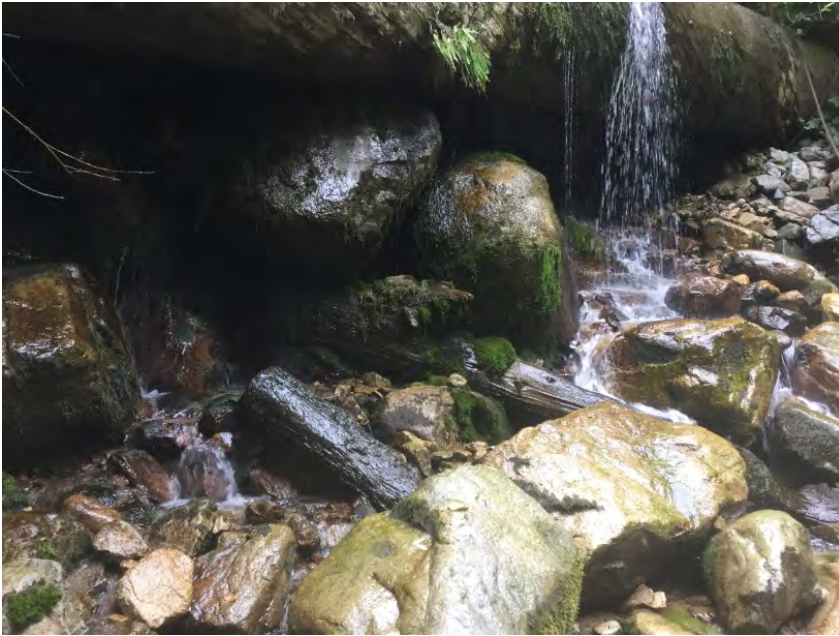
Log retaining fill middle anchor bears on organics (old log)

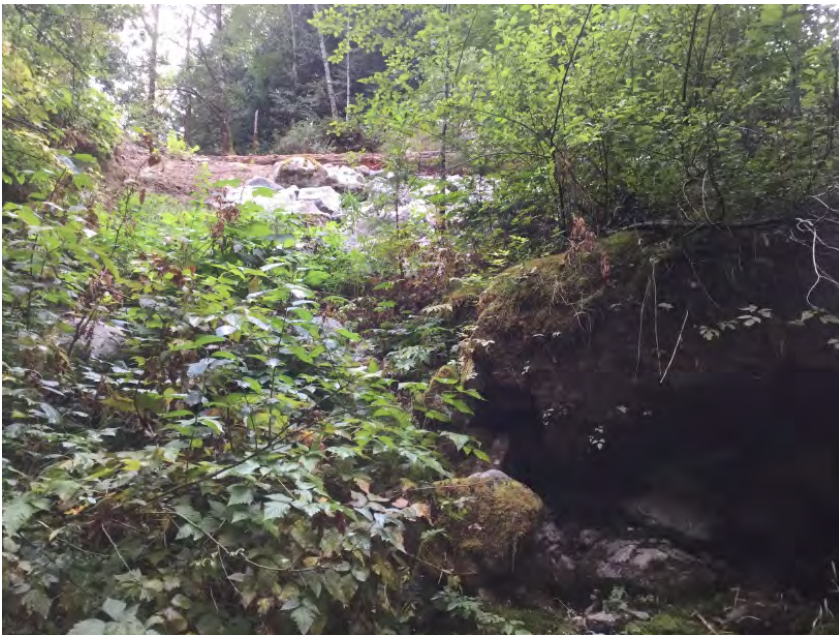
Downstream right bank fill repair immediately above large log retaining fill
