CK-2451

NORRISH CREEK 5.6km

2017 Inspection

| Structure Class | Major Culvert |

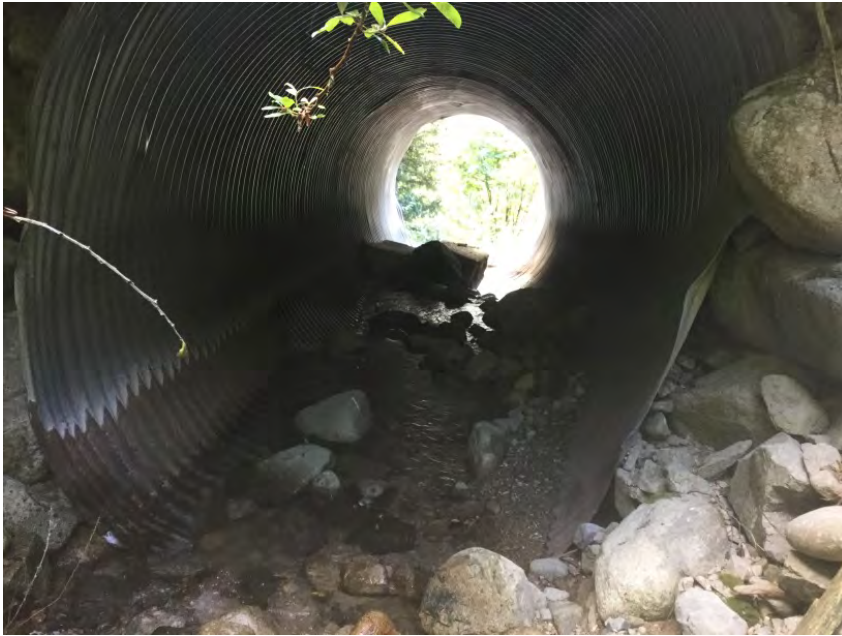
Inlet

Some damage but still functional

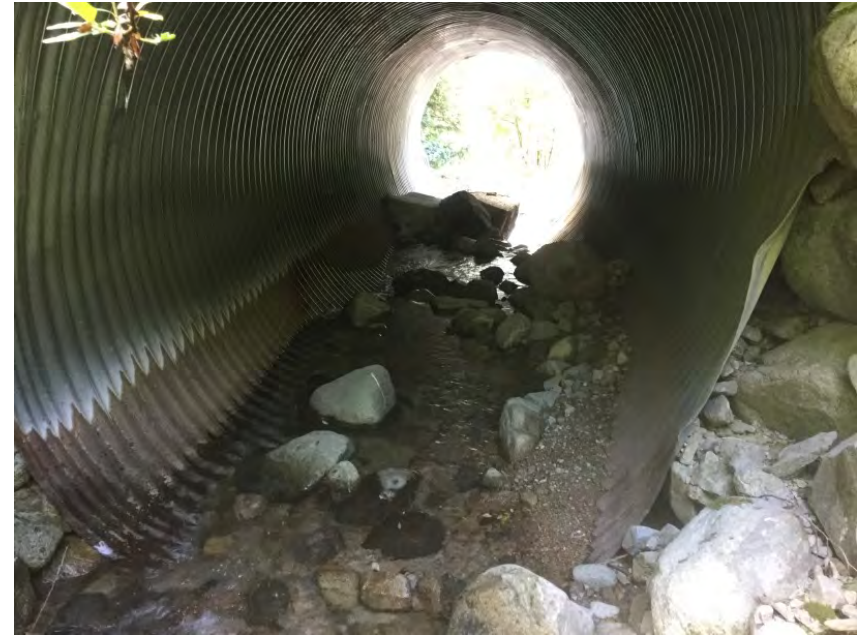
Comments    Material is being transported into the culvert and should be cleaned

Material being washed into the culvert

| Item | Priority | Repair Description |
|---|---|---|
| 1 | Medium | Remove material from within the culvert and consider digging a sump |

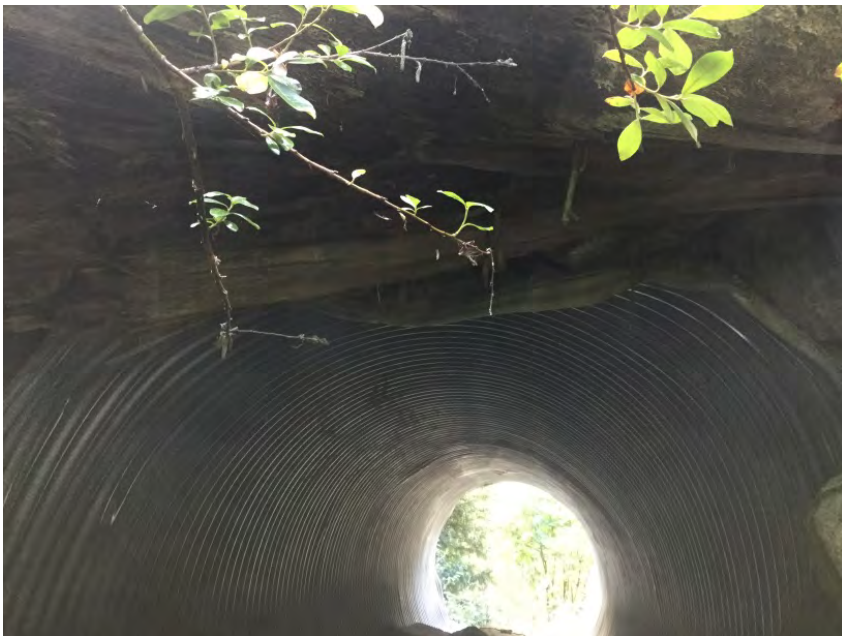
Roof damage
