CK-2454

NORRISH CREEK 8.2km

2017 Inspection

| Structure Class | Major Culvert |

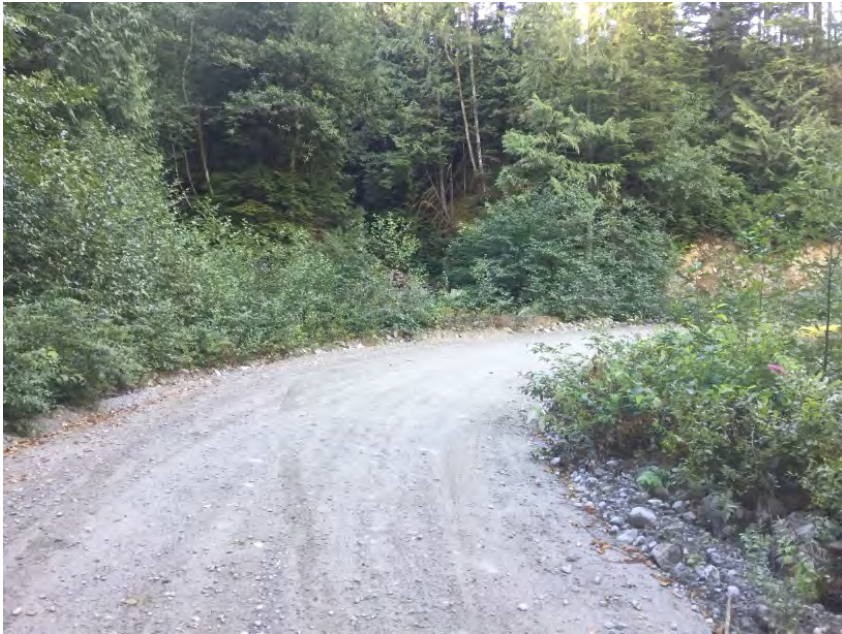
Approach from Right Bank when facing downstream

| 2 | Low | Brush approaches |

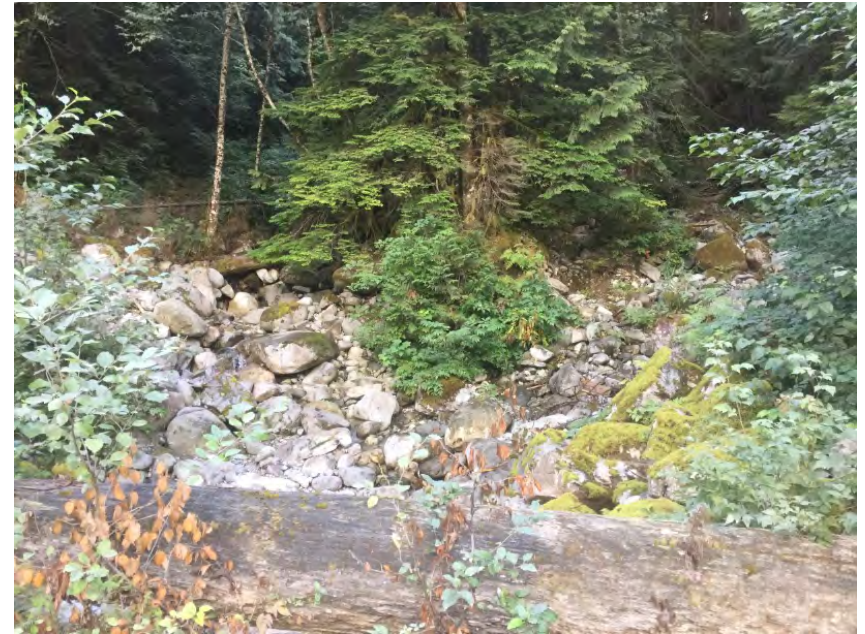
Looking upstream from road

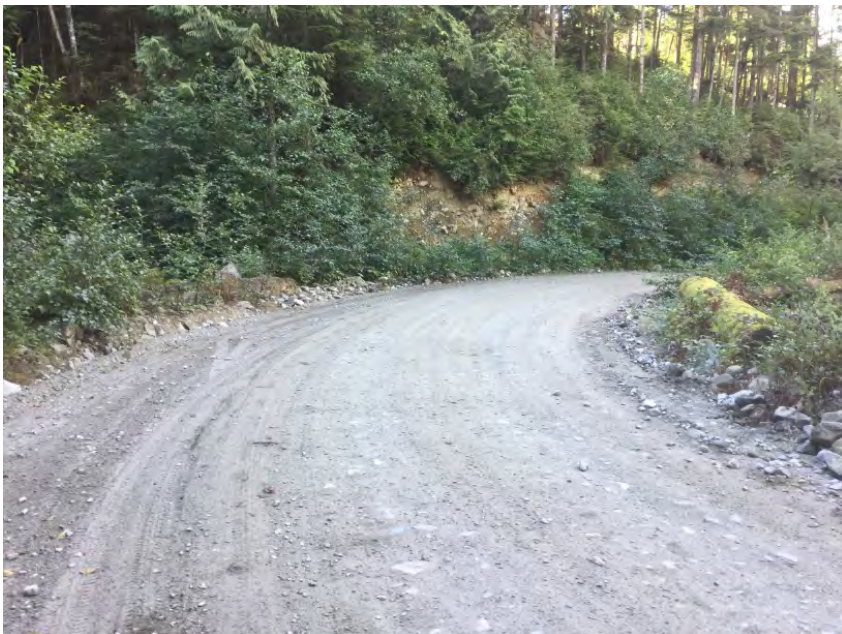
Approach from Right Bank when facing downstream

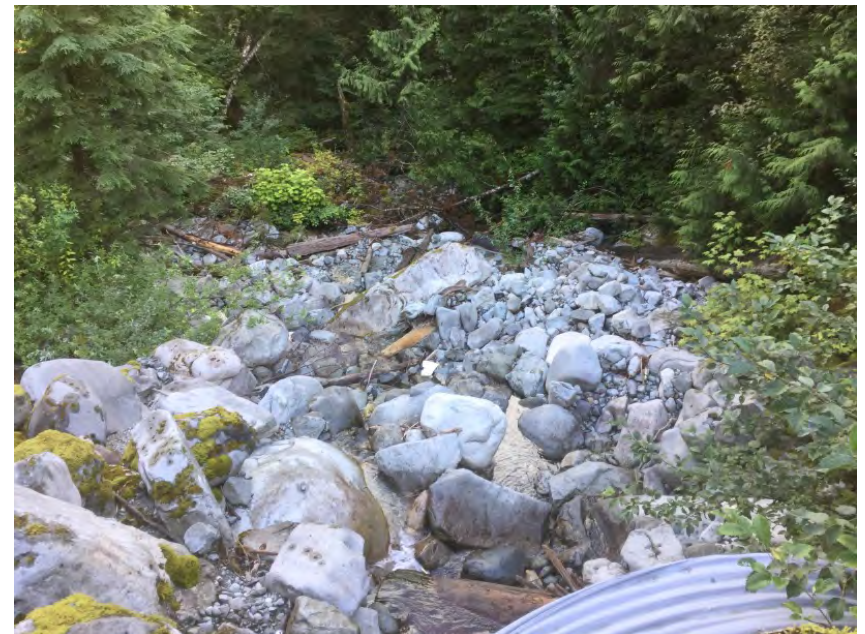
Looking downstream from road

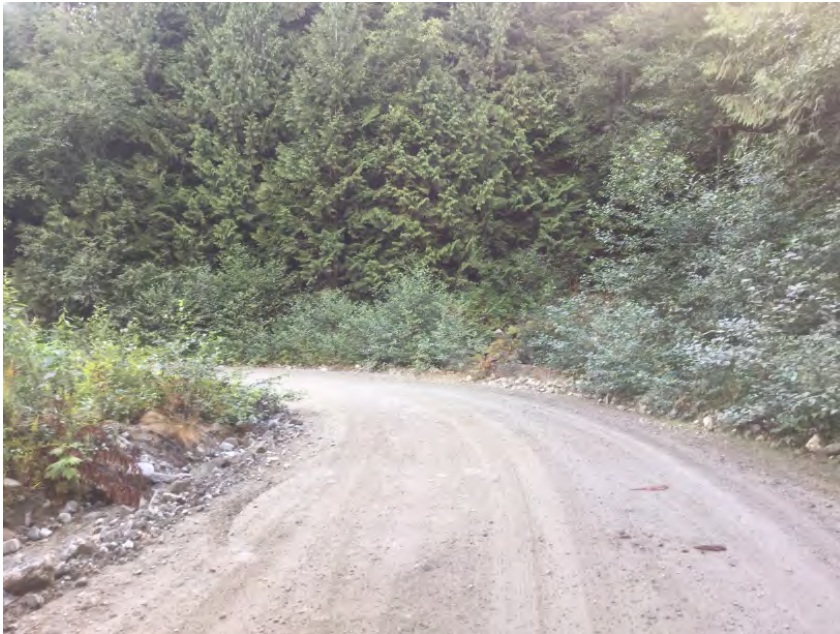
Approach from Left Bank when facing downstream

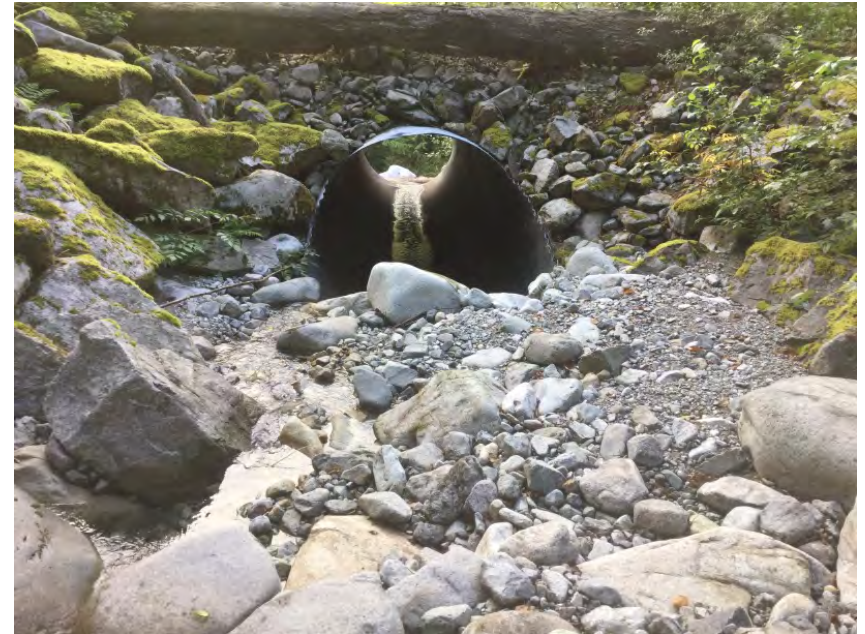
Inlet

Fair to poor as it is 50% plugged

| 1 | Medium | Clean inlet |

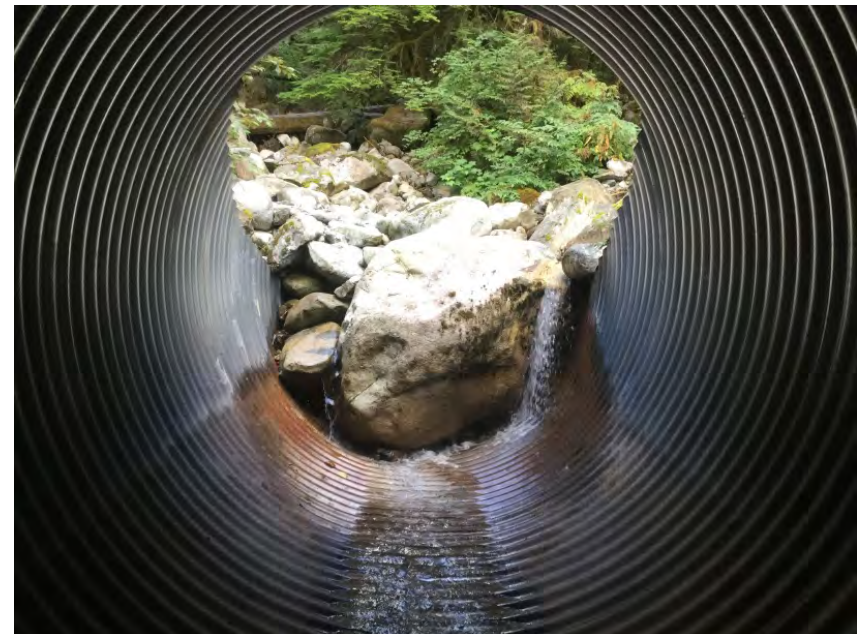
Inlet 50% plugged

Clear partially blocked inlet and brush approaches. Current load rating of L165 or 150 tonnes to continue.
