CK-2455

NORRISH CREEK 8.5km

2017 Inspection

| Structure Class | Major Culvert |

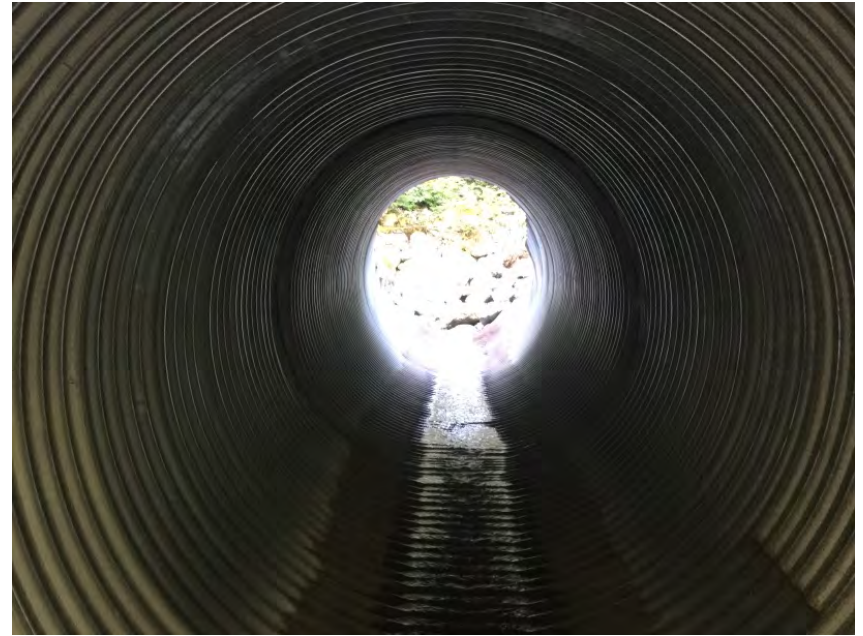
Inlet      Good

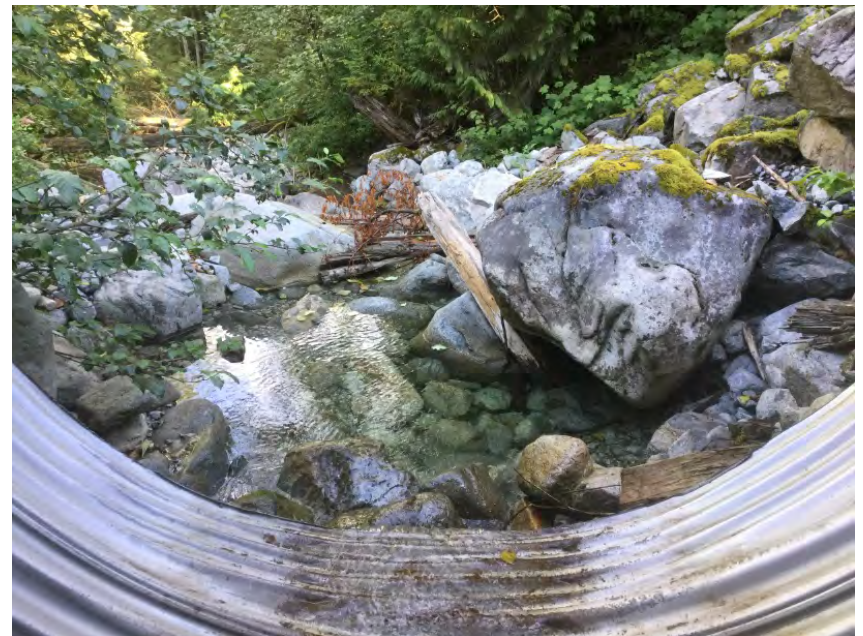
Outlet      Good
