CK-2456

NORRISH CREEK 9km

2017 Inspection

| Structure Class | Major Culvert |

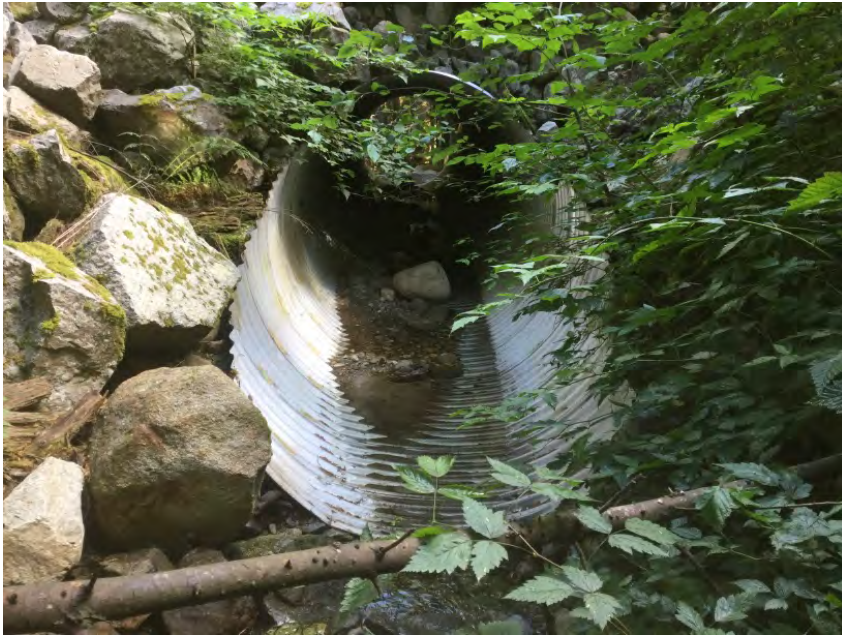
Inlet

Comments    Monitor material being transported into culvert, low gradient stream

| Item | Monitor Description | Frequency |
|---|---|---|
| 1 | Monitor material being transported into culvert | Routine Inspection |
