CK-2457

NORRISH CREEK 13.6km

2017 Inspection

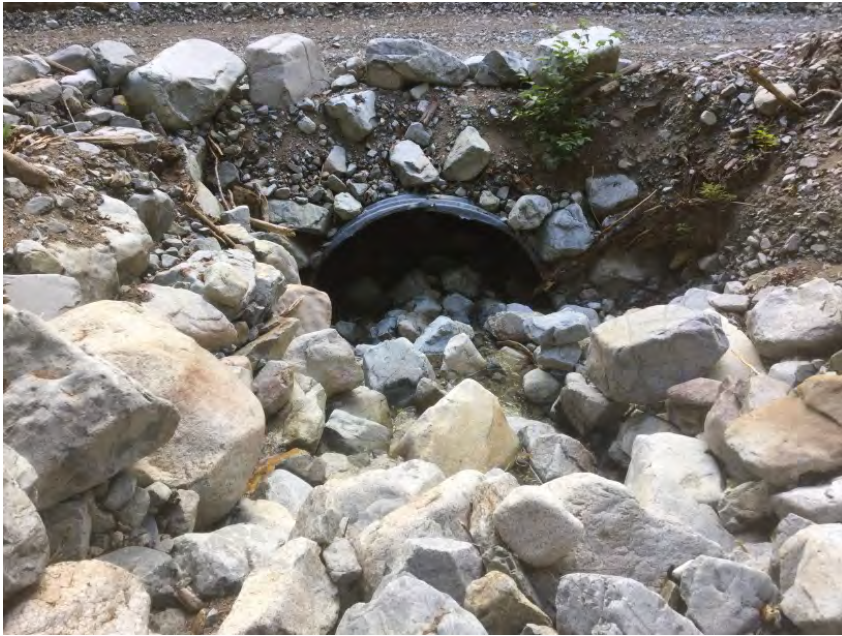
Inlet

Aggrading, approx 50% full

| Estimated Present Water Level Width (m) | 1.5 | Aggradation | <input checked="" type="checkbox"/> | Scour | <input type="checkbox"/> |

Comments Stream aggrades consistently, consider replacing this structure

Consider replacing structure with a large culvert or bridge

Monitor aggradation following heavy rainfall or rain on snow events. Consider replacing with a larger culvert or bridge. Current load rating of BCL625 or 63 tonnes to continue.

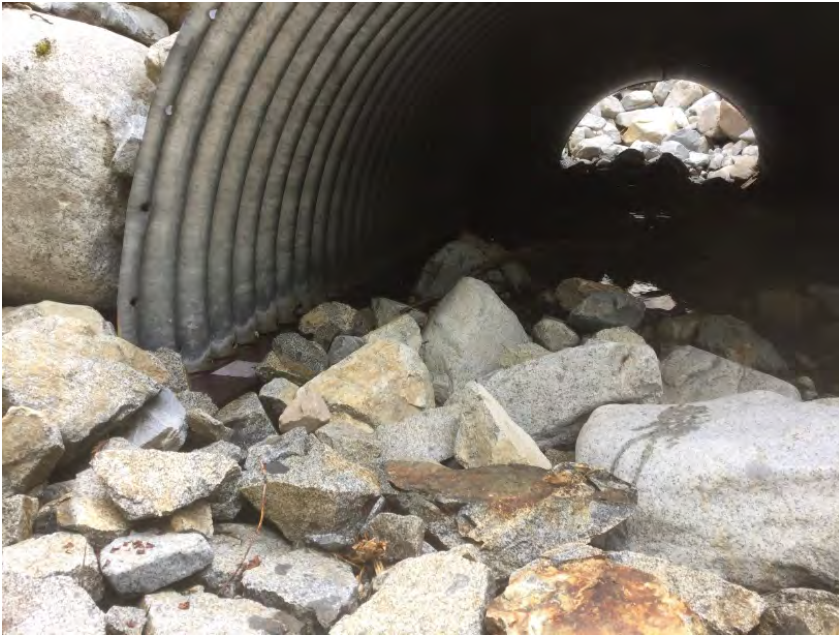
Has been repaired since last inspection

Consistent bearing on both footings, right bank shown
