CK-2458

NORRISH CREEK 19.9km

2017 Inspection

| Structure Class | Major Culvert | | |

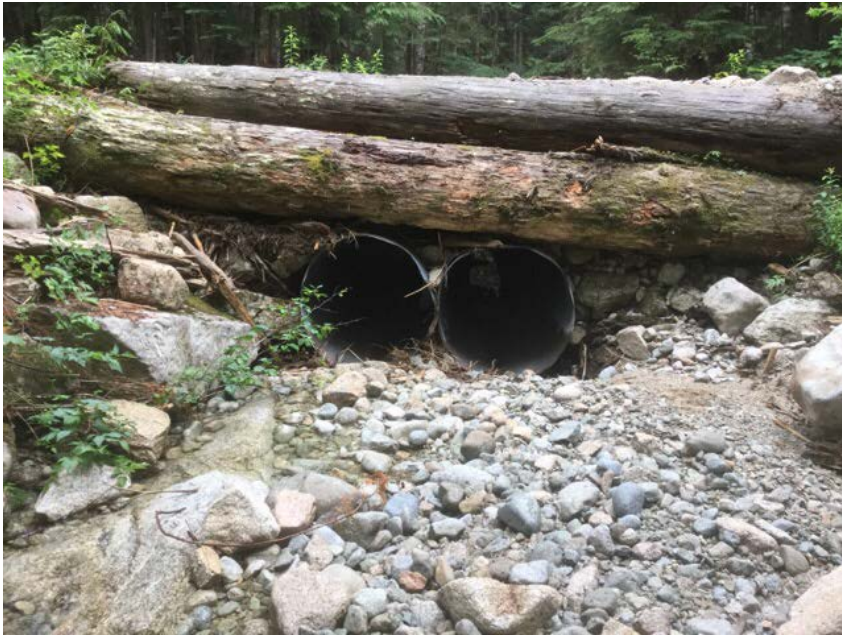
Inlet Good

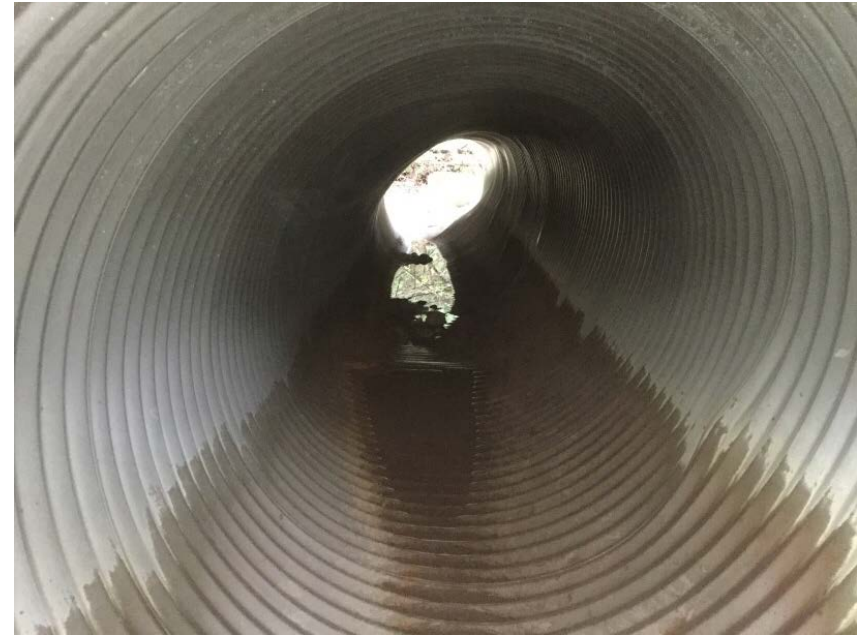
Roof Poor damage noted

Sidewalls Poor damage noted

Damage to roof of right culvert

Monitor the damage noted to both culverts. Determine expected stream flows and stream classification. If the stream has flows greater than 6m<sup>3</sup>/s or is classified as fish bearing then consider replacing the structure. Limit loading to BCL625 or 64 tonnes.

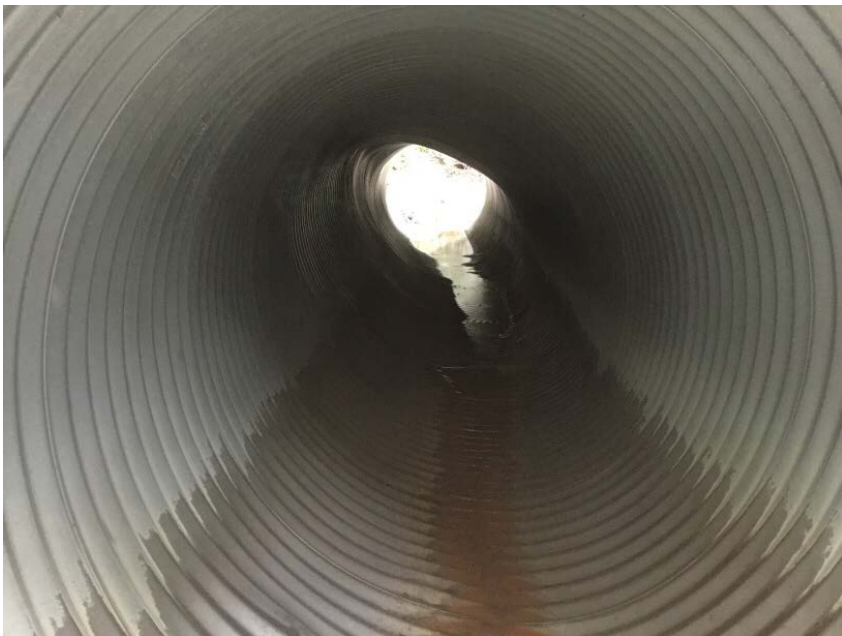
Damage to roof of left culvert

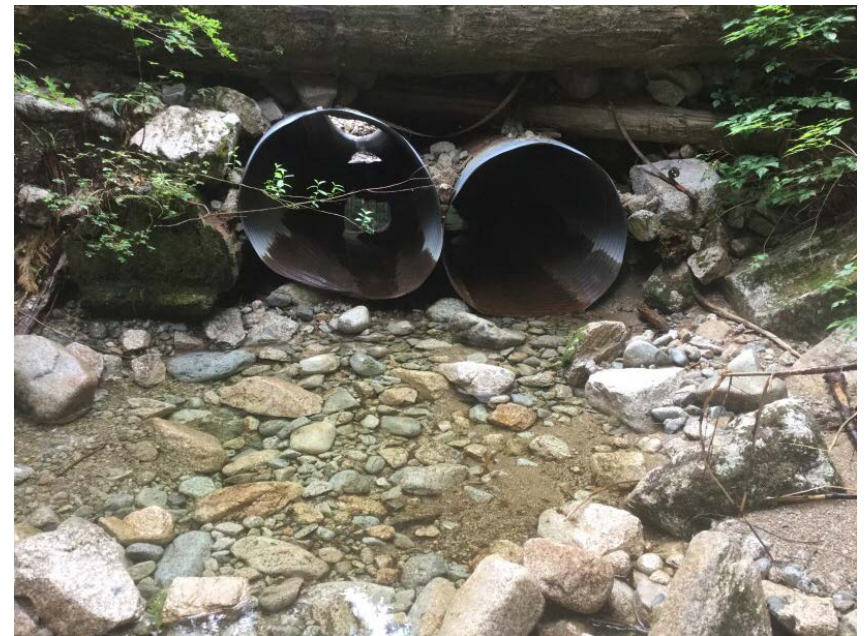
Outlet Good
