CK-2466

GARNET CREEK 7.6km

2017 Inspection

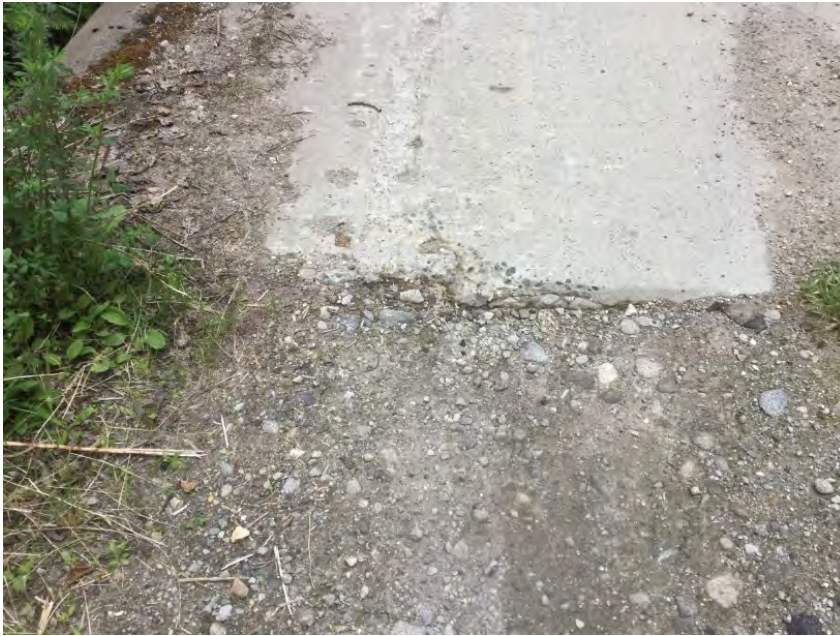
Damage to left bank slabs

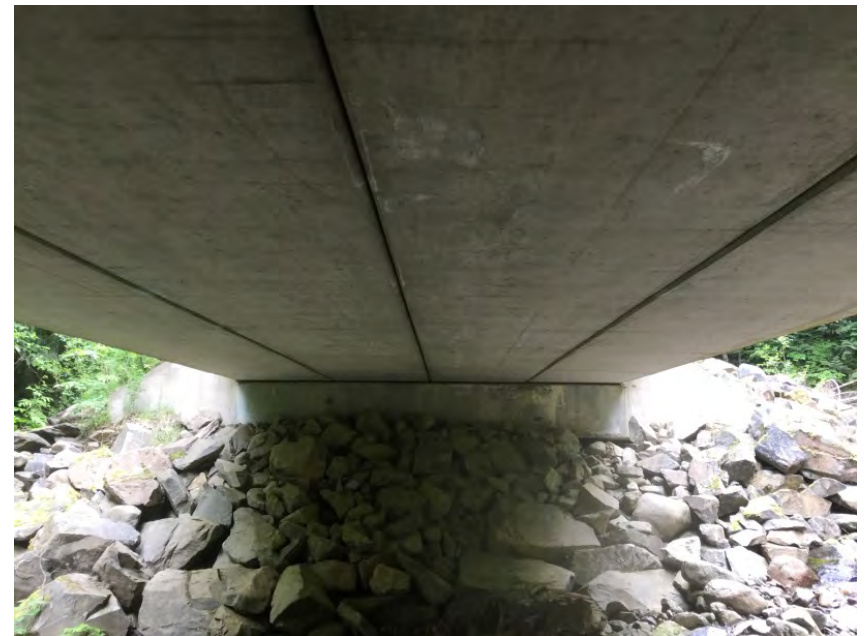
Superstructure

4 concrete slabs - small hairline cracks noted on underside of slabs

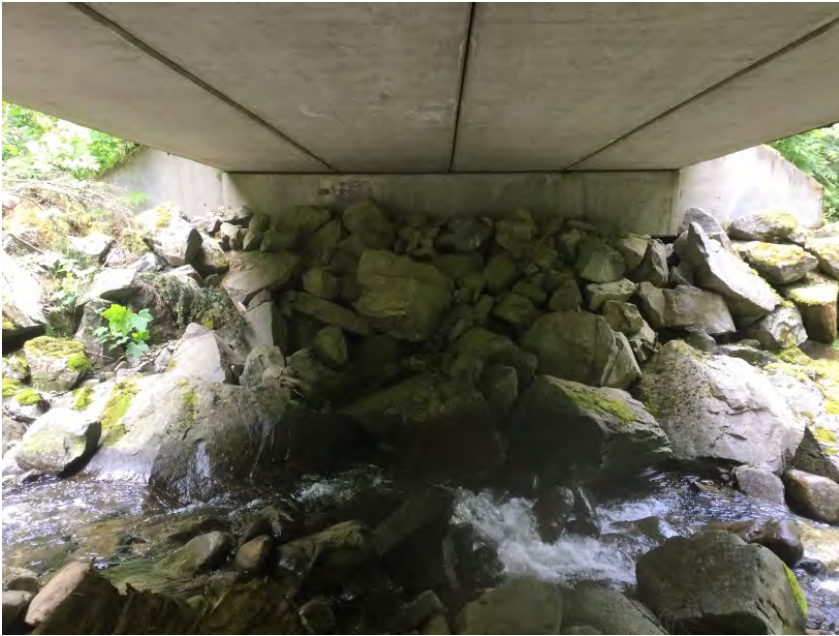
Left Bank Abutment when facing downstream

Riprap Good Monitor downstream left bank as 1:1 slope

Monitor left downstream riprap.
