CK-2471

CHEHALIS-MAISAL 3.2km

2017 Inspection

| Structure Class | Major Culvert |

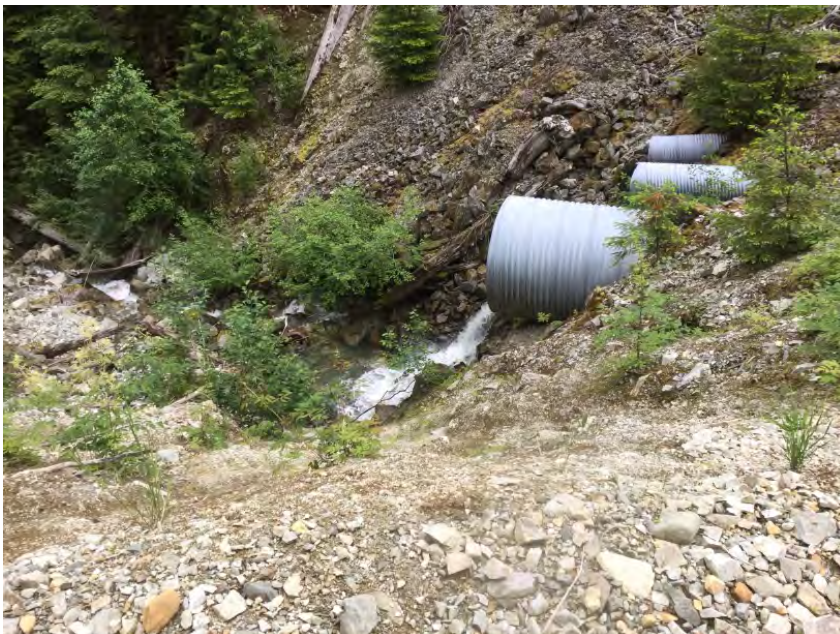
Outlet

approx 5.0m drop at outlet but well armoured
