CK-2488

STS'AILES 10.1km

2017 Inspection

| Structure Class | Major Culvert |

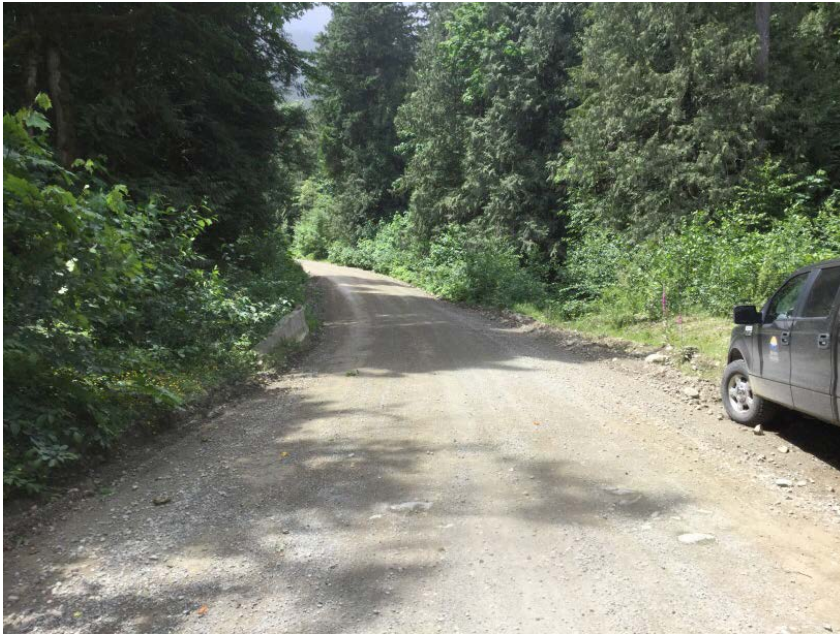
Approach from Left Bank when facing downstream

Alignment Good

Road Surface Good

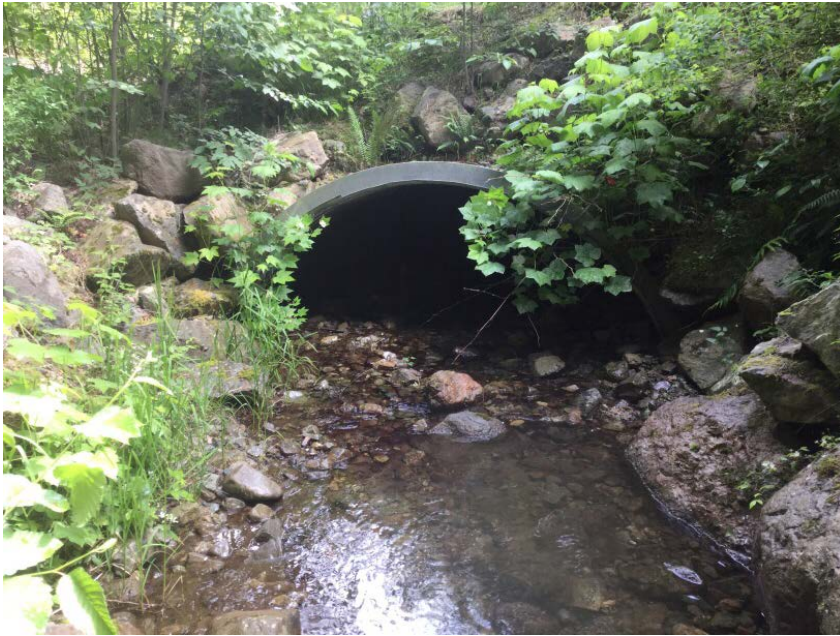
Inlet

Good

1200mm opening

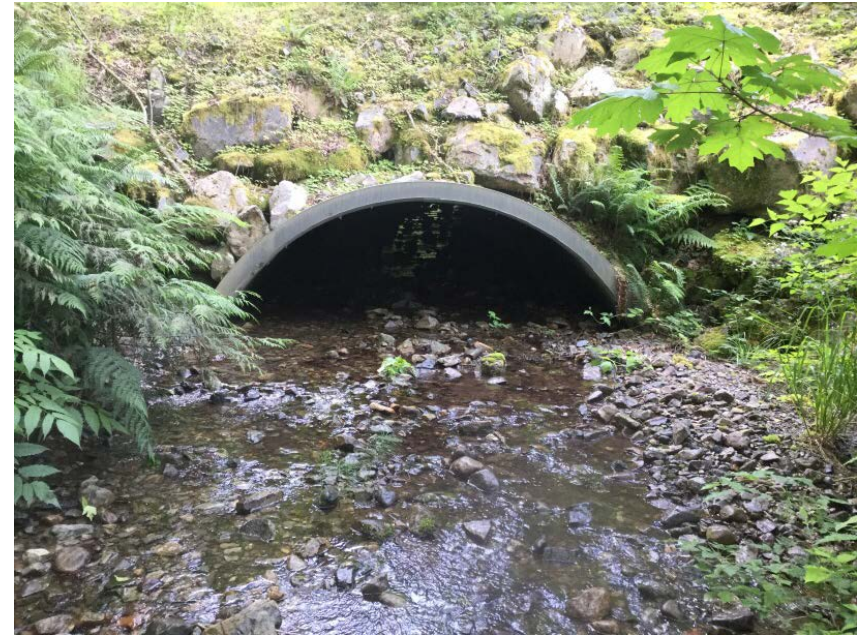
Outlet

Good

1100mm opening
