CK-2489

BENCH 7.2km

2017 Inspection

| Structure Class | Major Culvert |

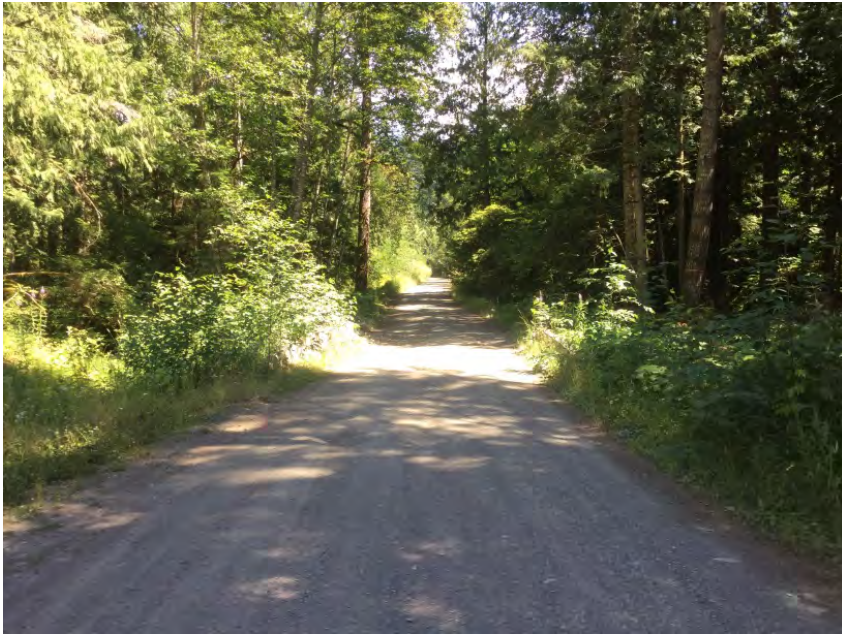
Approach from Right Bank when facing downstream

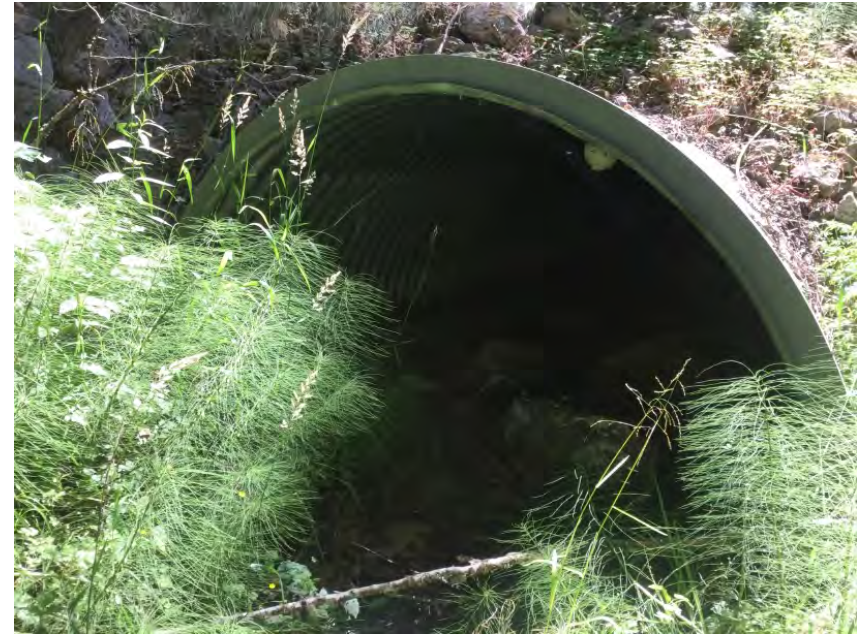
Inlet

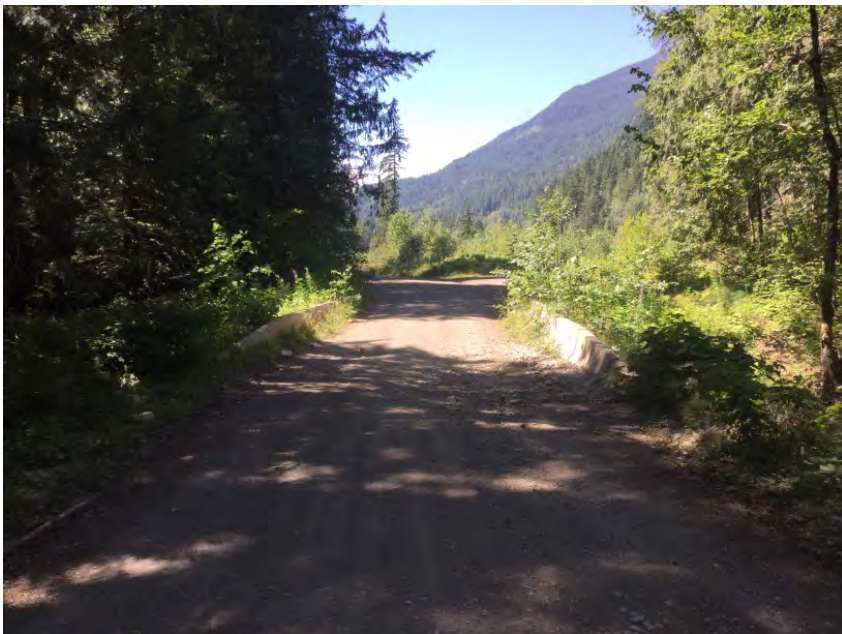
Approach from Left Bank when facing downstream

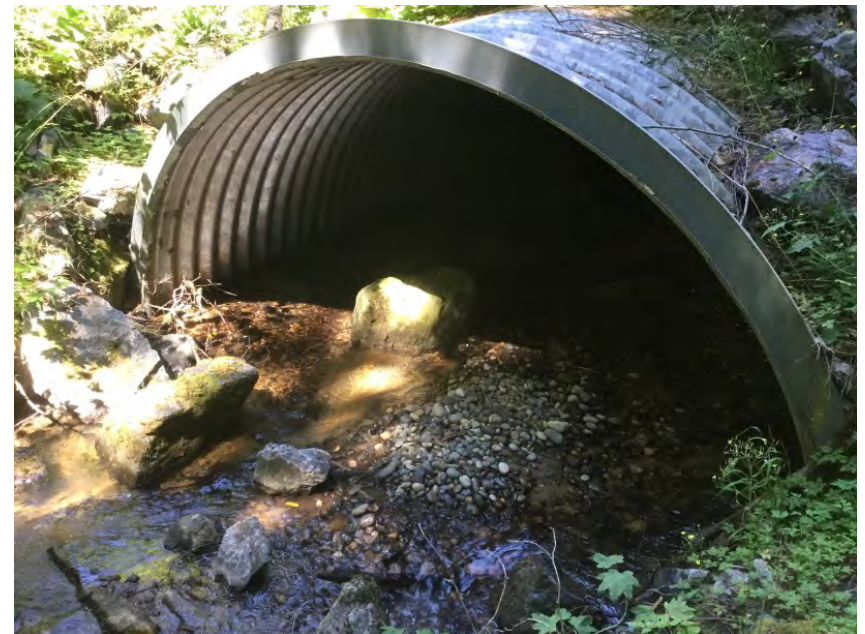
Outlet

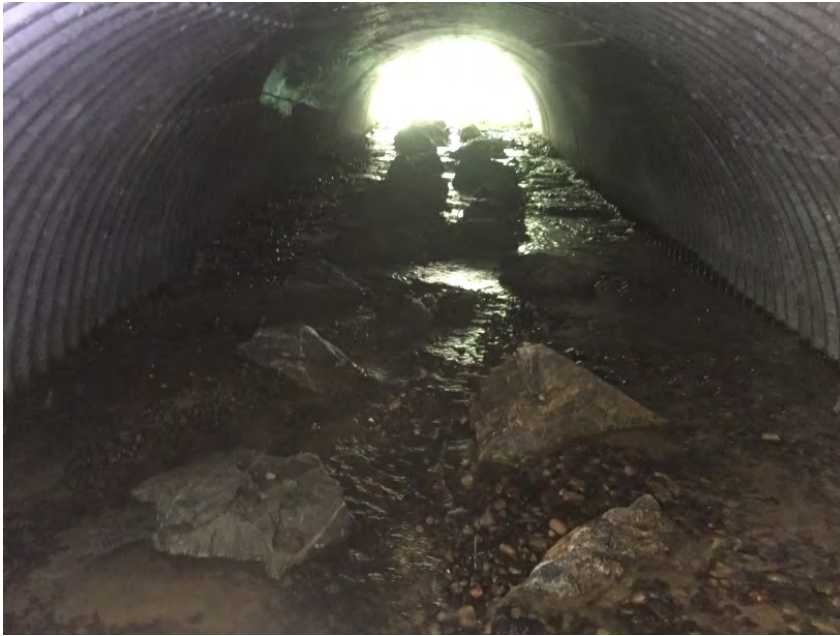
Looking through culvert from outlet
