CK-2493

RUBY ELEVEN 0.15km

2017 Inspection

| Crossing Name | Mahood Creek |

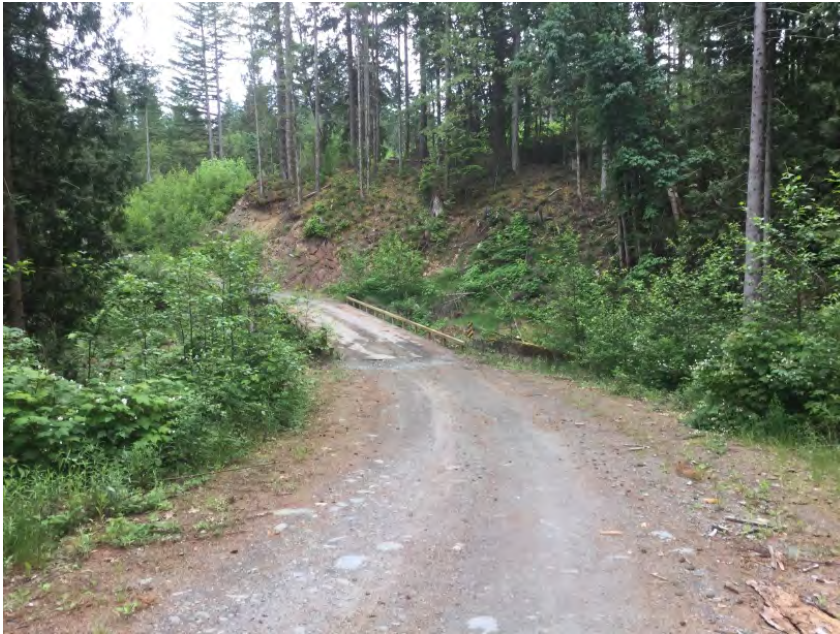
Approach from Left Bank when facing downstream

Bridge Ahead Signs  
Missing
☐ 0
 ☐ 1
 ☒ 2

Delineator Missing  
Left
☐ 0
 ☒ 1
 ☐ 2
Delineator Missing  
Right
☒ 0
 ☐ 1
 ☐ 2

| Item | Priority | Repair Description |
|---|---|---|
| 1 | Medium | Replace missing delineator and post bridge ahead signs |

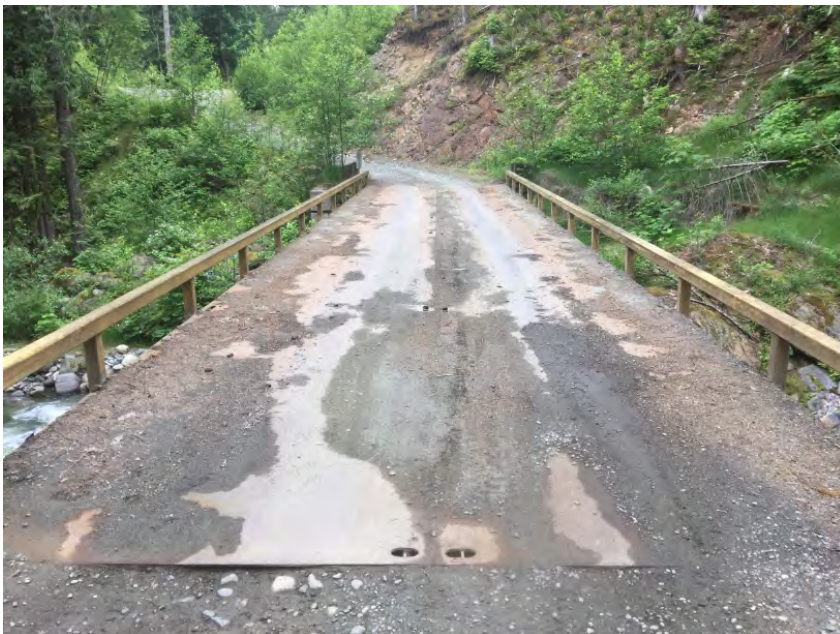
Steel Deck Plate      Fair      Slight deformation on wheel path and anti skid surface worn

| Item | Monitor Description | Frequency |
|---|---|---|
| 1 | Deformation of steel deck plate | Routine Inspection |

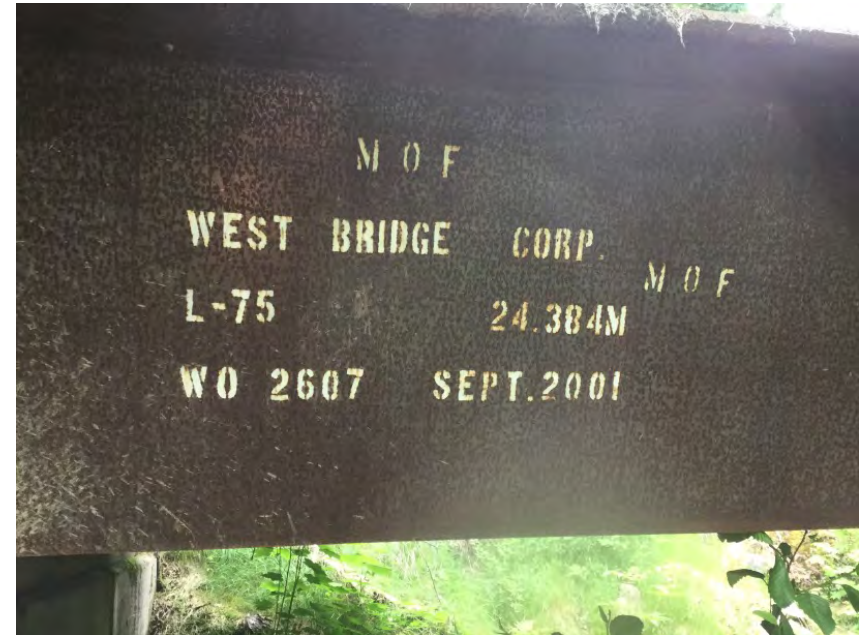
Structure ID

Serial/ID Plate L-75, WO 2607 West Bridge, TCH-0303

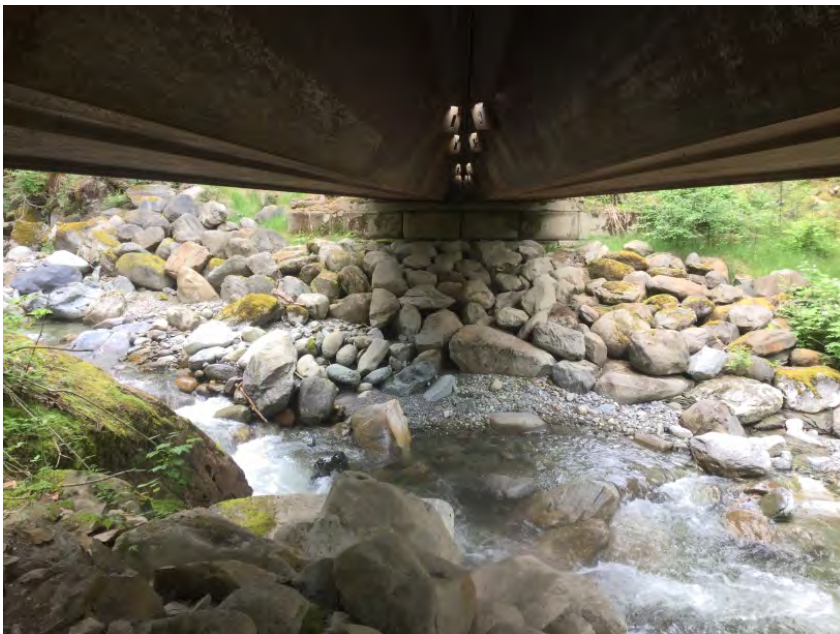
Left Bank Abutment when facing downstream

2x lock blocks RB, 1x LB

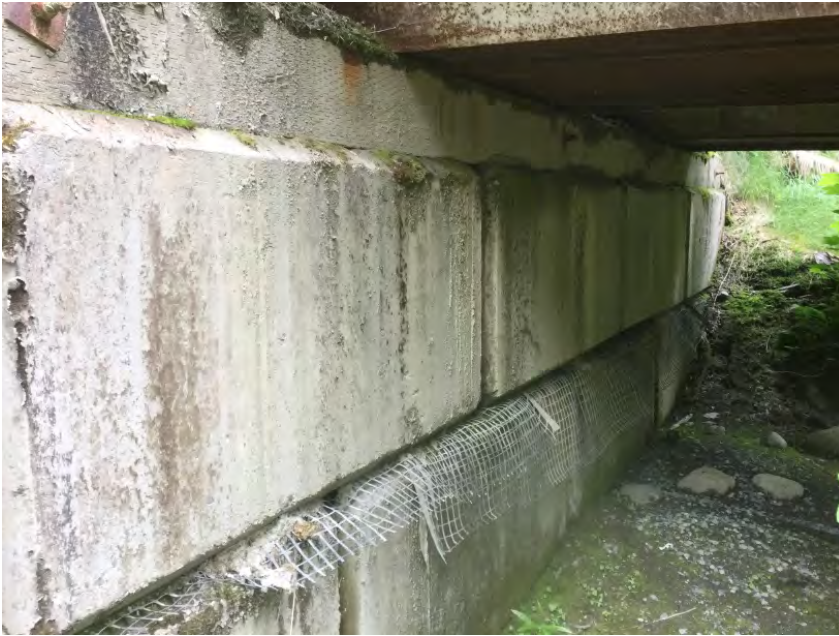
Right Bank Abutment when facing downstream

Only downstream RB

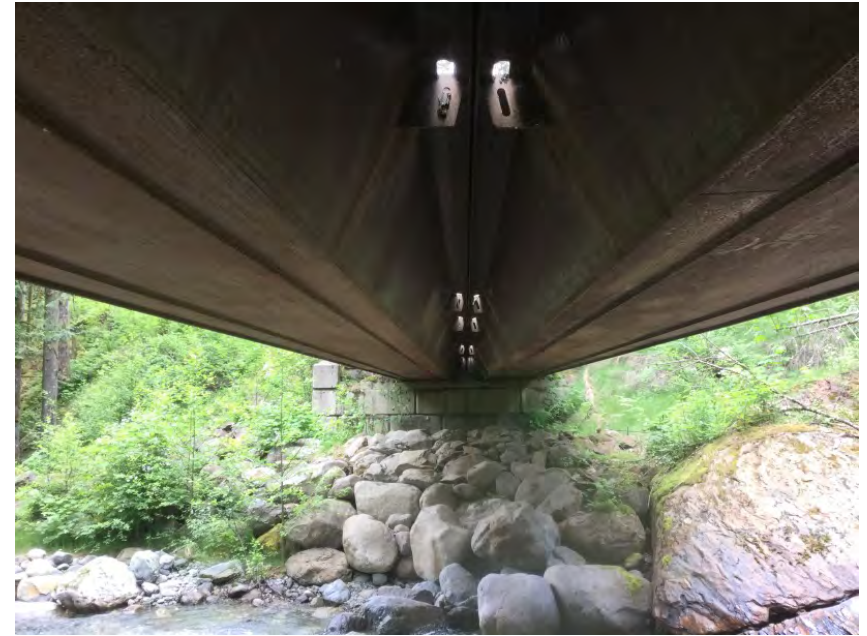
Superstructure

Girders Good

Diaphragms Unrated Inside box beams, no deformation apparent
