2495

STS'AILES 1.2km

2017 Inspection

| Structure Class | Major Culvert |

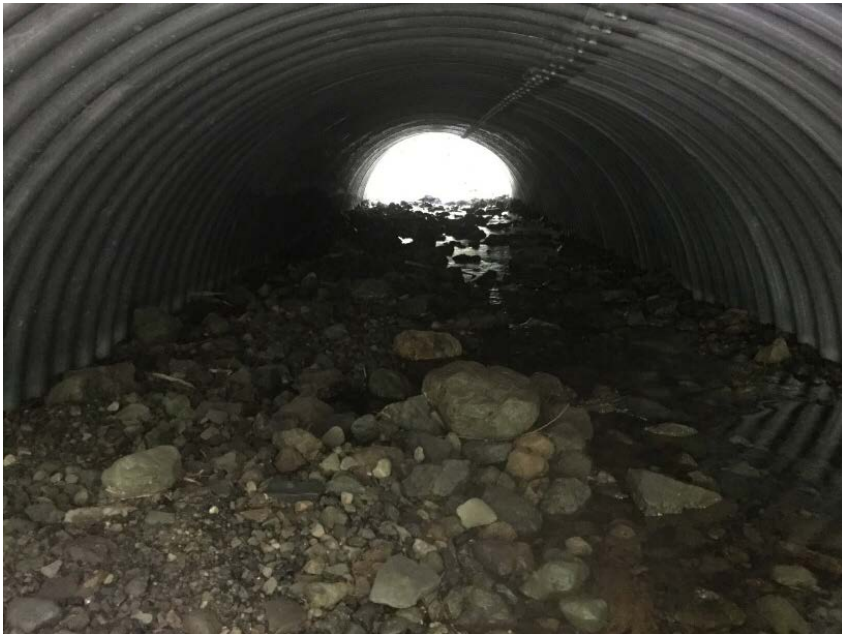
Looking through culvert

Slight deformation in 2 locations

Monitor the roof deformations. Present load rating of L100 or 91 tonnes to continue.
