CK-2500

STS'AILES 71.5km

2017 Inspection

| Crossing Name | Spring Creek |

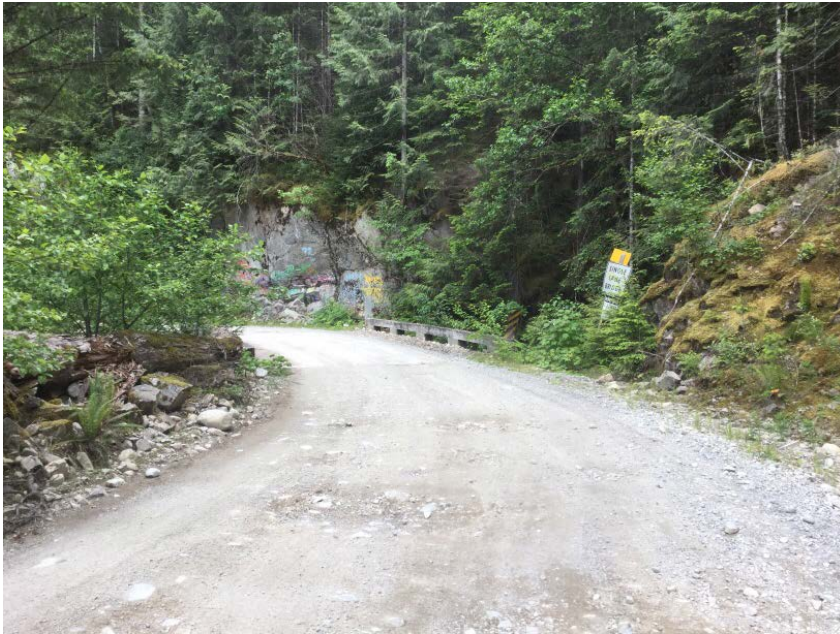
Approach from Left Bank when facing downstream

Delineator Missing  
Left ☐ 0 ☒ 1 ☐ 2

Missing U/S left approach and both right approaches

| 1 | Low | Replace missing delineator |
| 3 | Low | Replace missing fender logs |

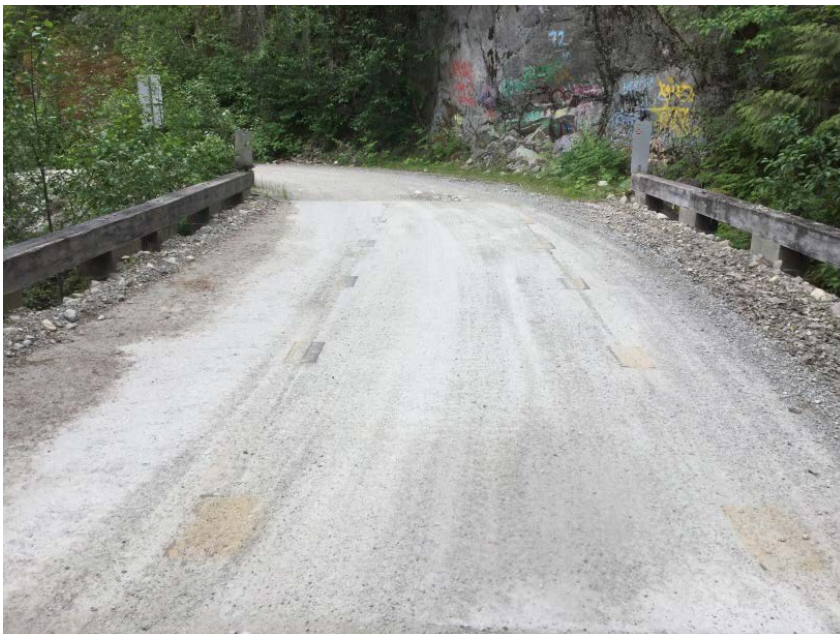
Overall Deck Condition      **Good**

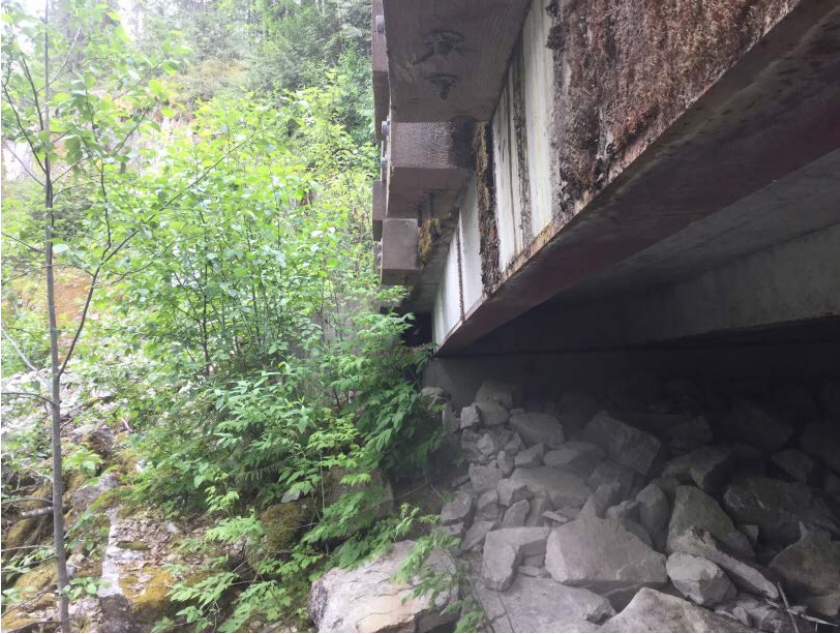
3 inverted C channels, flared D/S right bank

Downstream flare
