CK-2507

WINSLOW CREEK 5.4km

2017 Inspection

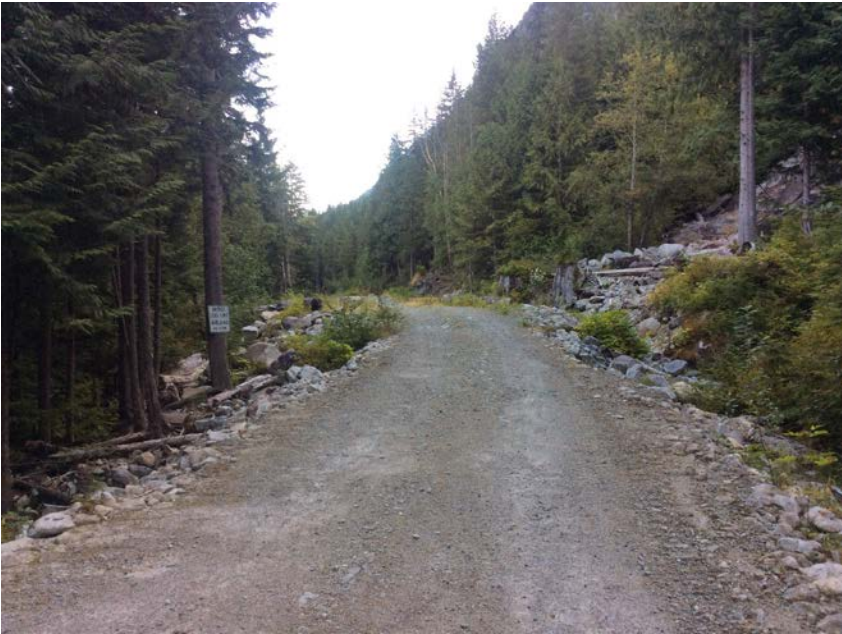
Approach from Left Bank when facing downstream

Delineator Missing  
Left ☐ 0 ☐ 1 ☒ 2 Doesn't have proper delineatorsDelineator Missing  
Right ☐ 0 ☐ 1 ☒ 2 Doesn't have proper delineators

| Repair Item | Priority | Repair Description |
|---|---|---|
| 1 | Medium | Replace all delineators |

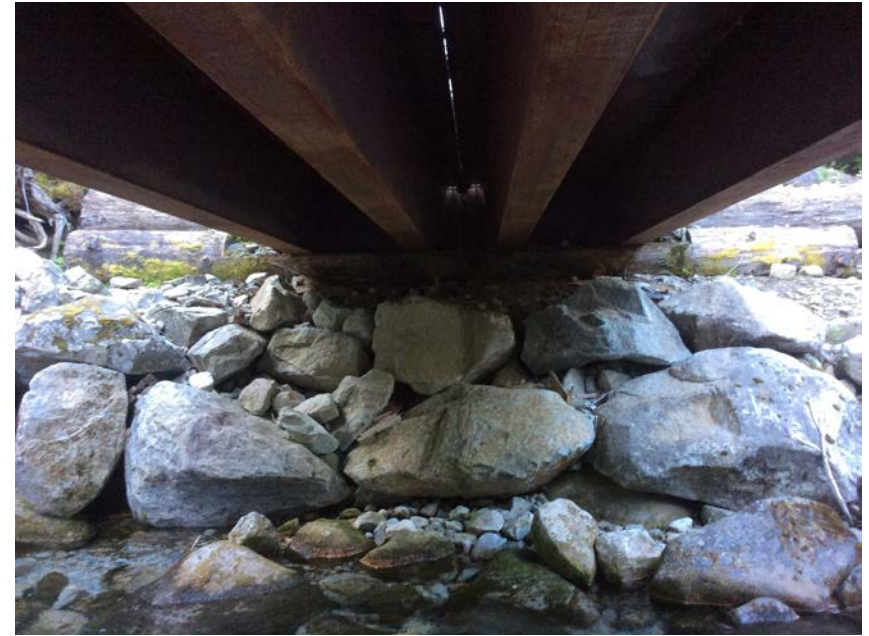
Left Bank Abutment when facing downstream

Log/Timber Cribs Good Single cedar sill notched for bearing

Bearings Fair Able to see lag bolts at downstream left corner at back Of bearing plate.

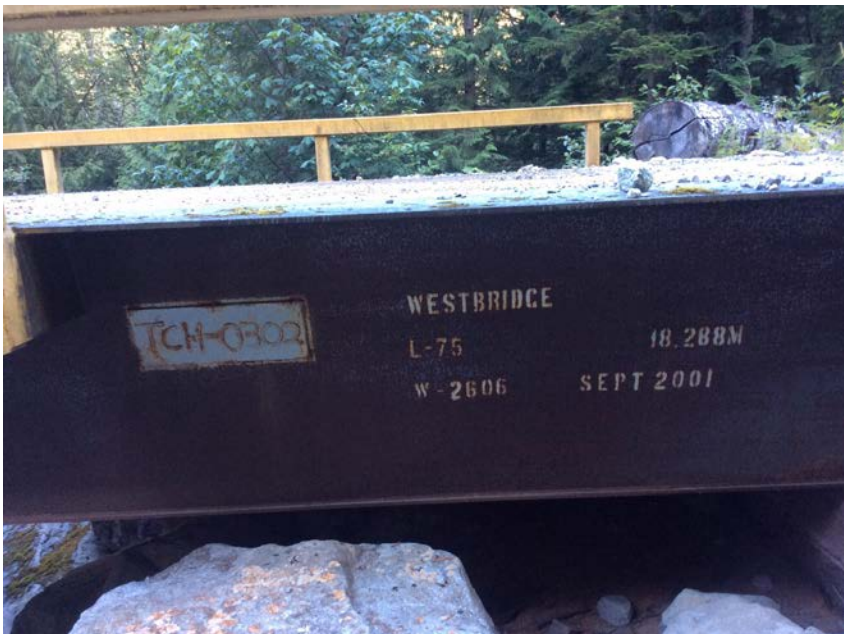
Structure Or Manufacturer ID

Serial/ID Plate TCH-0302 W-2606 L75 westbridge
