CK-2518

AMERICAN CREEK 9.7km

2017 Inspection

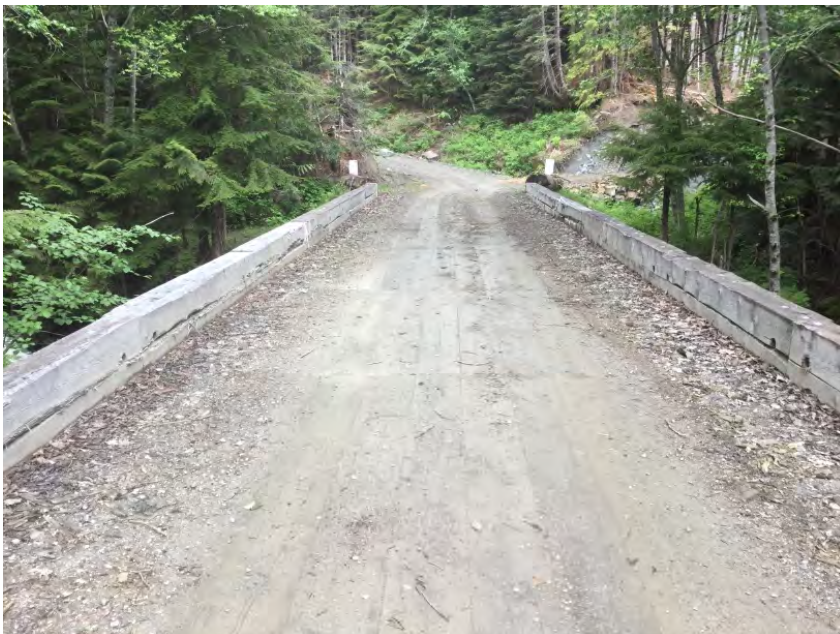
| Overall Deck Condition | Fair | |

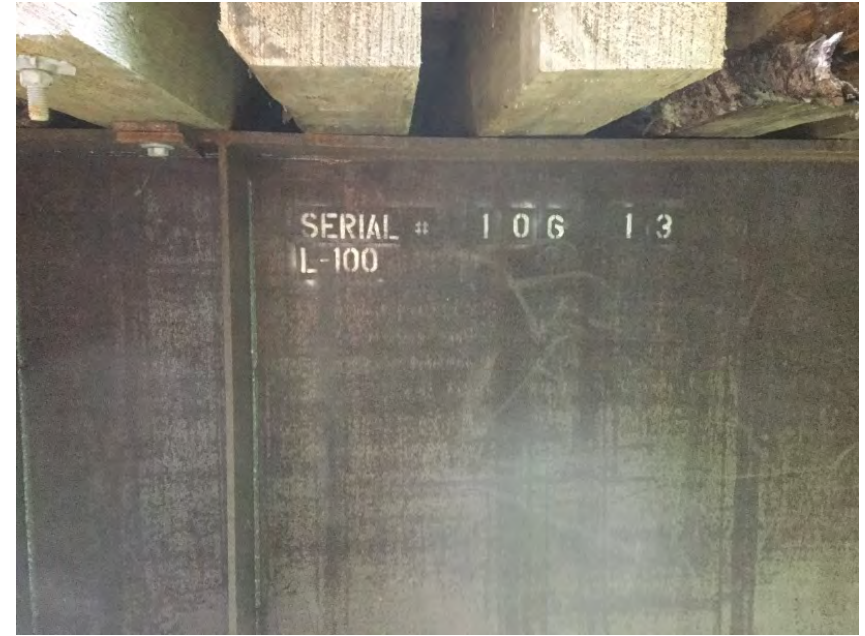
Structure ID

Serial/ID Plate L100, serial # 106-13

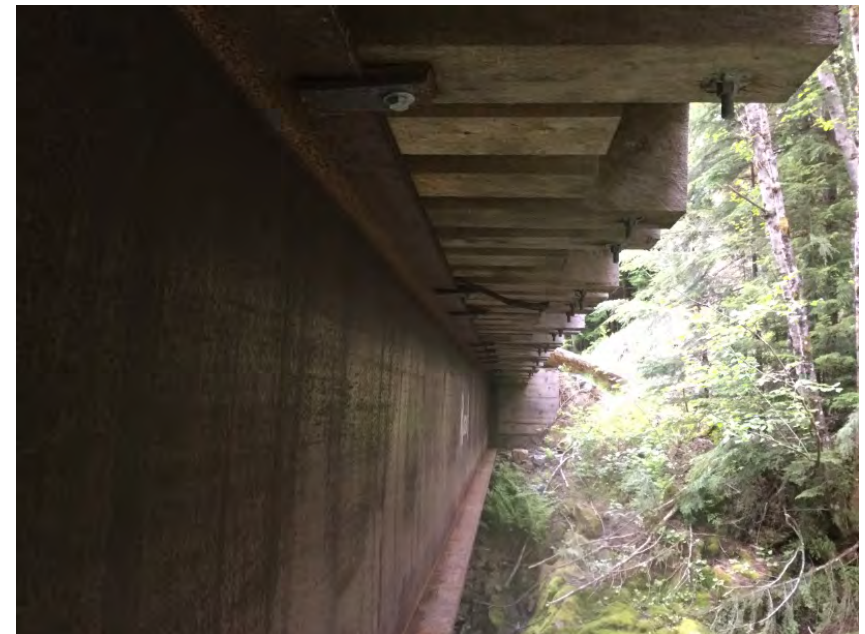
Deck clips

| Deck to Girder Bolts | Good | Every modular panel fastened in 2 locations |

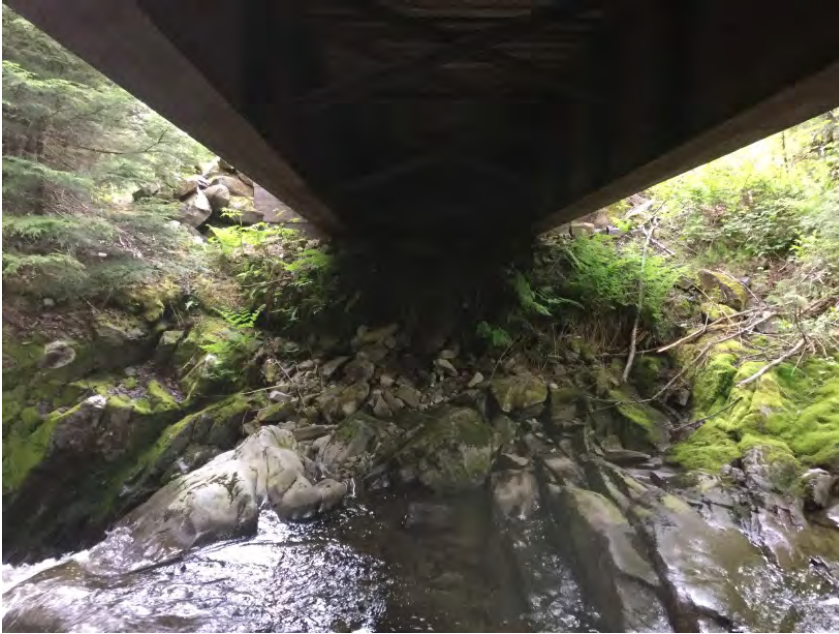
Right Bank Abutment when facing downstream

At the time of this installation a 3 year lifespan was assumed and long-term rock armouring was not added, leading to risk from scour. According to the record drawings the right bank (town end) abutment is founded on bedrock but the left bank (woods end) is founded on compacted fill, which is very susceptible to scour and needs to be monitored. According to the record drawings the load rating is L100 or 91 tonnes, which can continue; however I recommend placing riprap at the left upstream location and monitoring both abutments for scour. Post bridge ahead signs. Please submit the structural drawings.

| 1 | Abutment scour | Annually |

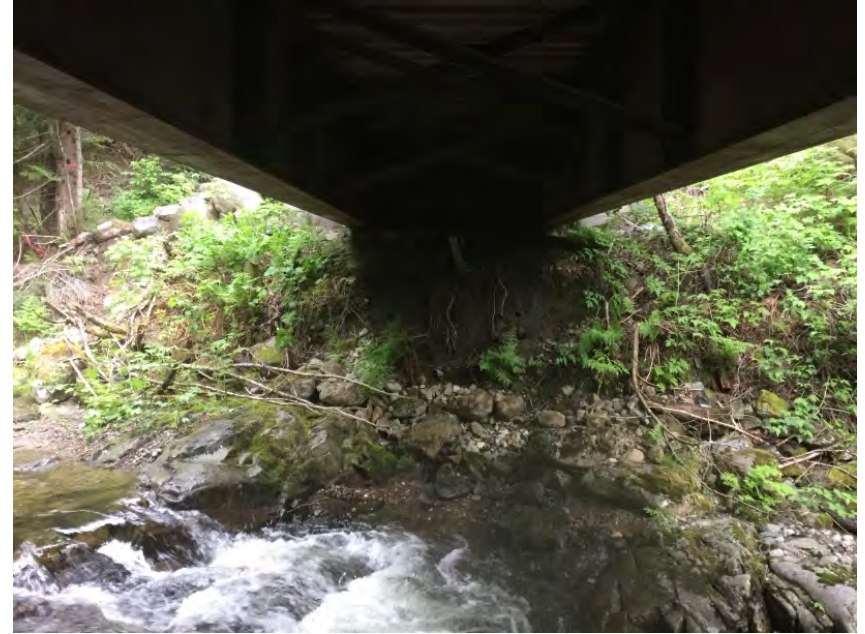
Left Bank Abutment when facing downstream

Material in front of left bank sill appears highly erodable  
 Could add riprap to U/S left bank

None in front of sills and potential for scour - monitor

| 2 | Medium | Place riprap at upstream left bank corner |

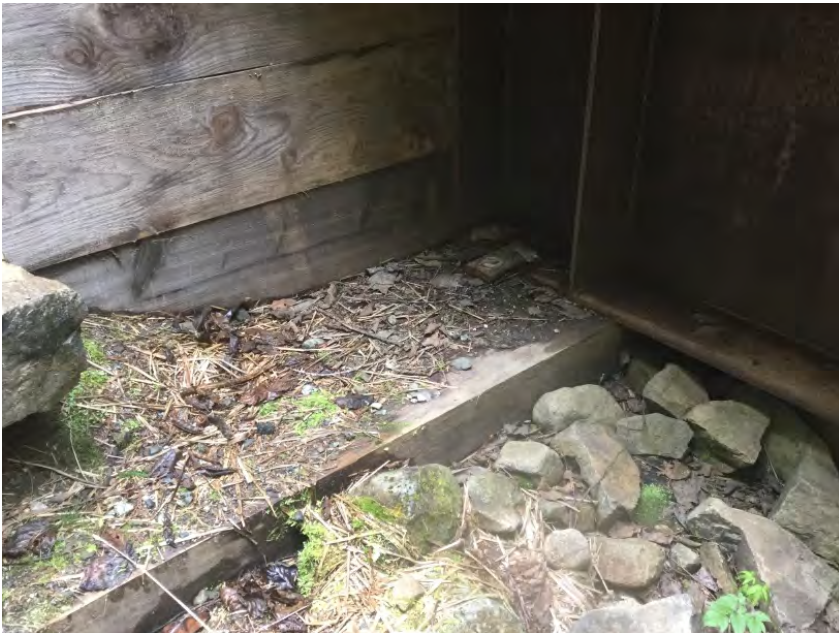
Caps or Sills Fair

Sills are 2 - 250mm x 250mm timbers

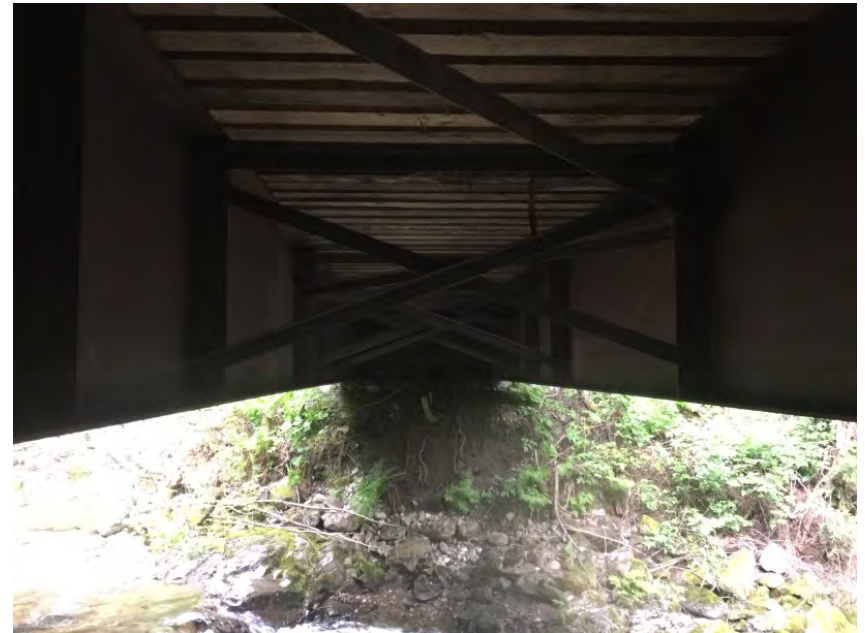
Superstructure

Girders Good

Diaphragms Good 6 welded bays
