CK-2519

GARNET EAST 3.5km

2017 Inspection

| Crossing Name | East Fork Garnet Creek |

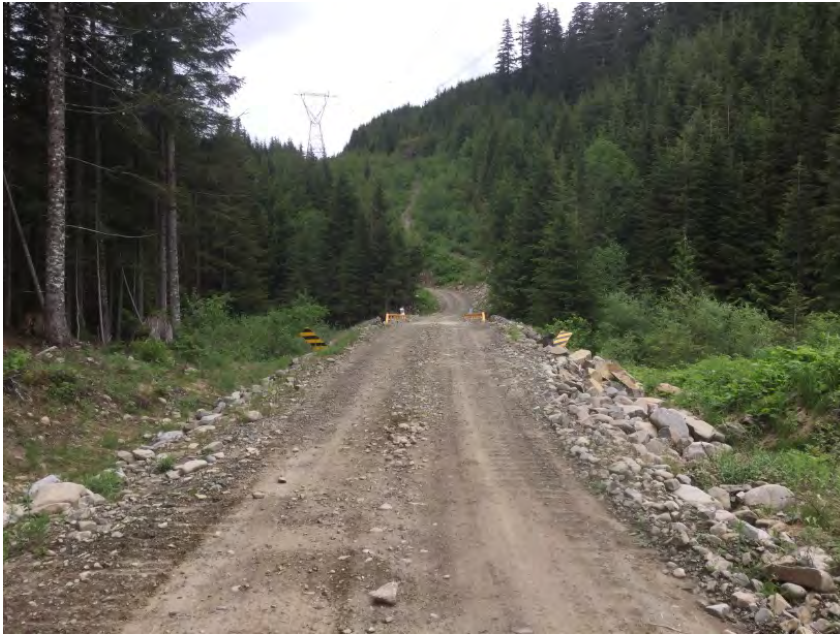
Bridge Ahead Signs  
Missing ☐ 0 ☐ 1 ☒ 2

Approach from Right Bank when facing downstream

| 1 | Medium | Post bridge ahead signs |

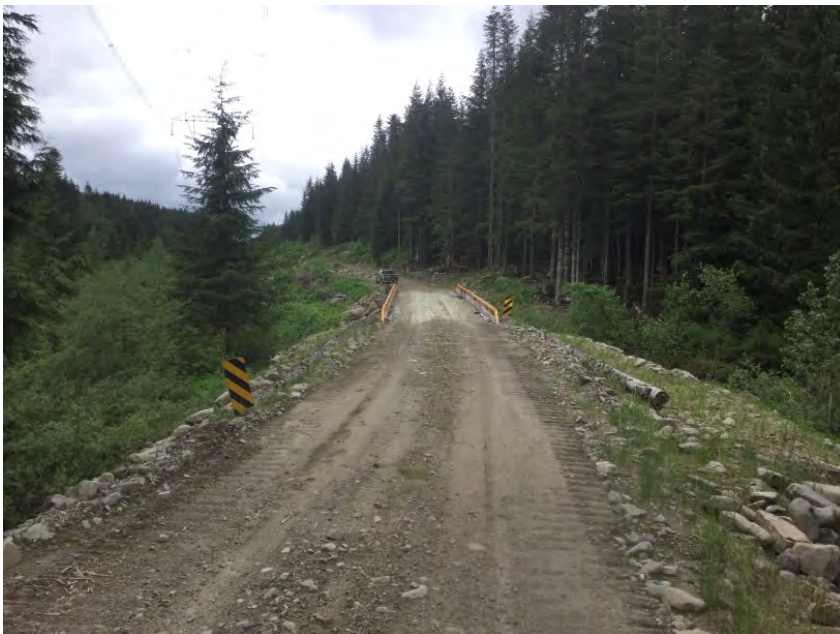
Approach from Right Bank when facing downstream

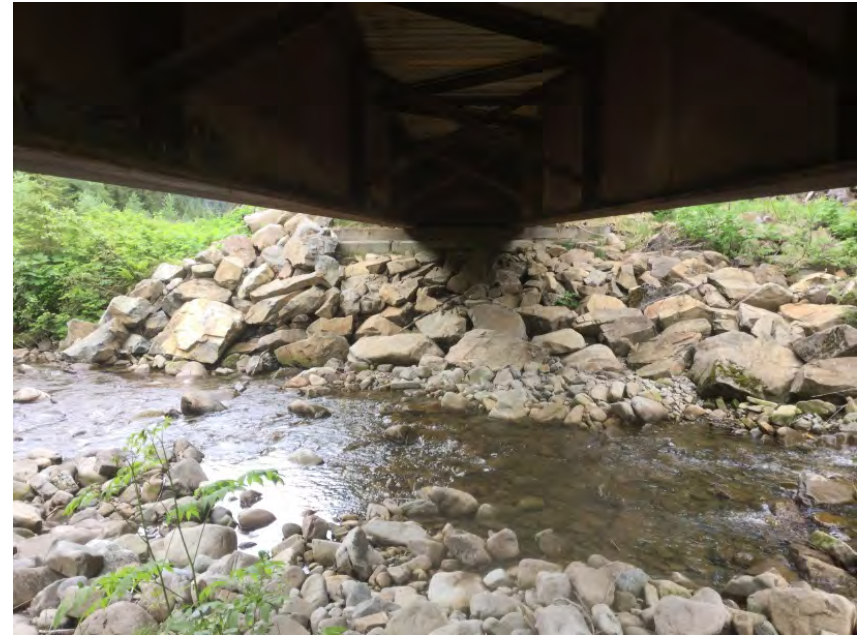
At the time of the installation a 3 year lifespan was assumed and the lock block abutments were raised in the field to accomodate increased freeboard; however over the longer term this leaves the underside of the abutment (lock blocks) at an increased risk of scour as they are higher than the streambed. At the time of inspection the riprap was in fair condition but needs to be monitored. The record drawings indicate L100 or 91 tonnes load rating, which can continue. Post bridge ahead signs. Please submit structural drawings for the file.

Right Bank Abutment when facing downstream

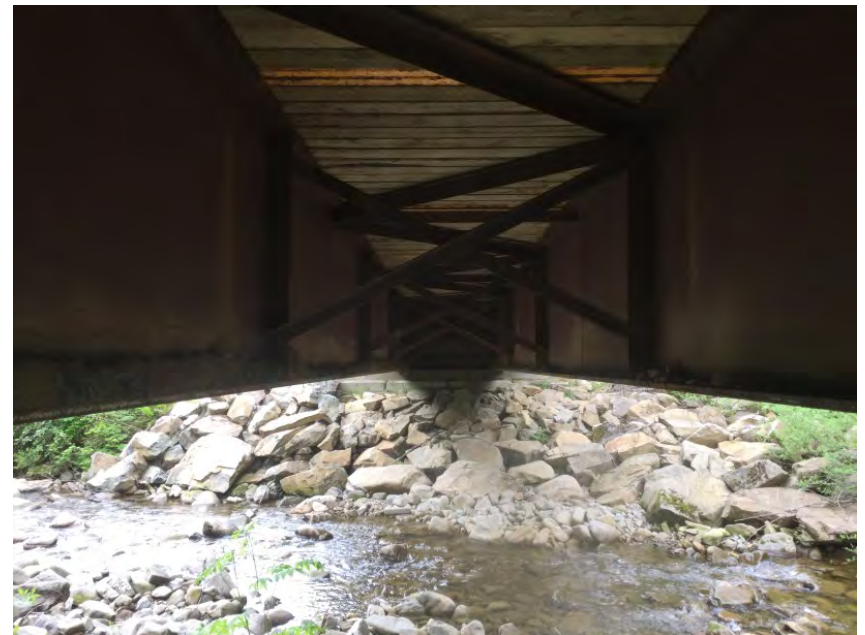
Girders Fair Slight corrosion

Diaphragms Fair 6 welded bays, lightly corroded

Bracing Fair Lightly corroded

Superstructure

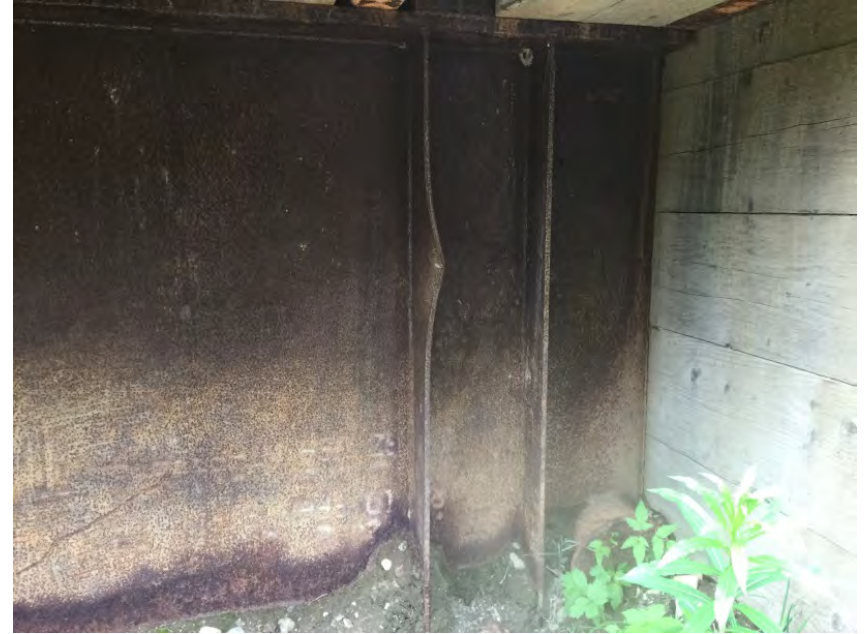
Damage noted to left downstream stiffener

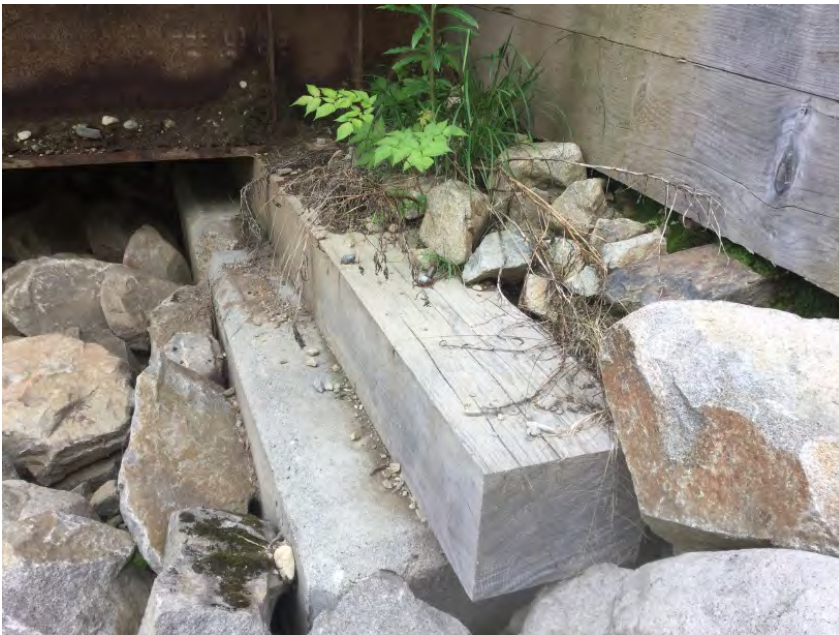
Caps or Sills Fair 250mm x 300mm timber bolted to blocks

Sill - typical both sides

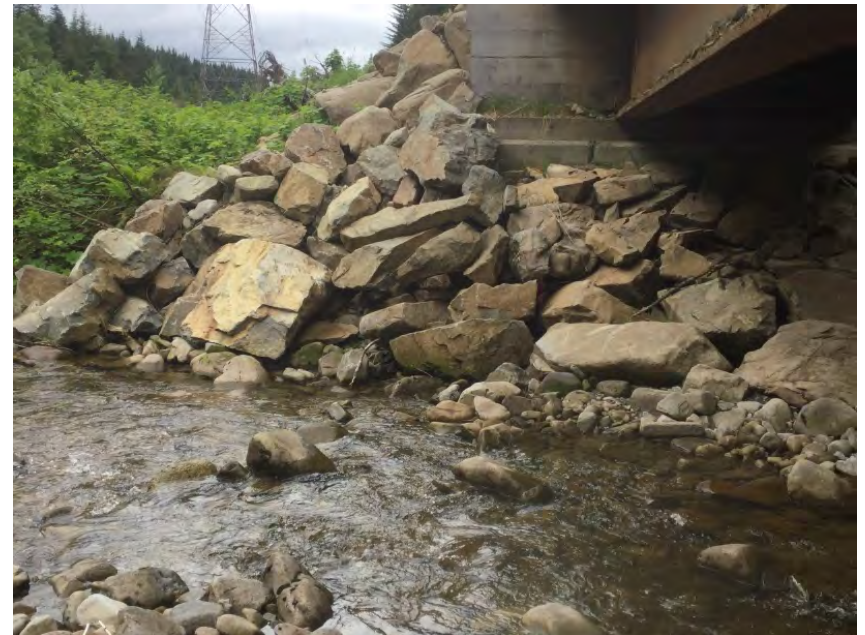
Riprap Fair right downstream bank appears to have been repaired recently

Slight riprap scour right downstream bank

| 1 | riprap condition | Annually |

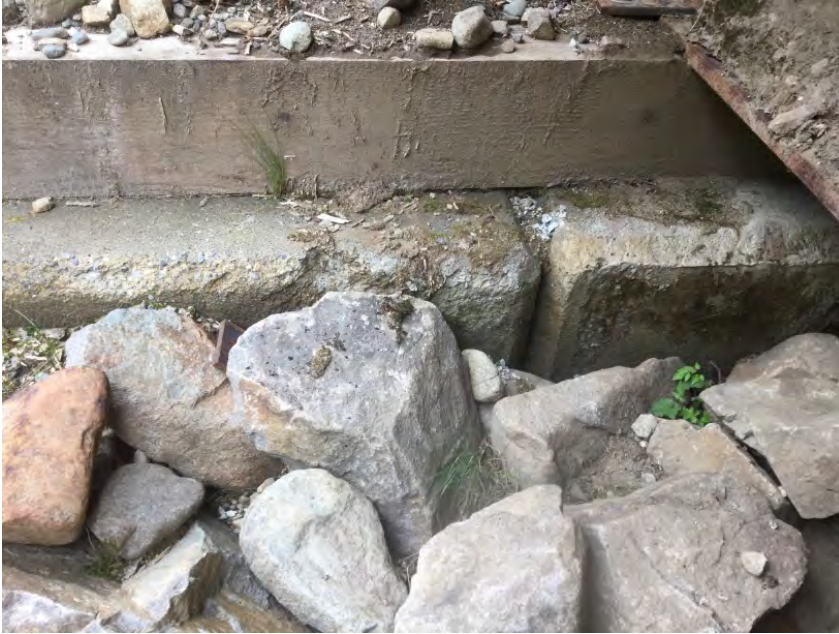
Concrete Fair Lock blocks - some spalling starting to occur

Left bank lock block condition

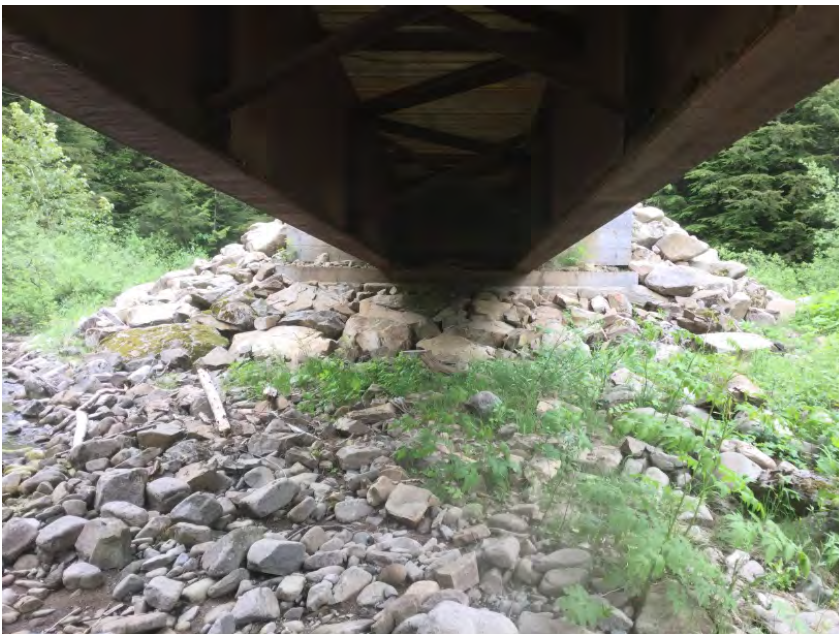
Left Bank Abutment when facing downstream
