CK-2522

CHEHALIS-EAGLE km

2017 Inspection

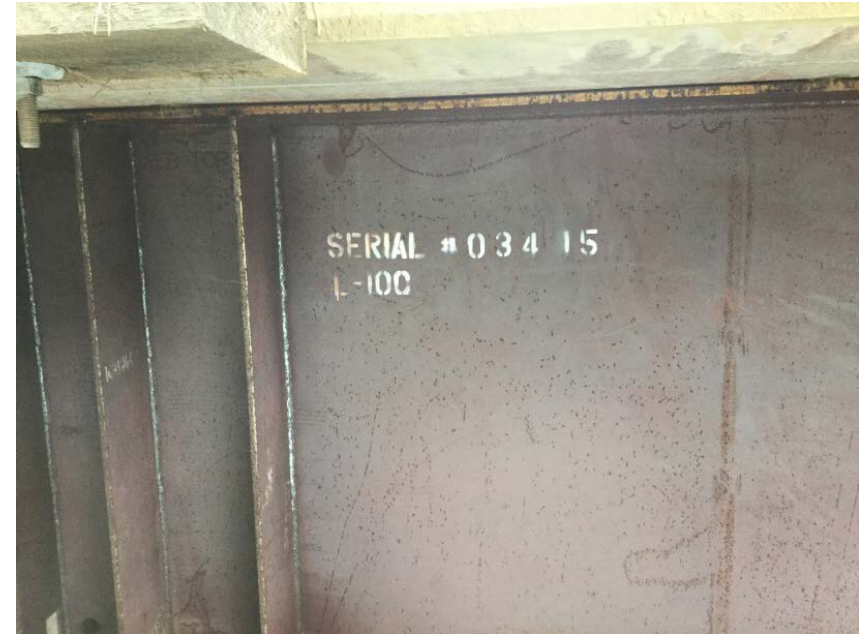
Structure ID

Serial/ID Plate 034-15, L100, CK-2522

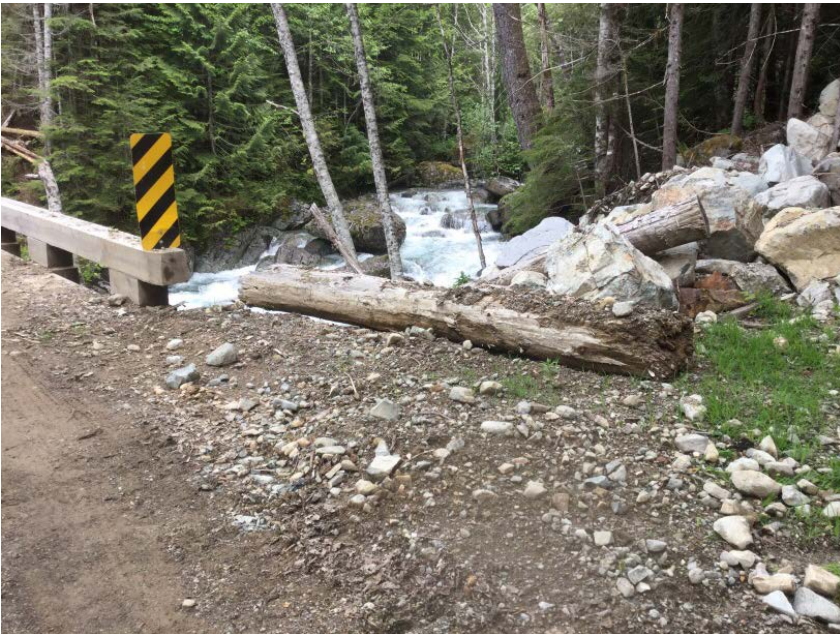
Logs - left upstream fender small

Left upstream approach fender - small

Present load rating of L100 or 91 tonnes to continue. Replace the upstream left approach guide log with a larger diameter one (min 600mm diameter x 6m length). Grade approaches when active.

| 1 | Medium | Replace left upstream fender when active |
