CK-2523

SQUEAH km

2017 Inspection

| Structure Class | Major Culvert |

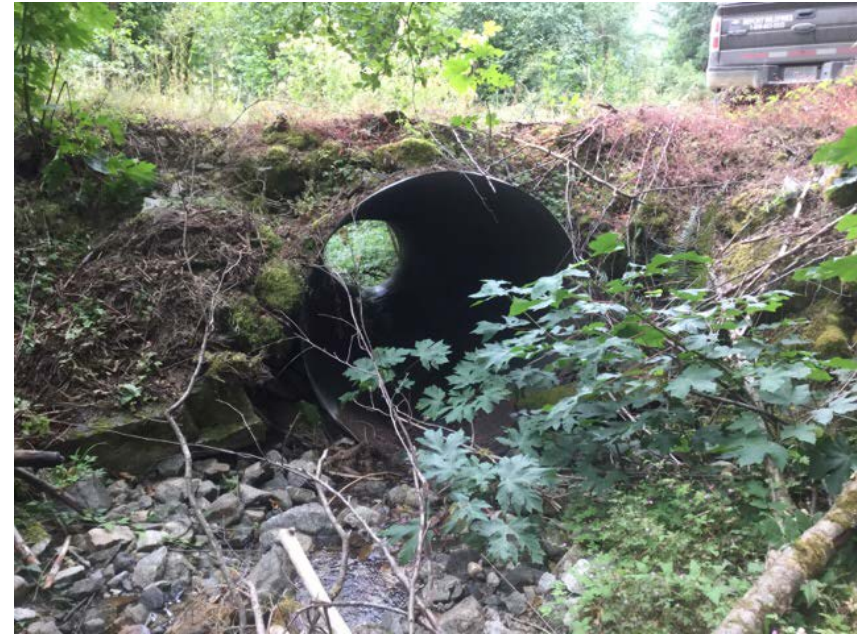
Inlet

debris accumulating

Monitor debris accumulations at the inlet. BCL-625 or 63 tonnes load limit.

| 1 | debris accumulations at the inlet | |

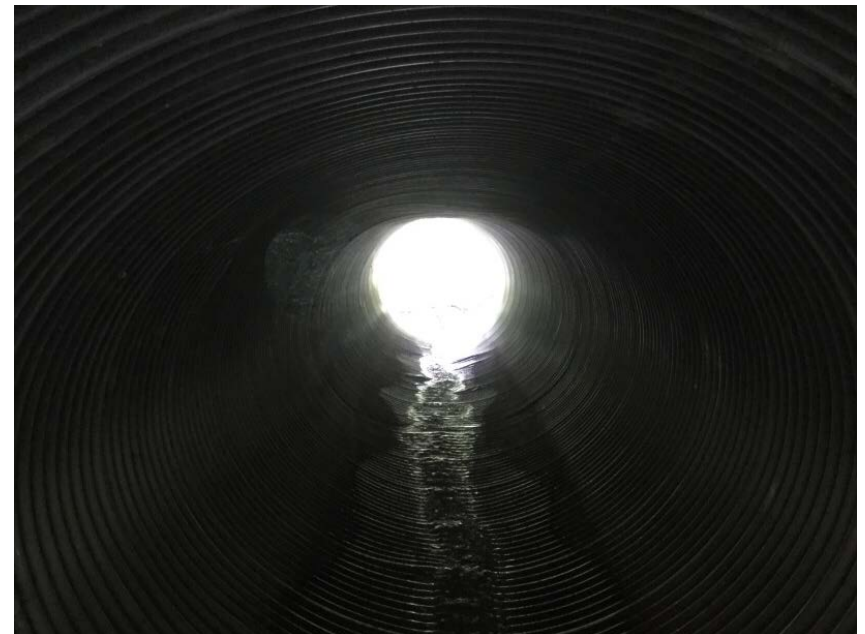
Minor damage at approx middle

Damage to roof

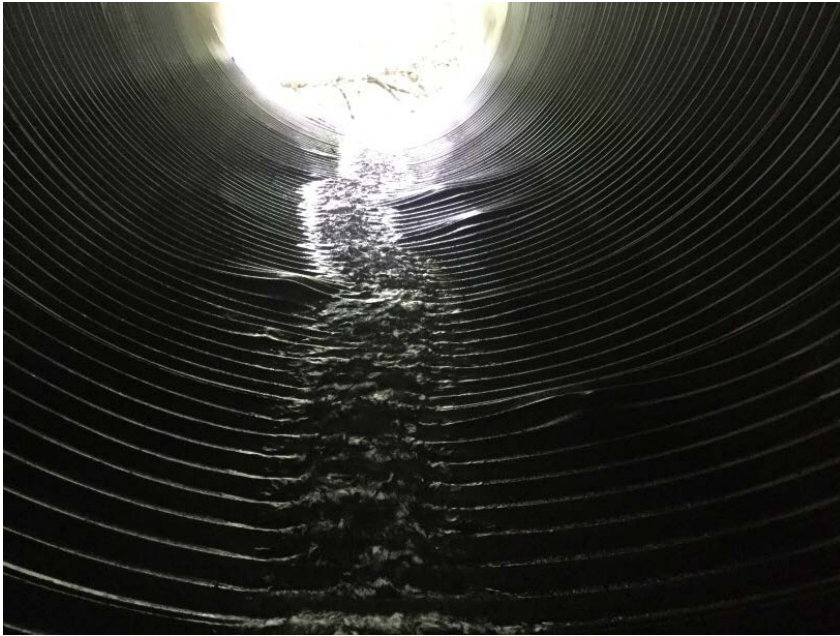
Minor damage

Minor damage to floor

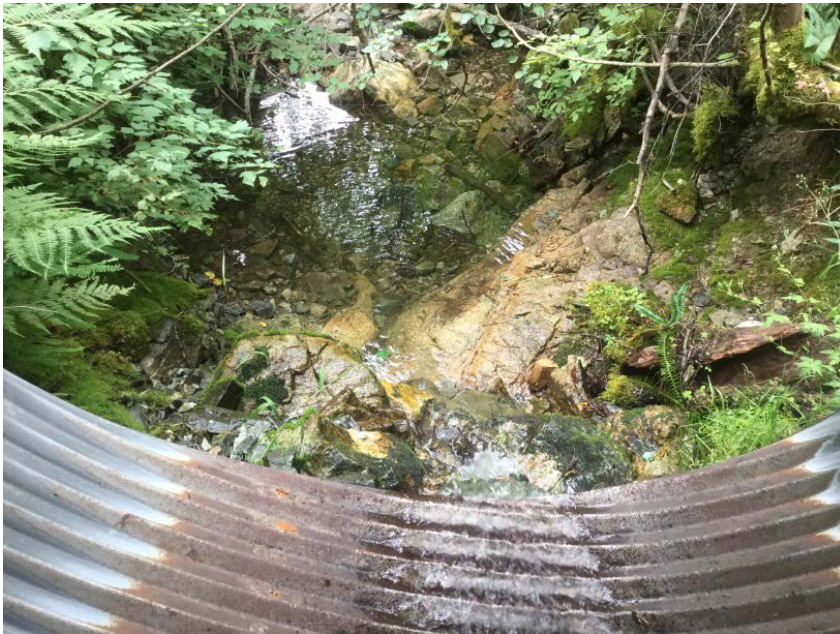
Outlet

2 m drop
