CK-2526

HARRISON EAST 47km

2017 Inspection

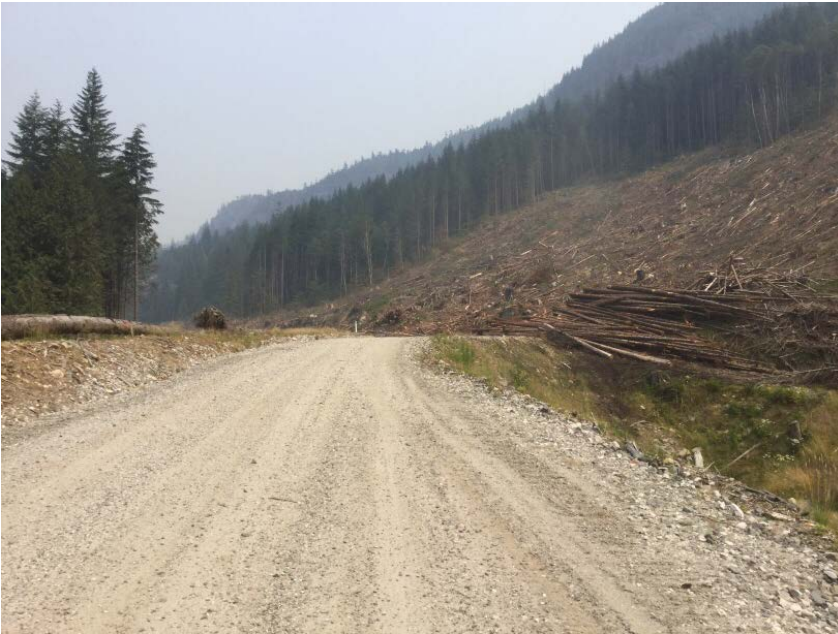
Approach from Left Bank when facing downstream

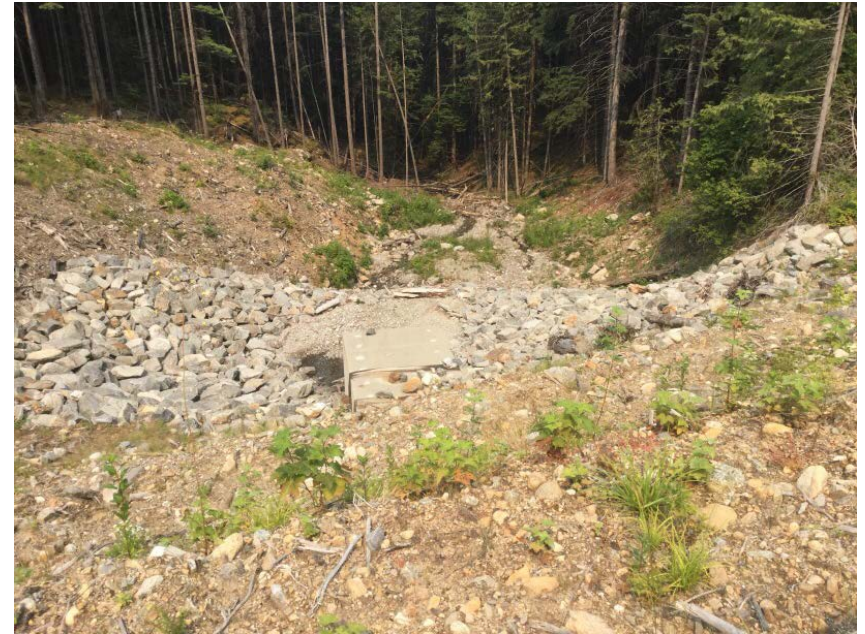
Looking downstream from road surface

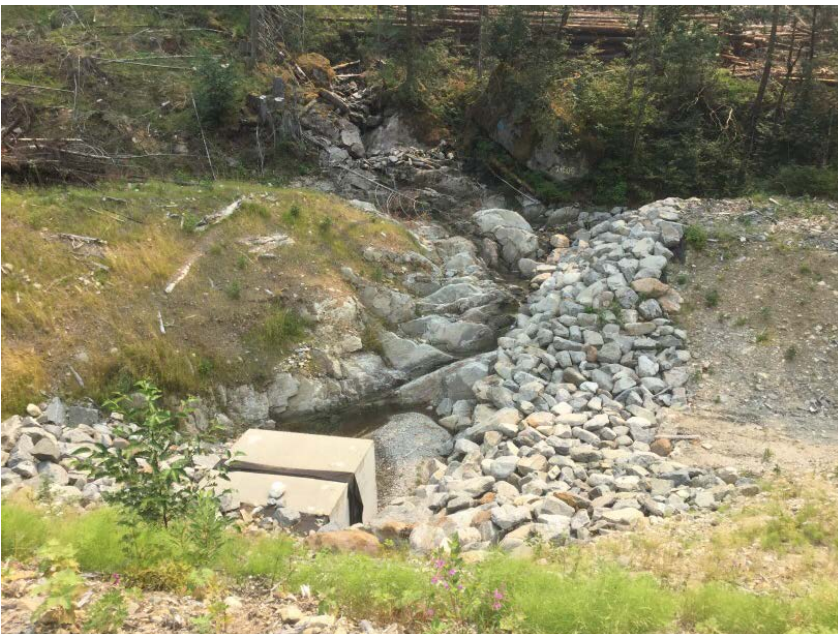
Looking upstream from road surface

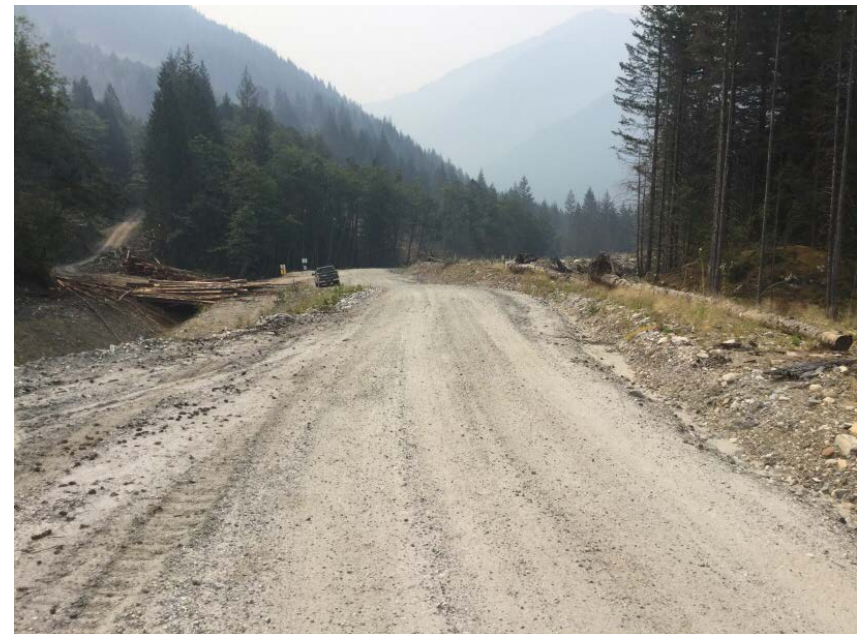
Approach from Right Bank when facing downstream

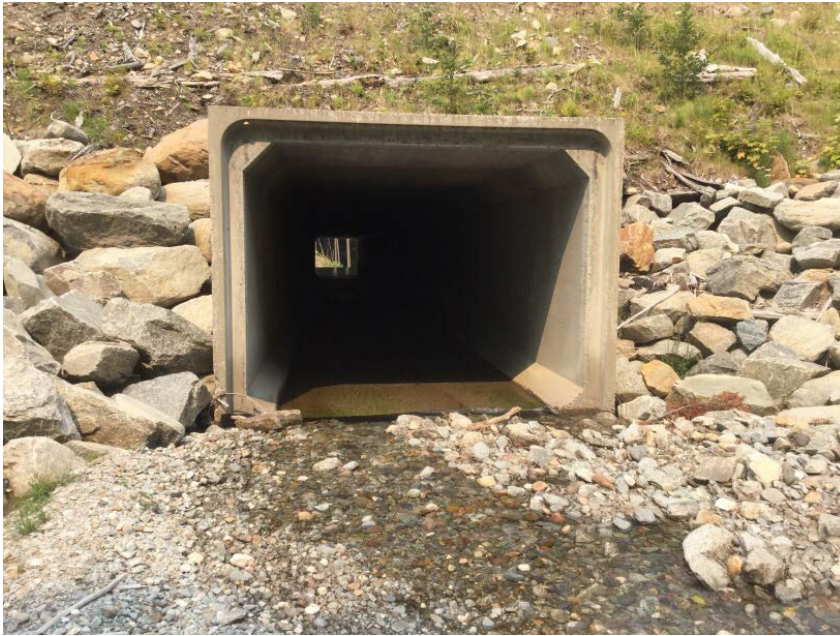
Inlet Good

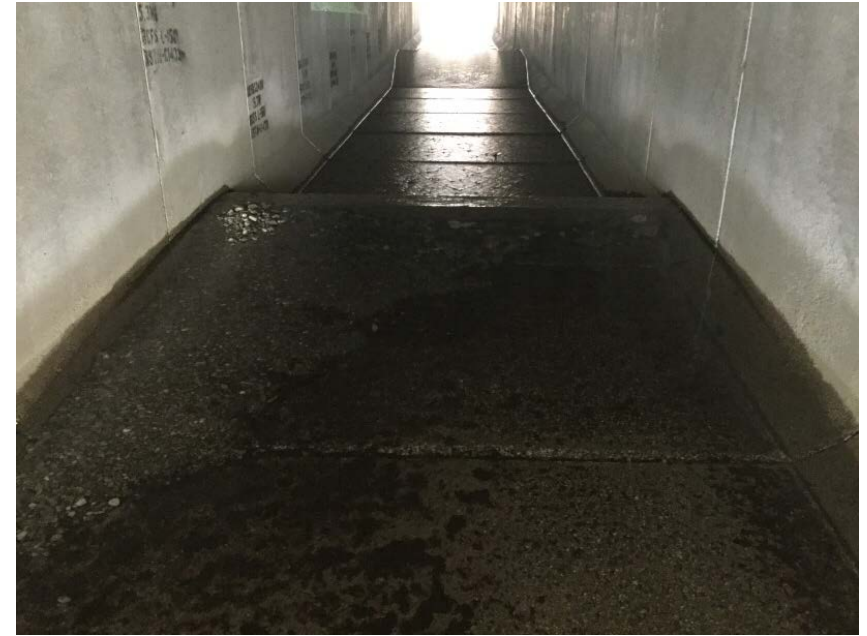
Baffles Good

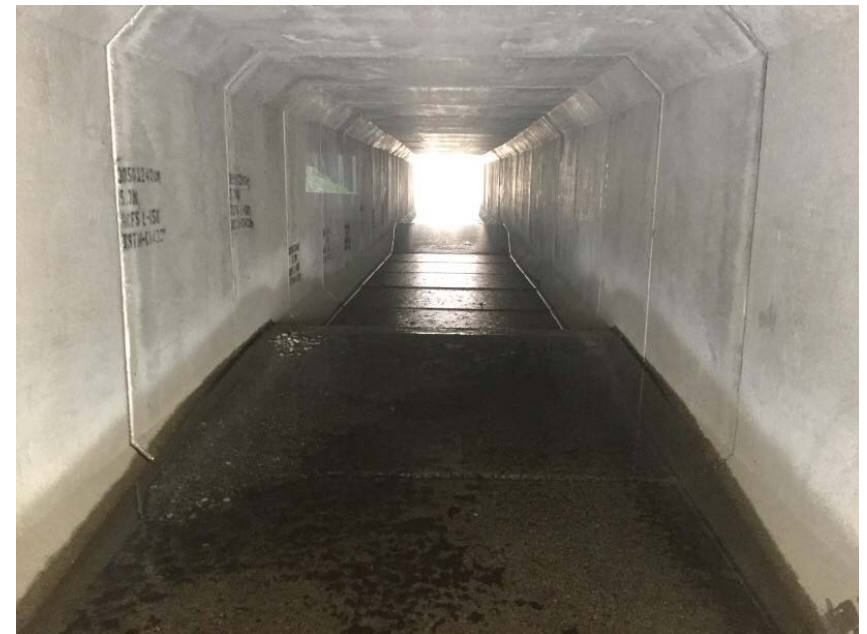
Looking through culvert from inlet

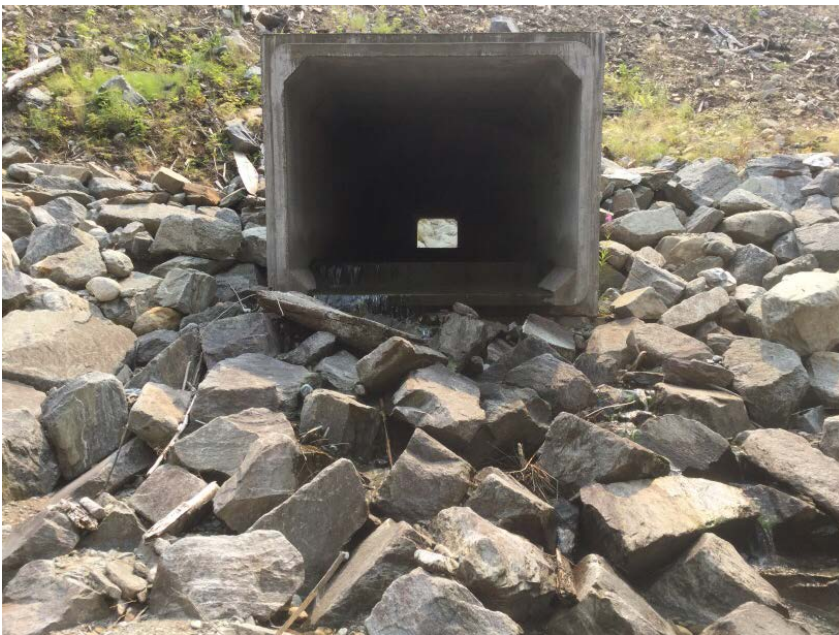
Outlet Good
