CK-2529

STS'AILES 0km

2017 Inspection

| Structure Class | Major Culvert |

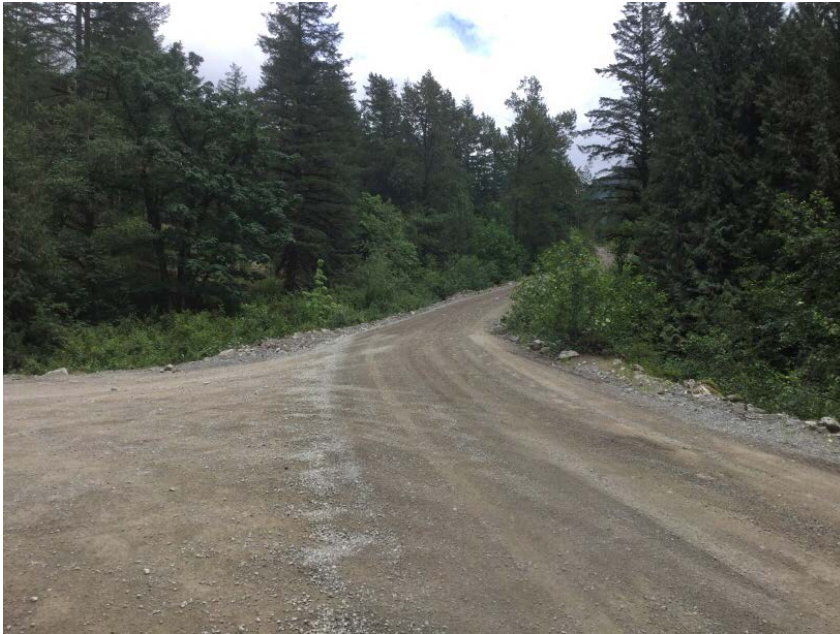
Approach from Right Bank when facing downstream

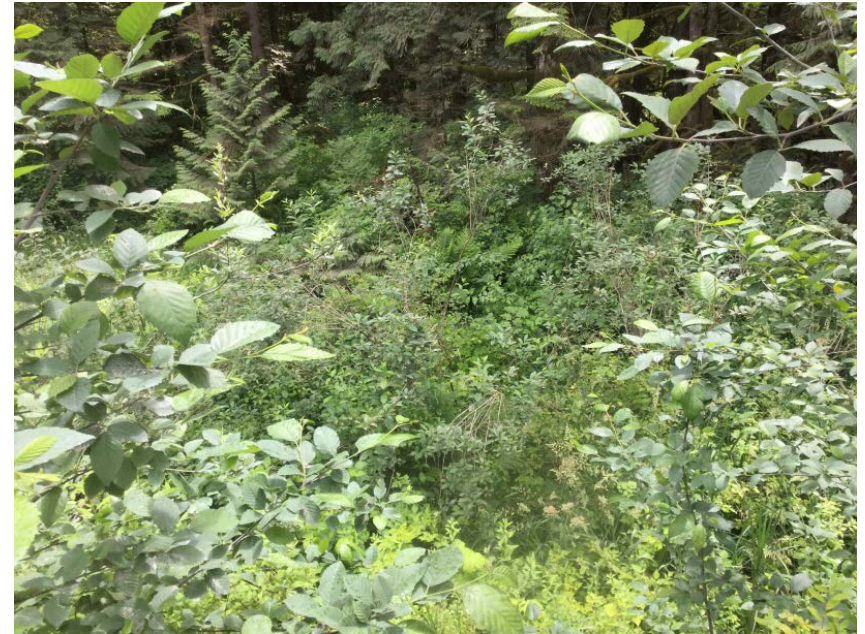
Looking downstream from road

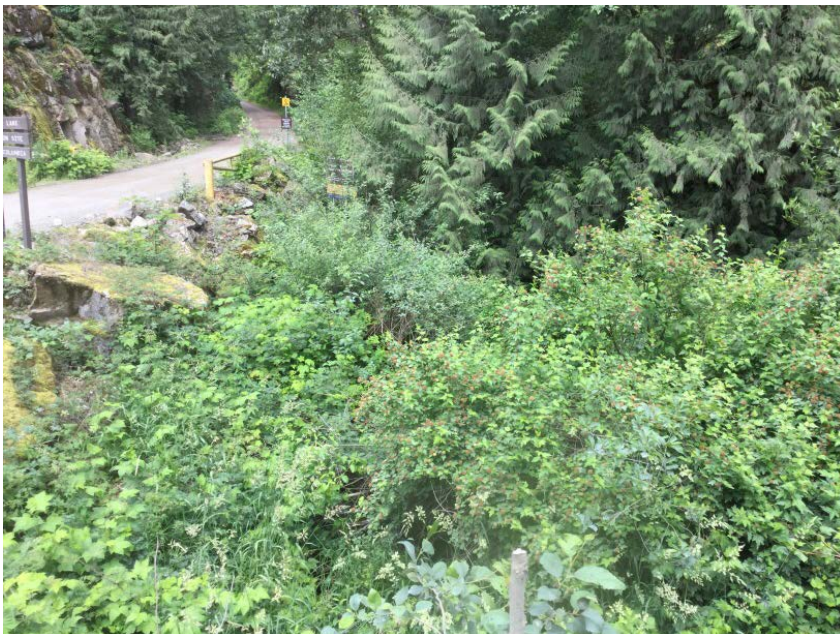
Looking upstream from road

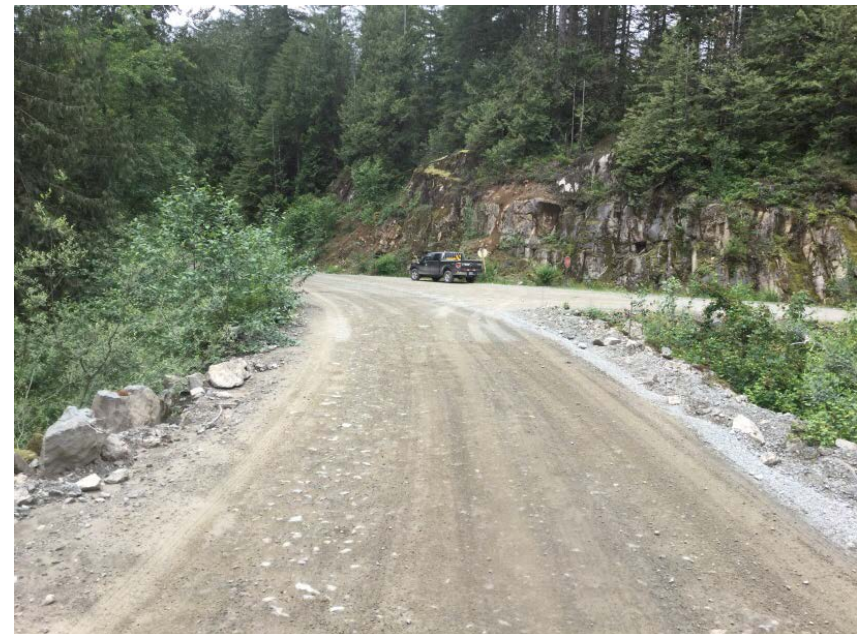
Approach from Left Bank when facing downstream

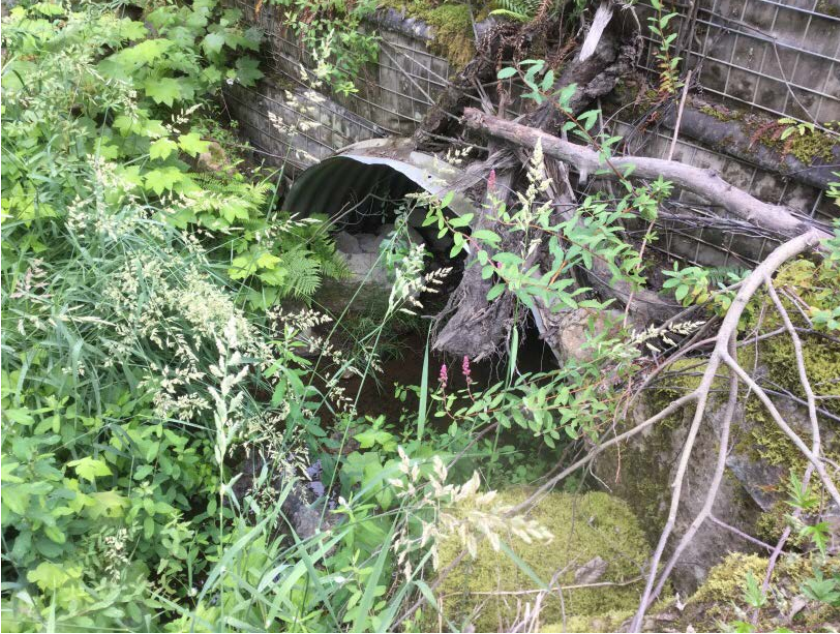
Inlet, nicely vegetated and stable

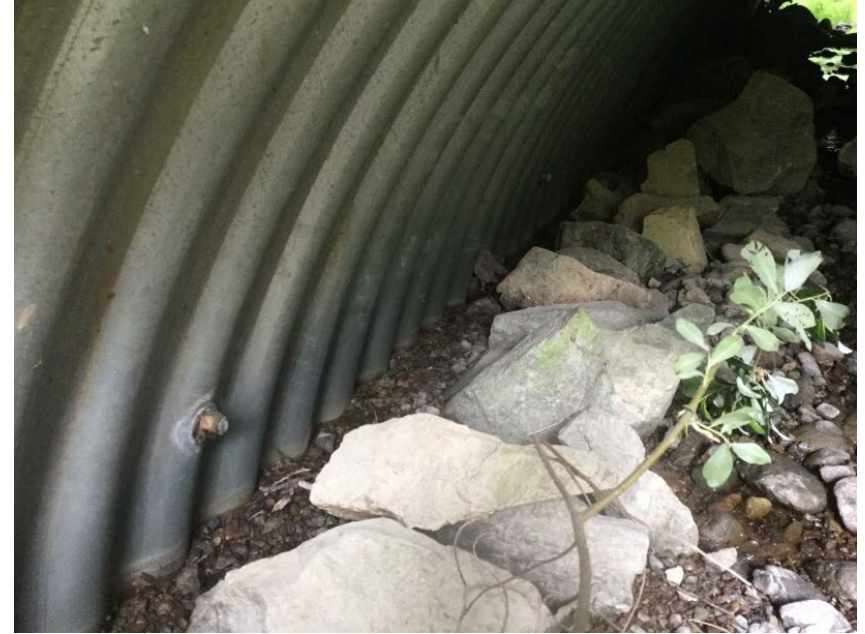
Anchor/tieback end assembly - 5/8" galvanized thread bar, typical throughout

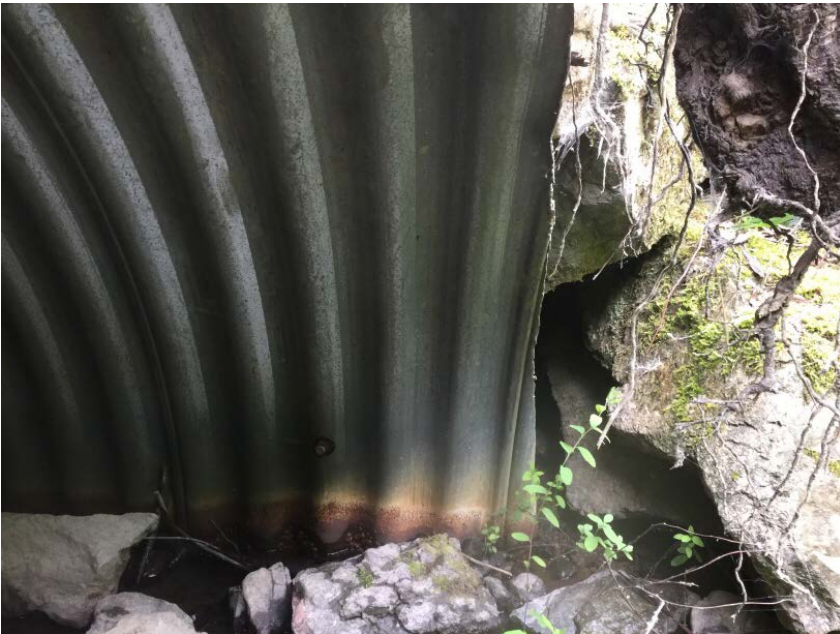
minor corrosion noted

Minor corrosion on culvert noted

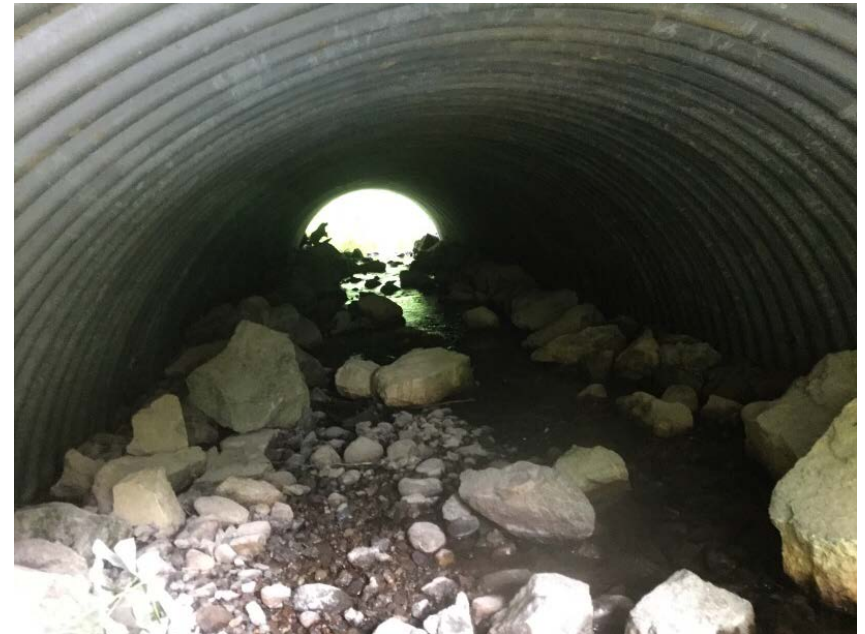
Stream substrate stable

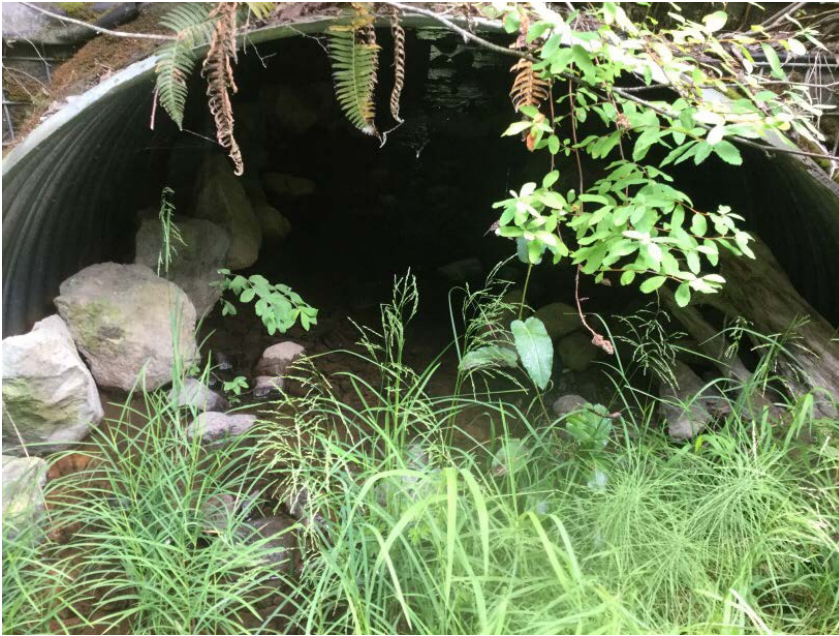
Outlet - nicely vegetated and stable
