CK-2530

HARRISON EAST 45.3km

2017 Inspection

| Structure Class | Major Culvert |

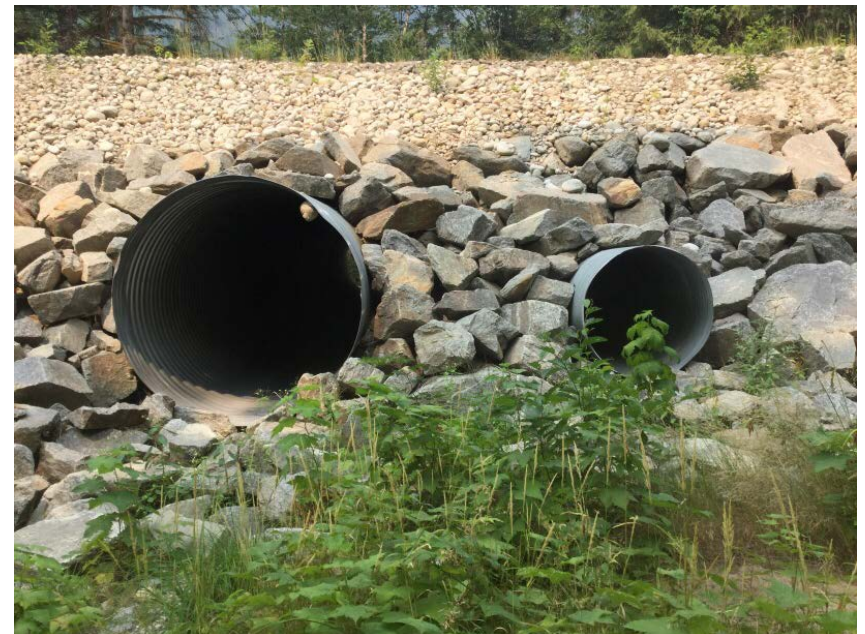
Inlet      Good

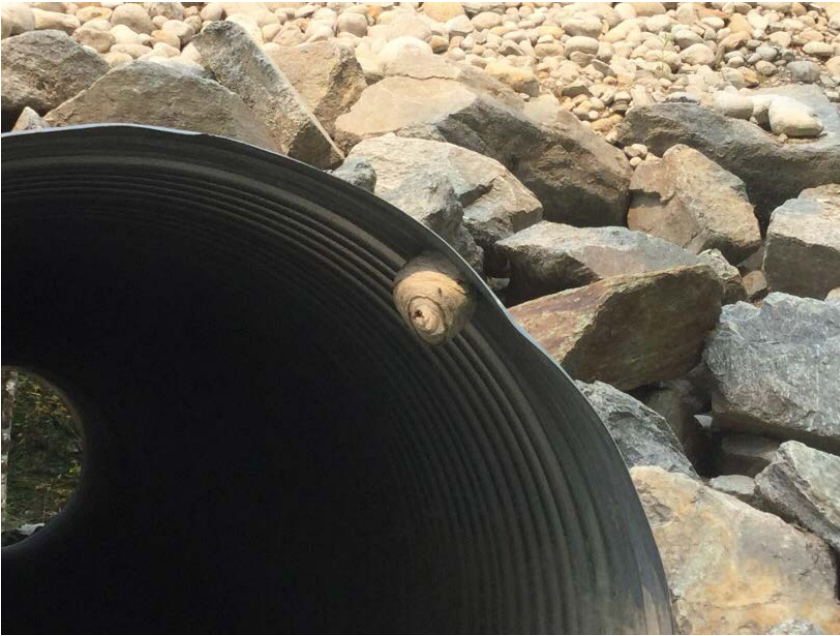
Bee hive

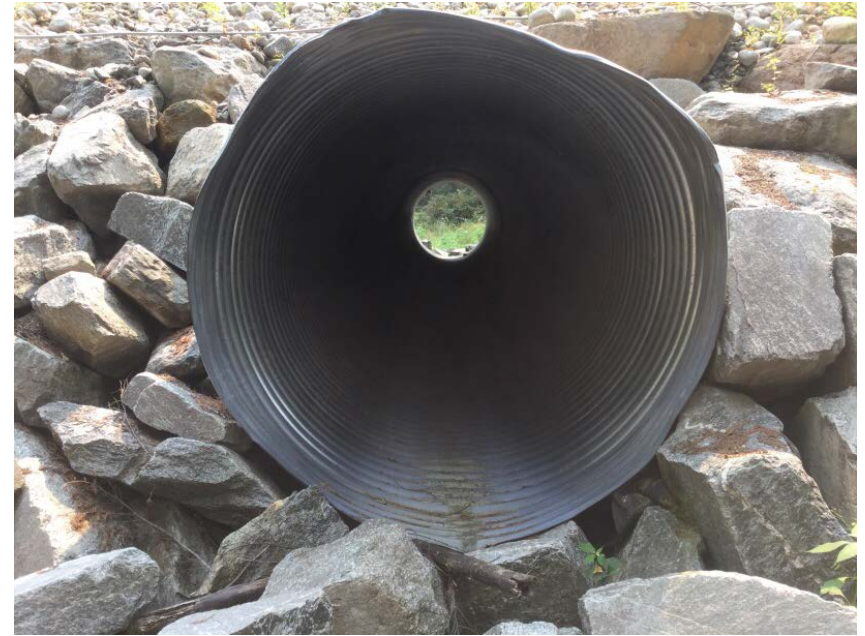
Outlet      Good
