CK-2535

PITT RIVER 13.3km

2017 Inspection

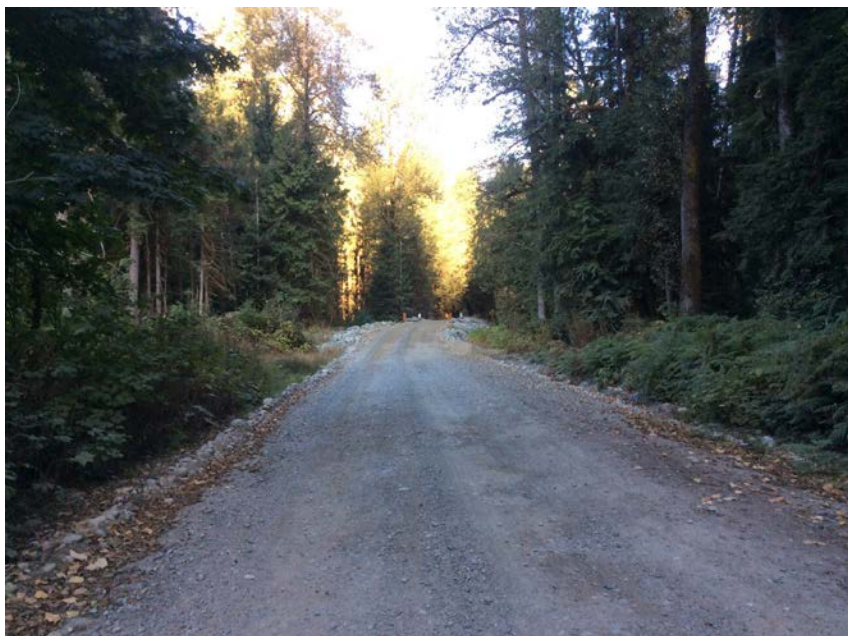
Approach from Left Bank when facing downstream

Missing downstream left approach log

| 1 | Low | Replace downstream left approach log. |

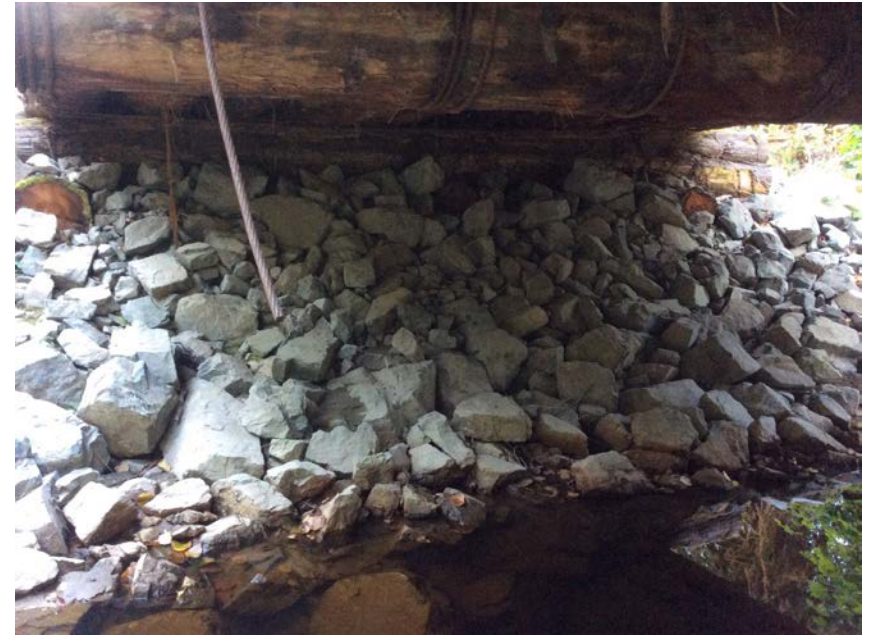
Left Bank Abutment when facing downstream

Cedar sill logs on tiebacks. Can't see if there is lower face log

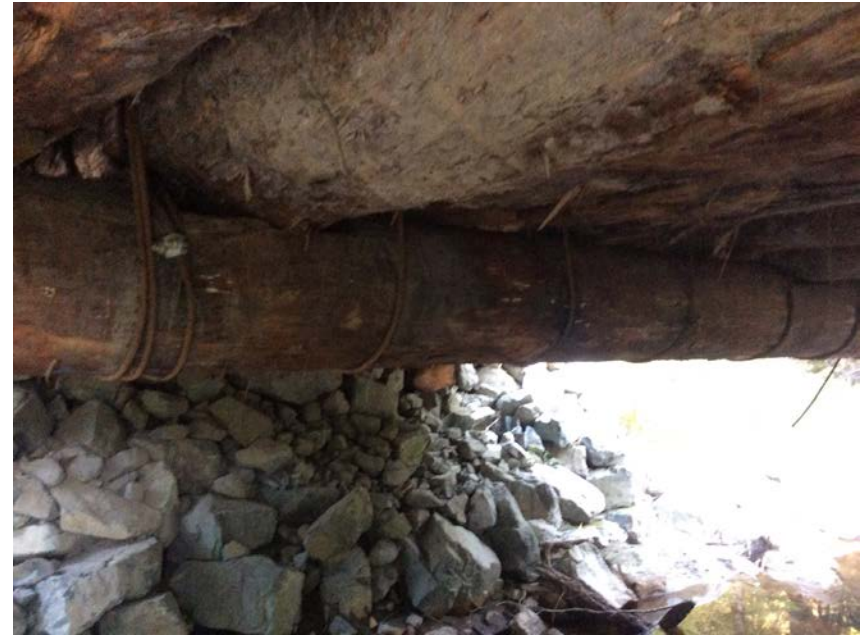
Needlebeam

Needle Beam Good Fd needlebeam well lashed and shimmed to stringers
