CK-2003

AMERICAN 7.9km

2018 Inspection

| Crossing Name | American Creek | | |

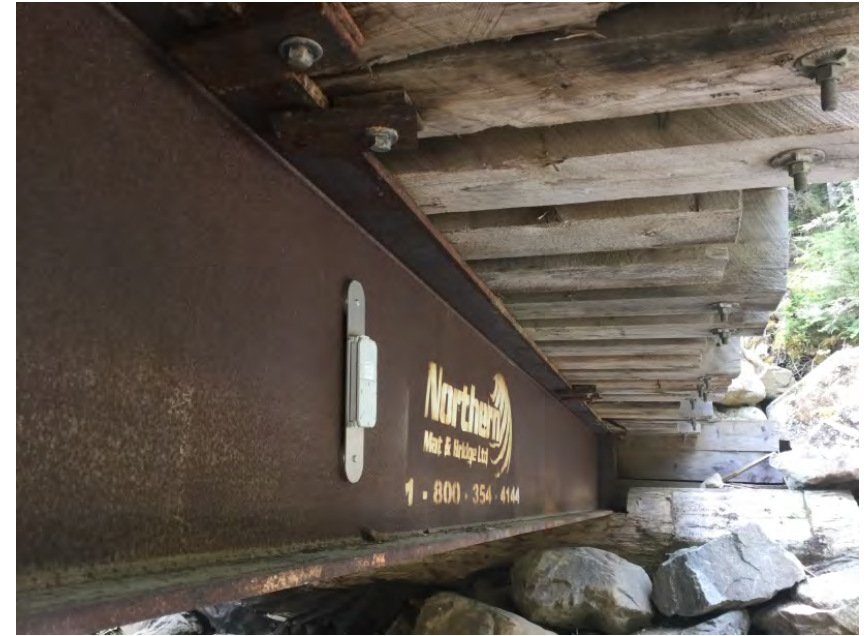
Deck to Girder Bolts Good Deck clips fasten deck to girders

Deck clips

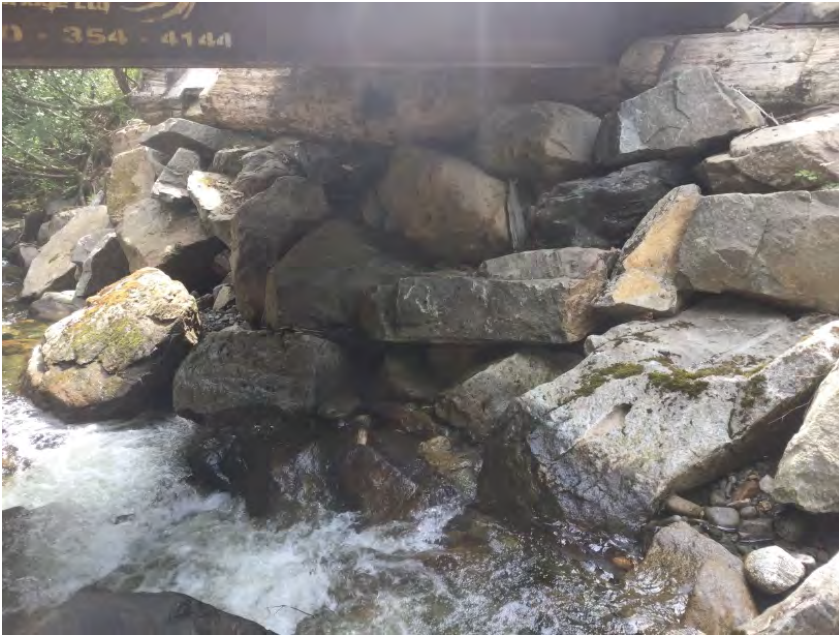
Single logs sills at both banks

Right Bank Abutment when facing downstream

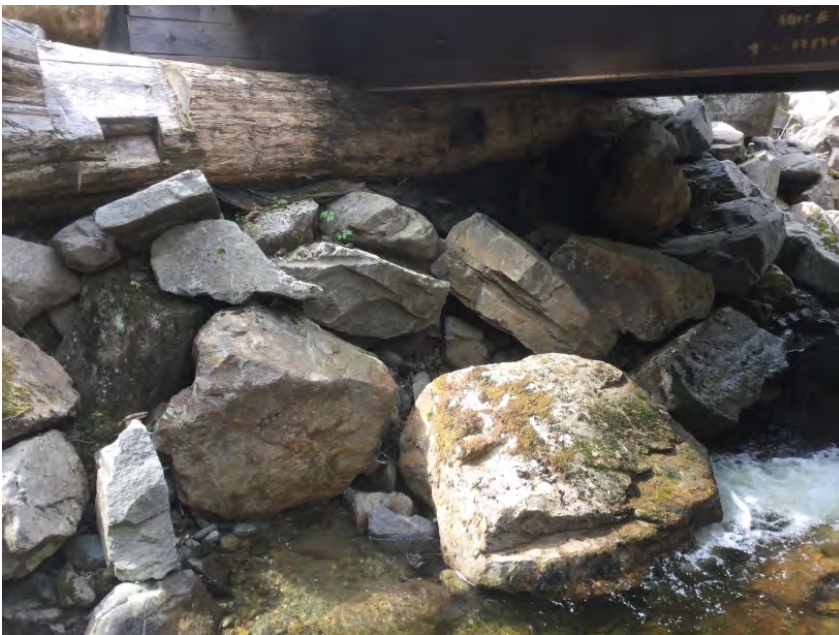
This bridge was originally installed in 2013 and assumed a 3 year lifespan. Due to the temporary nature of the install oversized riprap was used for the slope protection and was installed steeper (1H:1V) than typical. The riprap on the downstream right bank continues to erode putting the stability of the structure at risk. I recommend a temporary repair of the eroding riprap be completed at this time to ensure abutment stability and the riprap condition be monitored. The steel indicates L100 or 91 tonnes load rating which can continue at this time.

Poor at downstream right bank as it's eroding, both banks riprap 1H:1V and not well graded or keyed - monitor site while in use especially following heavy rainfall events

Eroding riprap right bank

| Repair Item | Priority | Repair Description |
|---|---|---|
| 1 | Medium | Repair riprap scour |

| Item | Monitor Description | Frequency |
|---|---|---|
| 1 | Monitor eroding riprap while in use | Weekly |

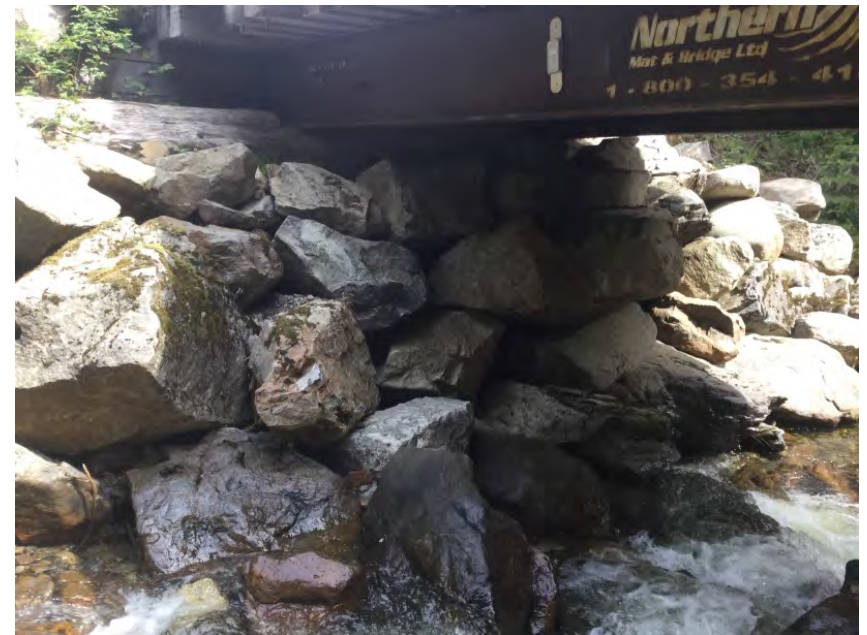
Left Bank Abutment when facing downstream

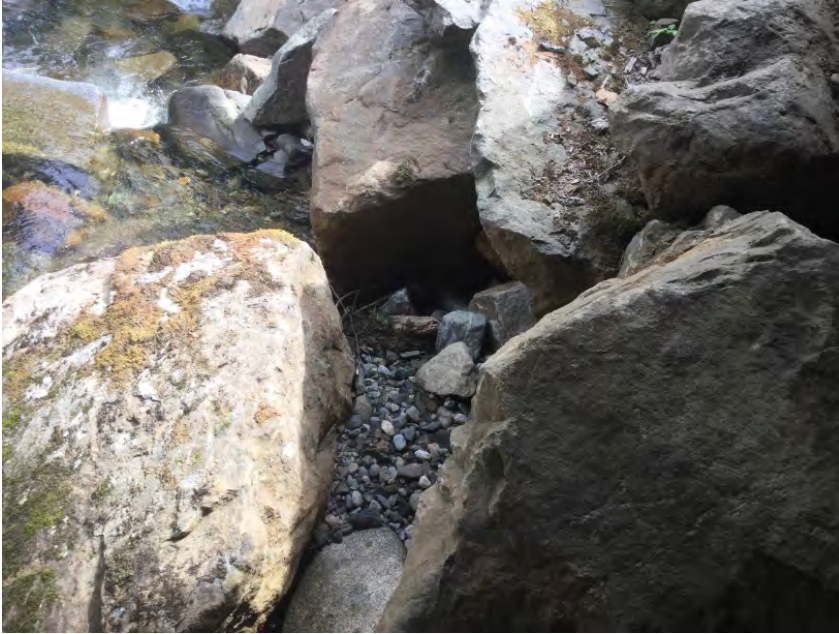
Eroding riprap at downstream right bank

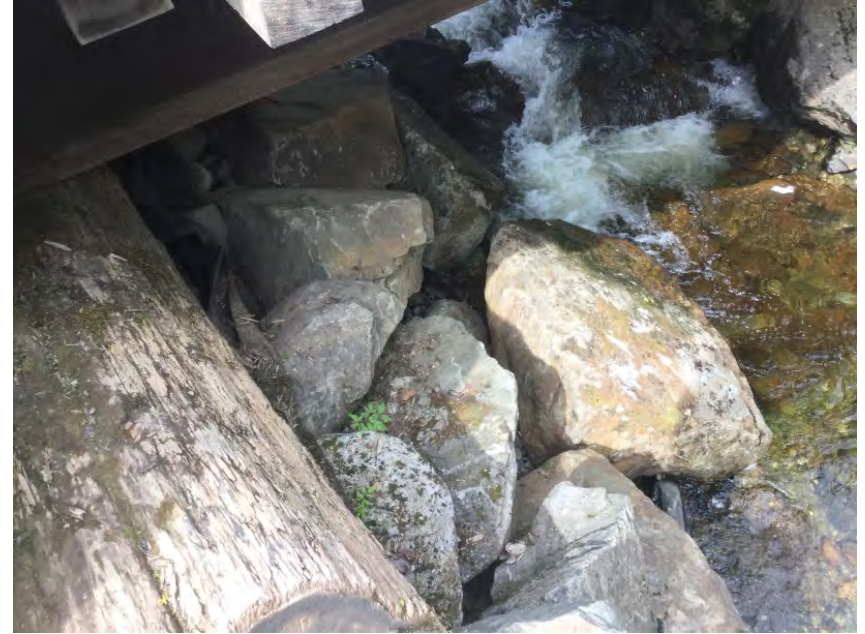
Eroding riprap at downstream right bank
