CK-2007

ANDERSON SEVEN 0.1km

2018 Inspection

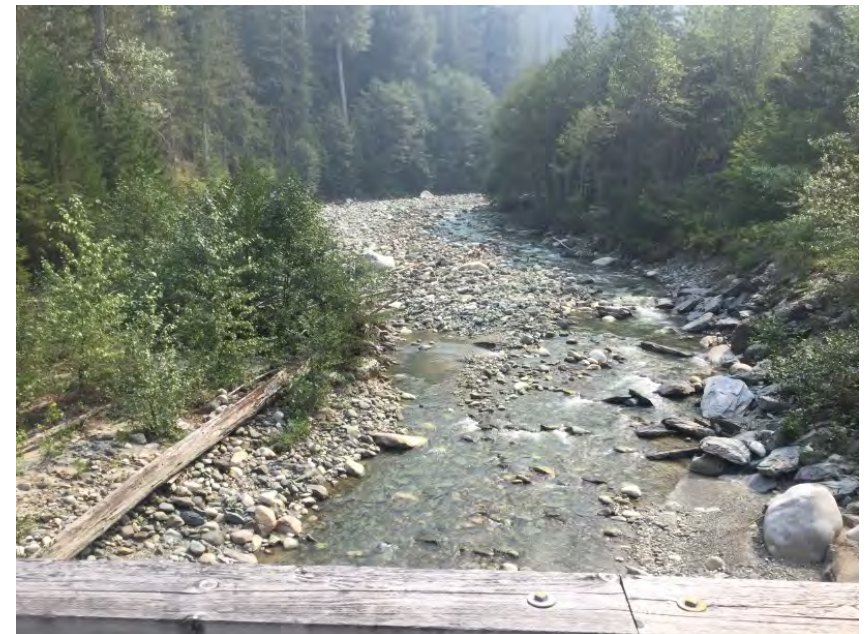
Upstream from Crossing

Comments    Some large debris noted upstream

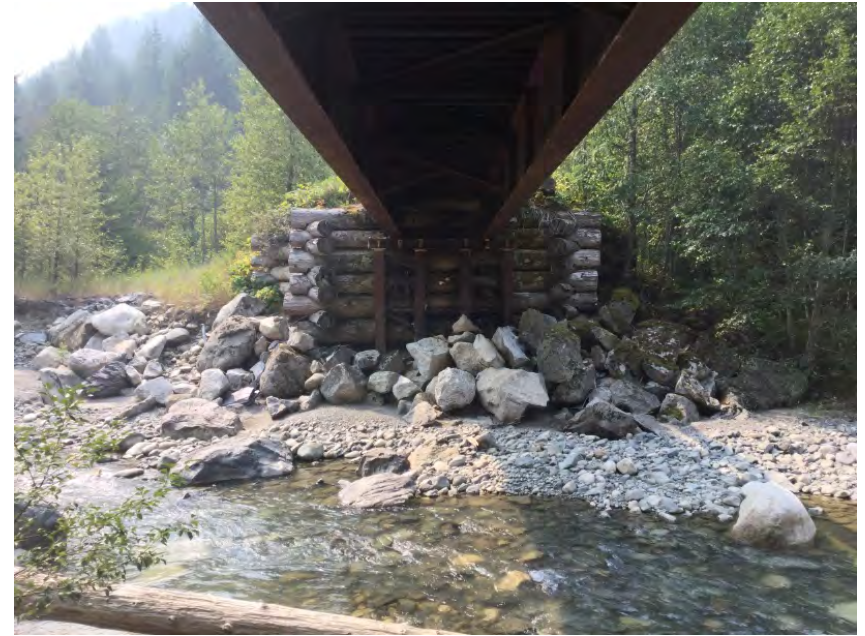
Left Bank Abutment when facing downstream

Upstream left abutment scour extends 400mm behind crib and wingwall, however no signs of movement

Upstream left abutment has large round boulders that are loose

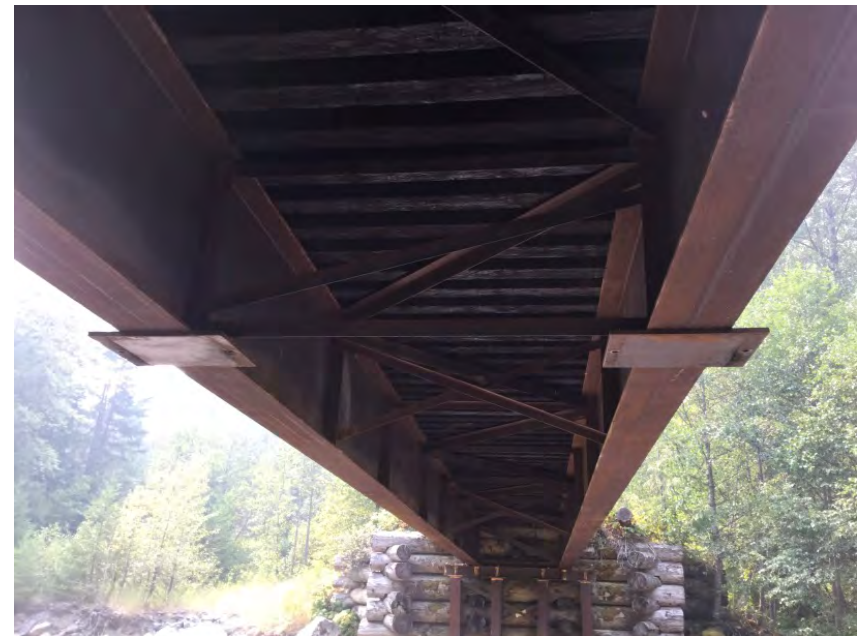
No access to bearing locations

Old bearing plates still visible

| Item | Monitor Description | Frequency |
|---|---|---|
| 2 | Bearing locations | Routine Inspection |

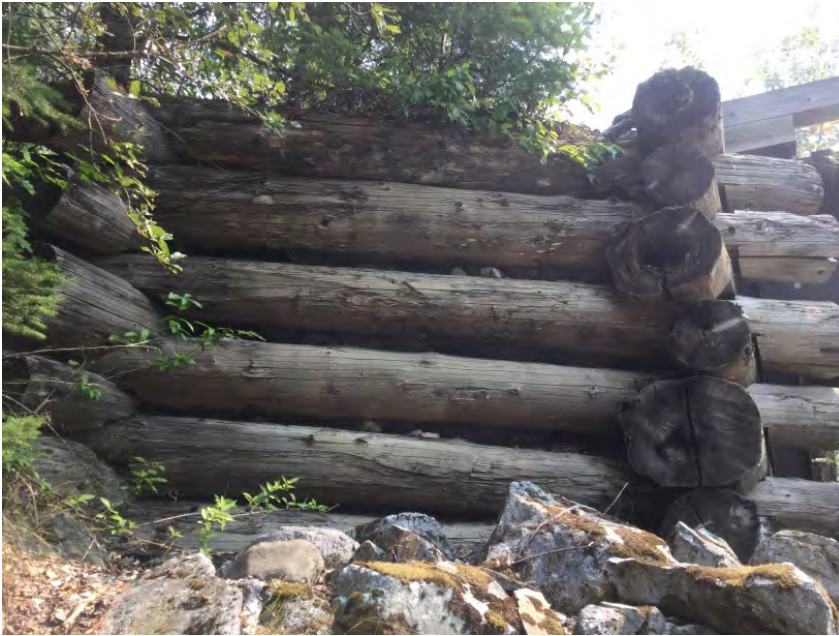
Log cribs only for fill retention. 450 - 800mm diameter face logs with up to 400mm heart rot as noted in larger logs at the ends. No signs of crushing of any face logs noted

Upstream left approach crib condition

| Item | Monitor Description | Frequency |
|---|---|---|
| 1 | Log crib condition | Routine Inspection |

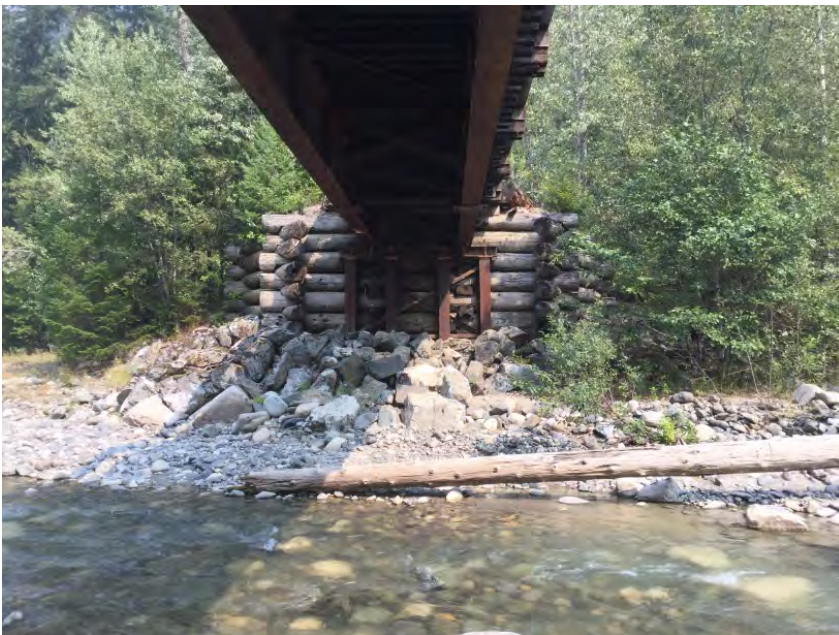
Right Bank Abutment when facing downstream

Top log on downstream right abutment has horizontal crack - monitor condition
