CK-2014

CANTELON 8.2km

2018 Inspection

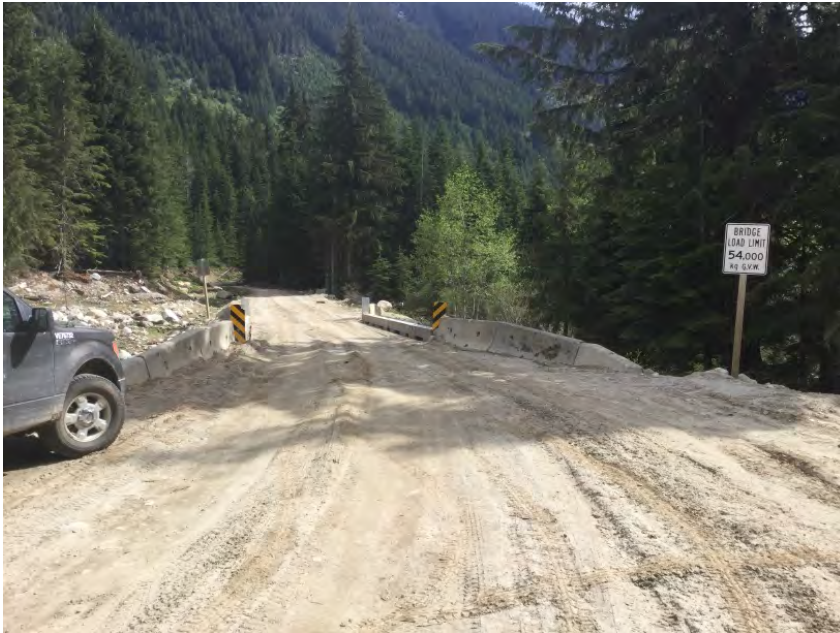
Approach from Right Bank when facing downstream

Road Surface Poor Rutted

| 1 | High | Grade road with activity |

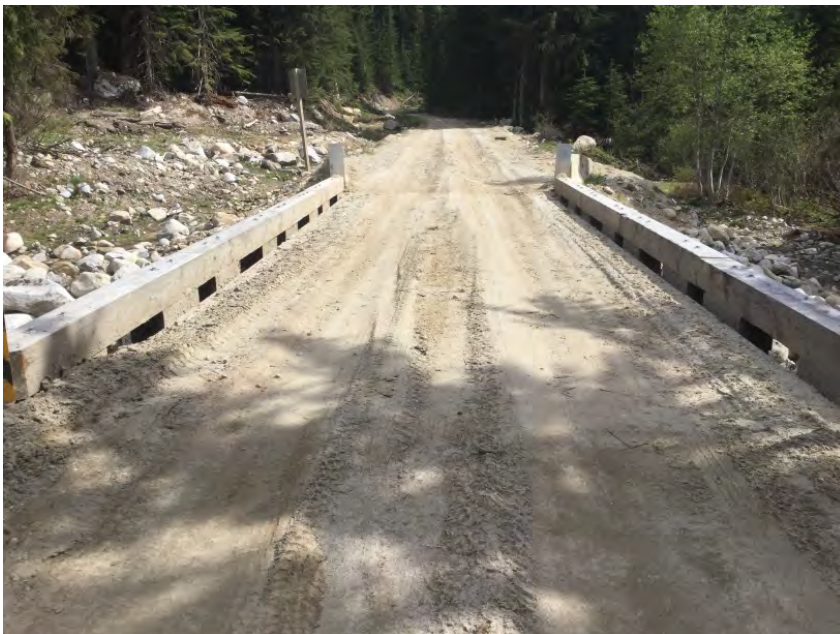
Deck

| Running Surface | Fair | Sediment on deck to be removed |

Clean sediment from deck and grade approaches. Present load rating of L60 or 54 tonnes to continue.

| 2 | Medium | Clean sediment off deck |

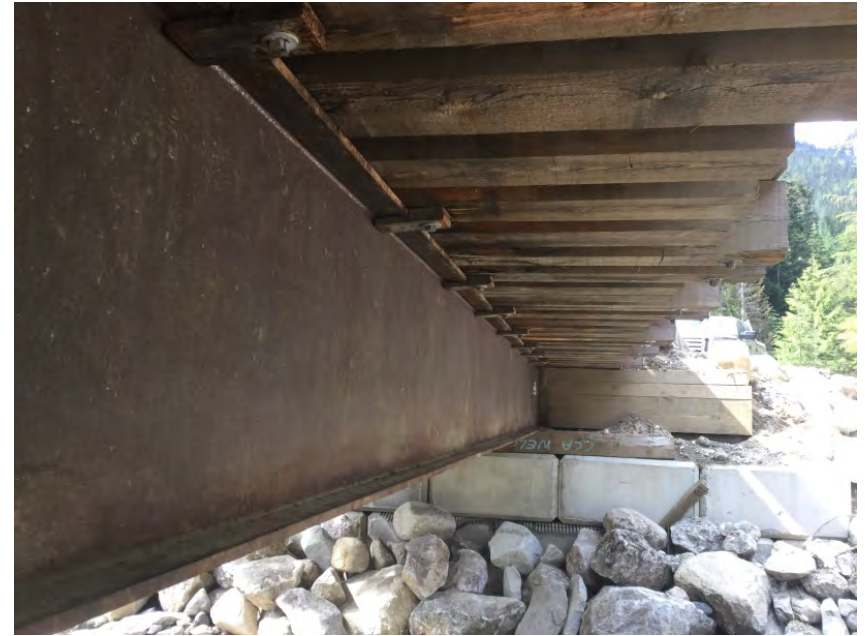
Deck clips

| Deck to Girder Bolts | Good | Clips |

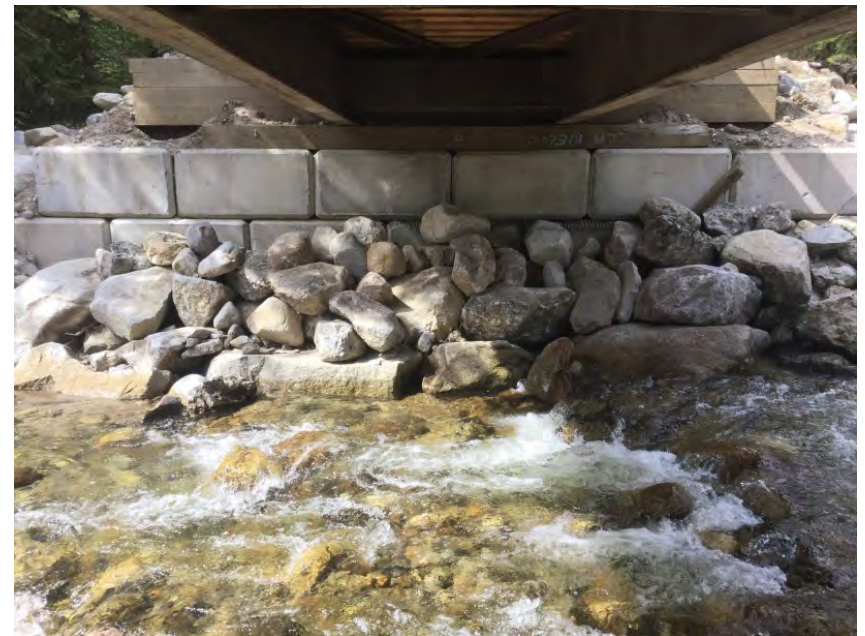
Right Bank Abutment when facing downstream

Concrete Good Lock block 3 rows high each abutment
