CK-2022

CHEHALIS 15.2km

2018 Inspection

Crossing Name Statlu Creek

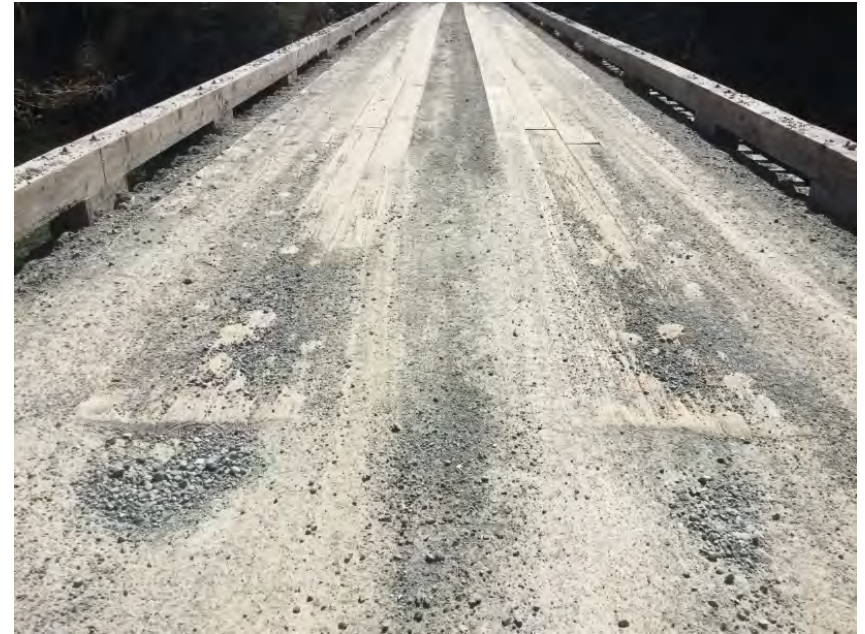
Wearing heavily at both ends

Deck - wearing on wheel path at both approaches

| Item | Priority | Repair Description |
|---|---|---|
| 2 | High | Replace complete timber deck assembly (ties, subdeck, wear planks, guardrail and risers) |

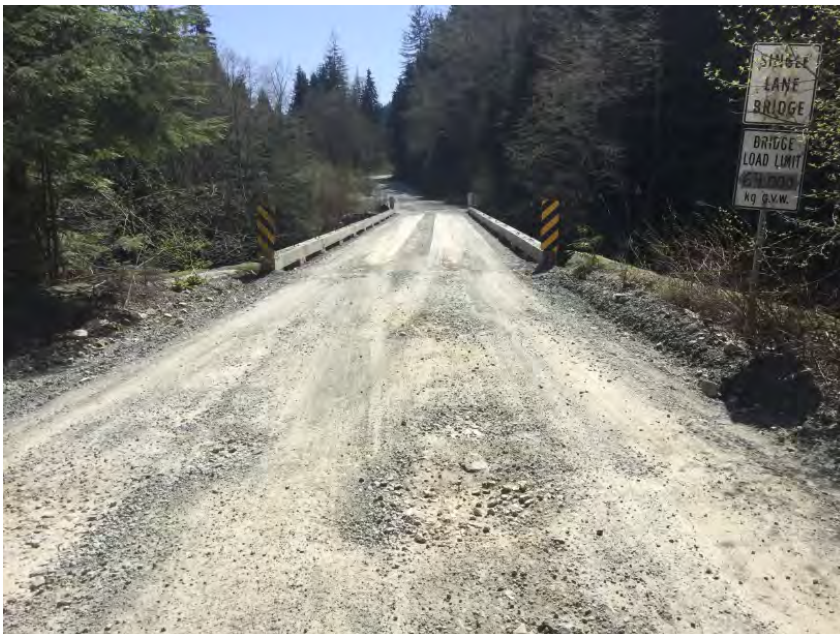
Fender Condition Fair left approach fenders are small and should be replaced with larger ones

Low fenders at left approach

Comments    Replace log fenders with appropriately sized ones  
                  Add riprap to upstream left bank to help support rotting logs and corresponding fill

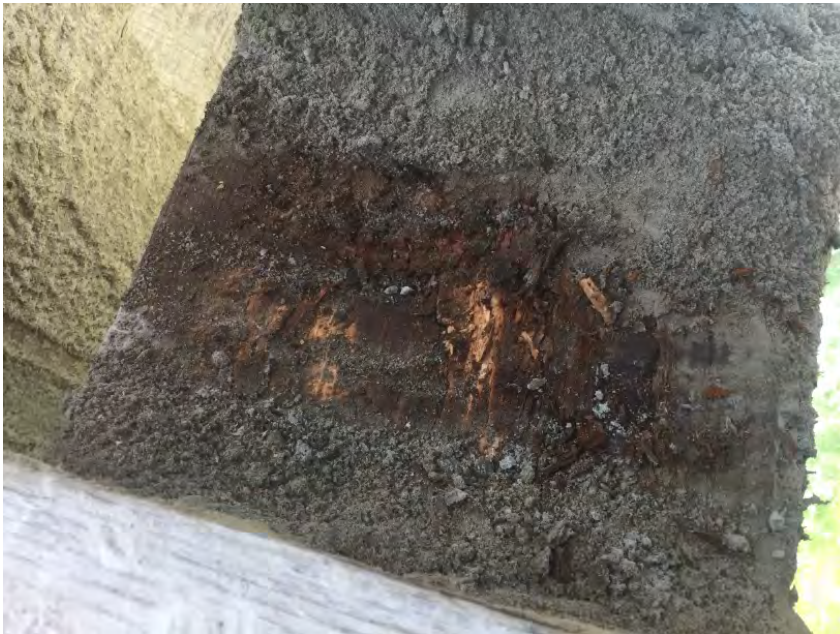
Fair to poor - cored in random locations and confirmed rot

Random tie exposed with signs of decay

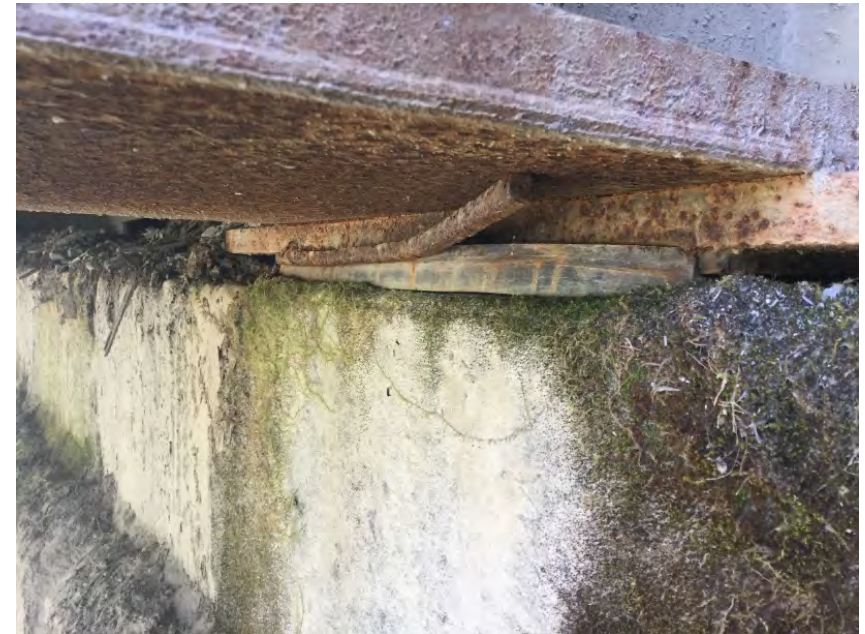
Bearings Fair Keepers have separated from plates

Upstream right bearing

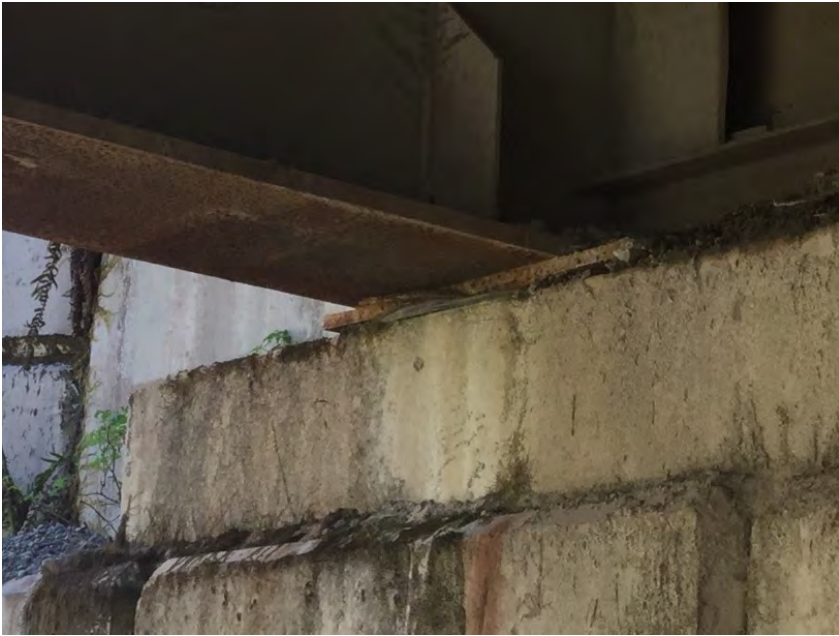
Downstream right bearing

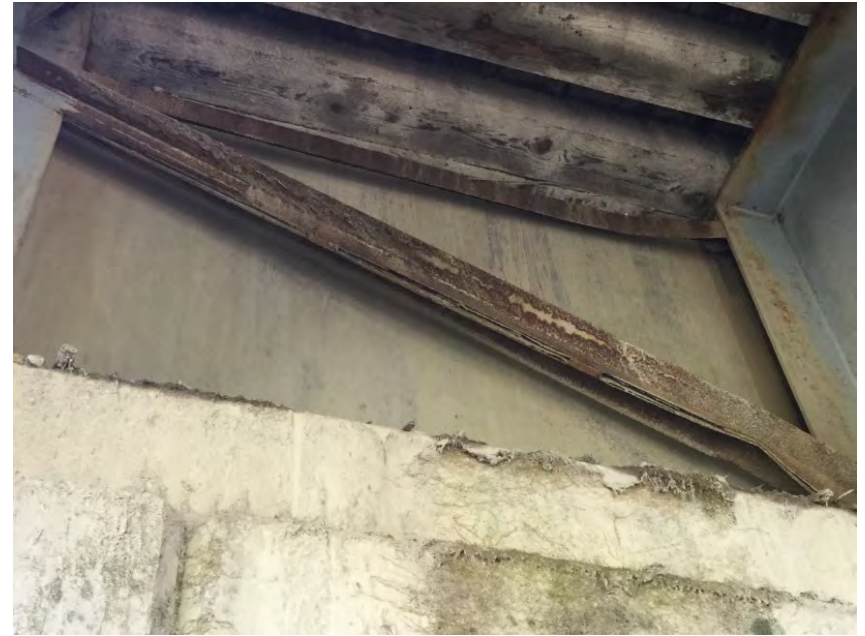
6 welded bays, heavily corroded at bearing locations

End diaphragm at right abutment heavily corroded

| Item | Priority | Repair Description |
|---|---|---|
| 3 | High | Replace end bracing sets at both ends |

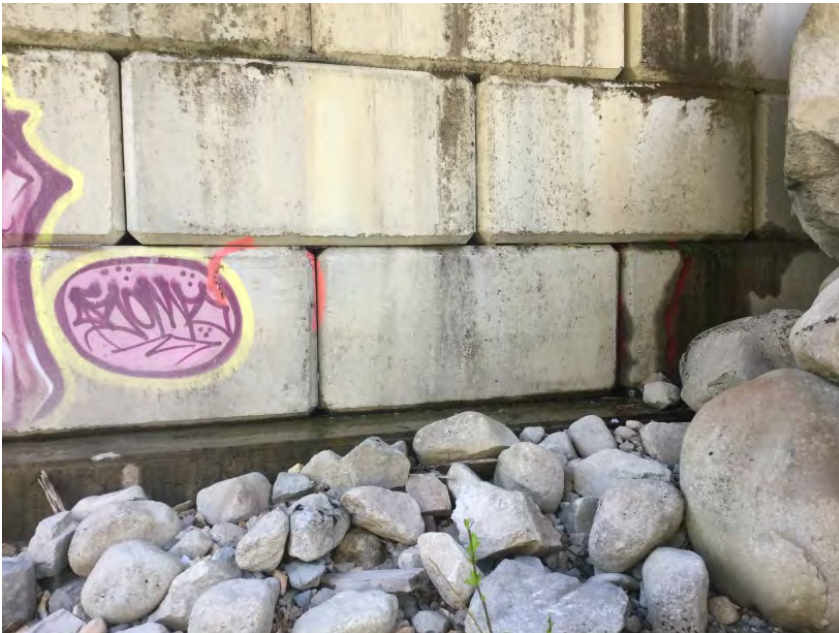
Concrete Fair Lock blocks at right bank, 3 on bottom are cracking and should be monitored, CIP left bank

Surficial cracking of lock blocks at right bank

| Item | Monitor Description | Frequency |
|---|---|---|
| 1 | Lock block condition at right abutment | Routine Inspection |

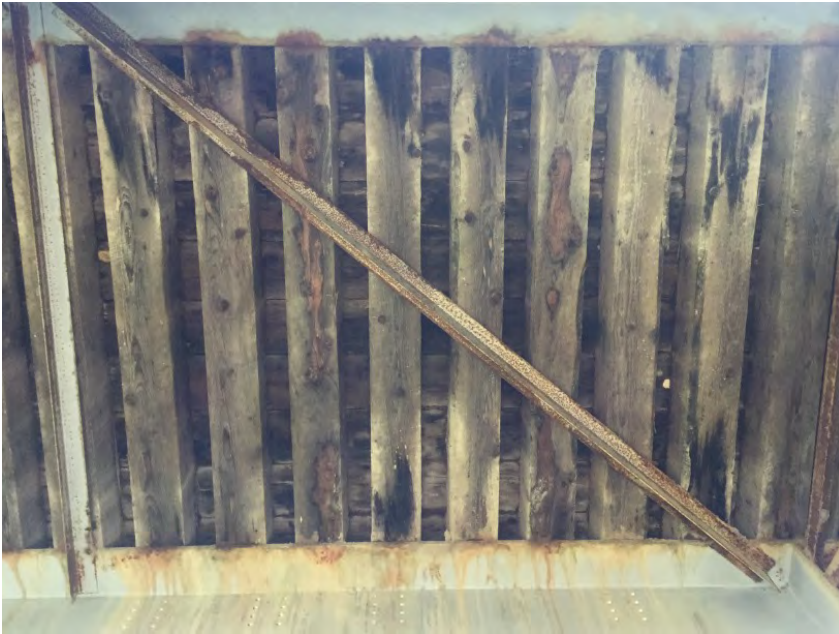
Numerous indicators of rot - cored at random locations and confirmed poor condition

Due to poor timber condition

Indications of deck rot throughout

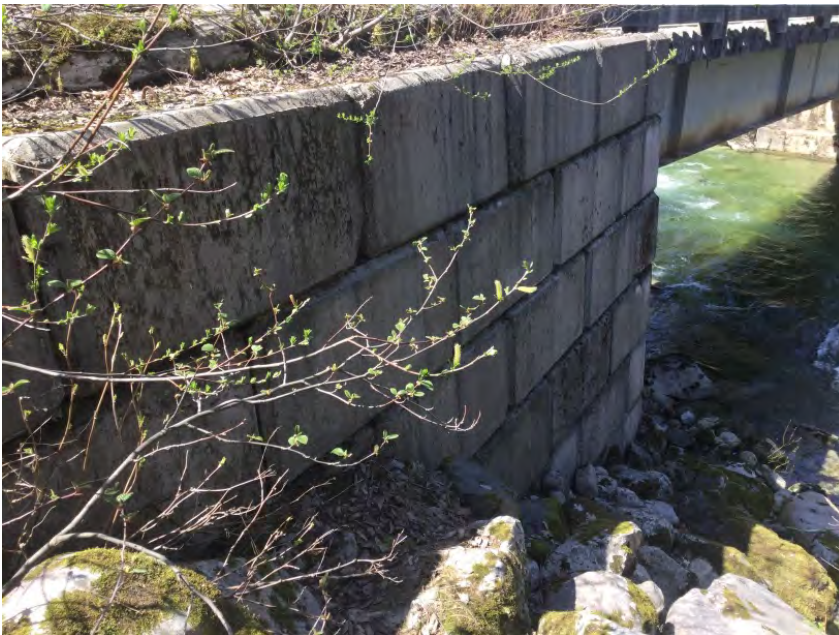
Wing Wall Fair Lock blocks downstream right bank, logs left bank

Lock block wing wall at downstream right bank

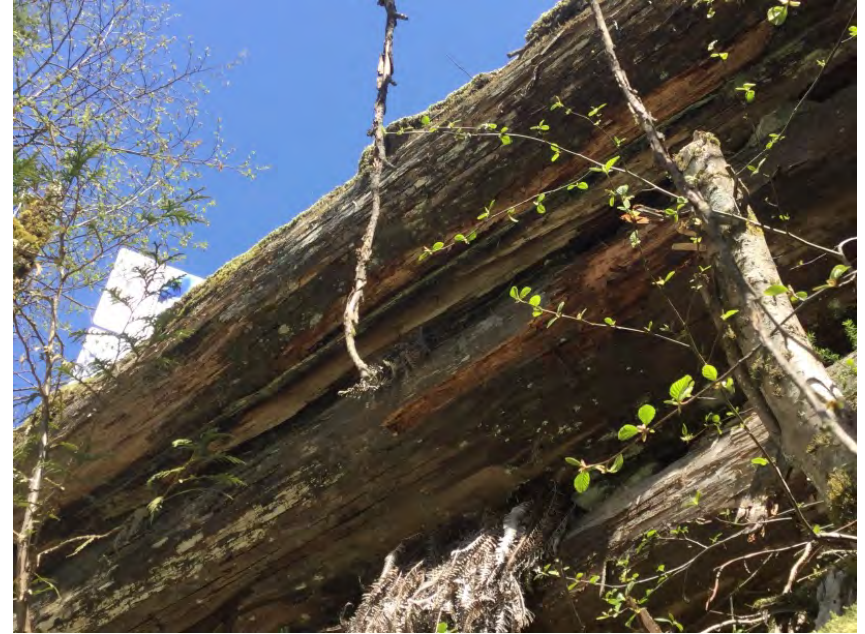
Up to 50mm sap rot on log wingwall on left bank

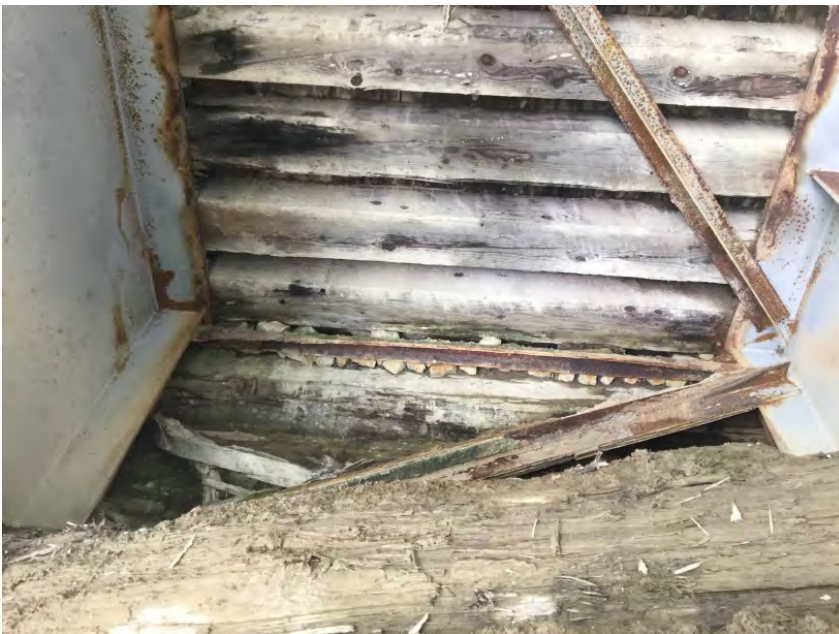
Bracing at left bank appears heavily corroded

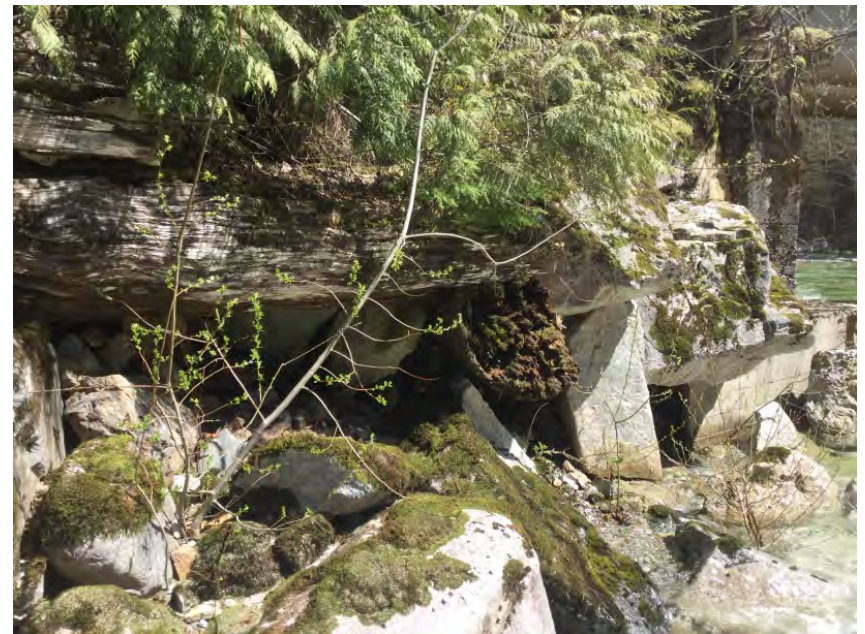
Fill Fair There are logs buried behind CIP abutment at the left bank that are old and supporting fill

Logs buried in fill at left abutment behind CIP
