CK-2023

CHEHALIS 21.8km

2018 Inspection

| Crossing Name | Upper Bentley Creek |

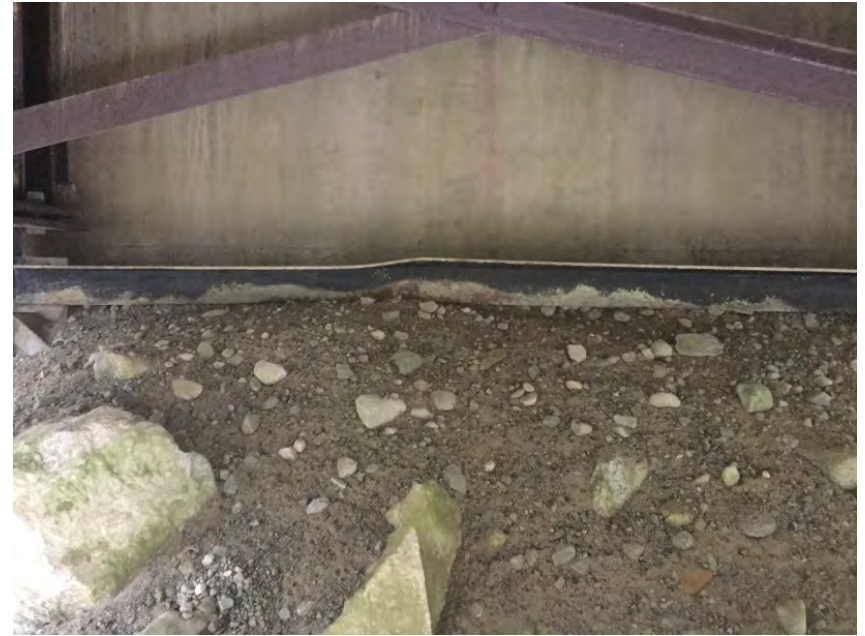
Minor damage to right bank bracing

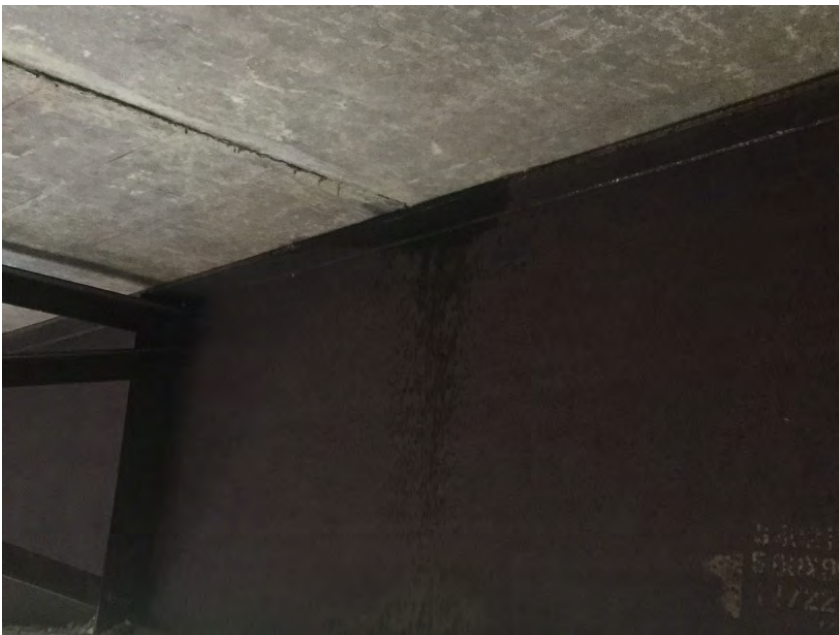
Deck Joints Fair evidence of water getting through random joints

Evidence of water getting through random deck joints

| 1 | Deck joints | Routine Inspection |
