CK-2024

CHEHALIS 23km

2018 Inspection

| Crossing Name | Dick Creek |

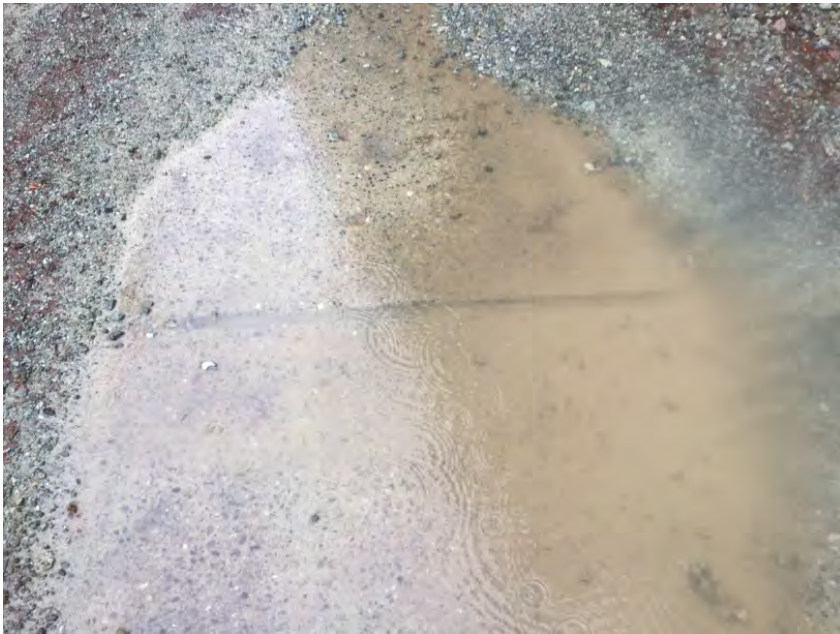
Deck Joints      **Fair**

Grout on deck joints not flush with deck

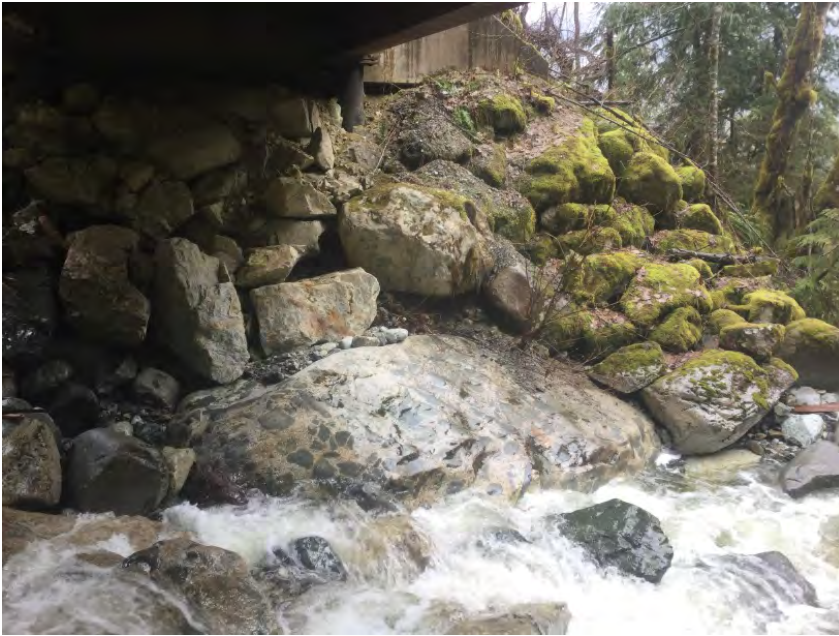
Riprap at the left bank has been scoured and starting to move

The riprap at the downstream left bank abutment appears to have been scoured since last inspection. I recommend repairing that scour and monitoring it into the future. Present load rating of L150 or 136 tonnes to continue.

Riprap Fair Fair to poor as left bank has been slightly scoured

Riprap at left bank has been undermined and starting to shift

| 1 | High | Repair riprap scour at left bank |

| Item | Monitor Description | Frequency |
|---|---|---|
| 1 | Monitor riprap scour | Routine Inspection |

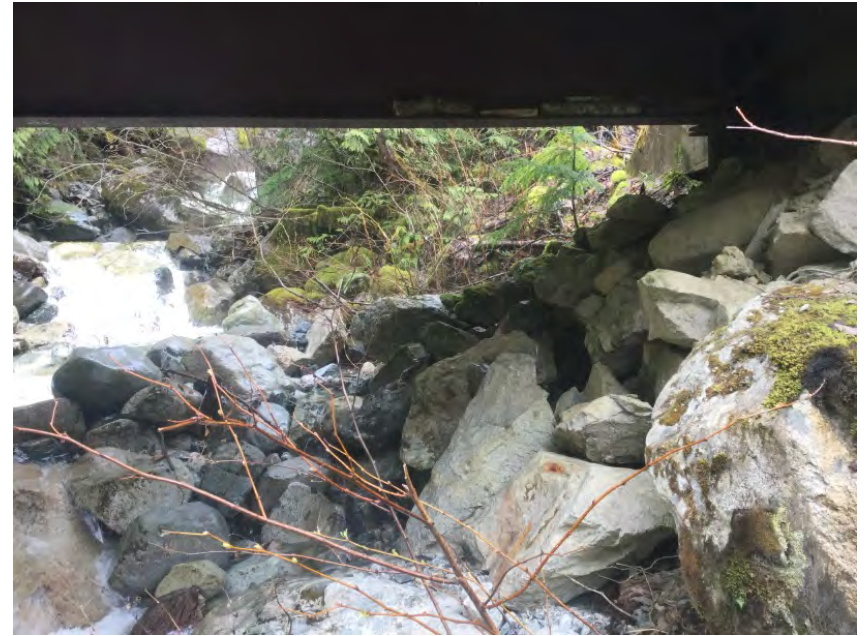
Riprap at left bank scour
