CK-2026

CHEHALIS 27.4km

2018 Inspection

Crossing Name Third Creek

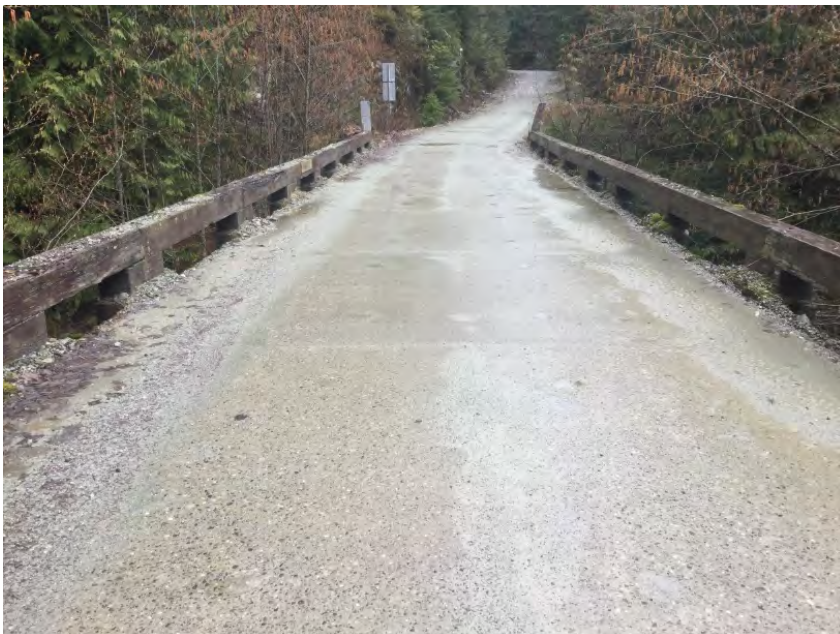
Curb Rail/Blocks/Posts      **Poor**      Cored random side blocks and risers and significant rot found

Hardware      **Poor**      Loose rail boltsOverall Deck Condition      **Poor**      Due to rail condition

| Repair | | Repair Description |
|---|---|---|
| 1 | Medium | Replace guardrail, risers and blocks |

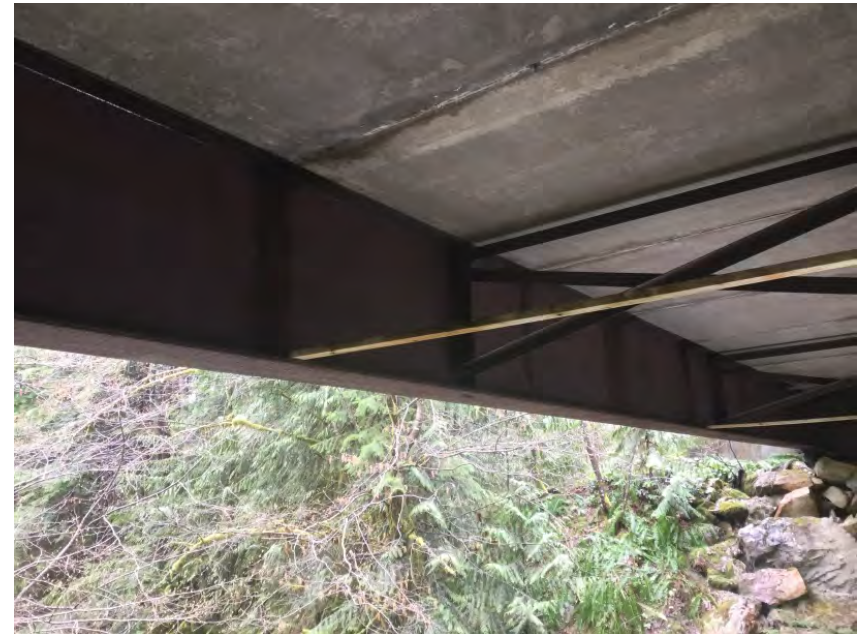
Evidence of water getting through deck joints
