# BC Ministry of Forests, Lands, and Natural Resource Operations

## Permanent Bridge Inspection Report

| Structure #: | CK-2032 | Site #: | CK-2032 | Road Name: | STATLU | Inspection Date: | 2018/04/17 |
| KM: | 4.90 | User km: | 4.90 | Crossing Name: | Statlu Creek | Next Inspection Date: | 2021/07/17 |

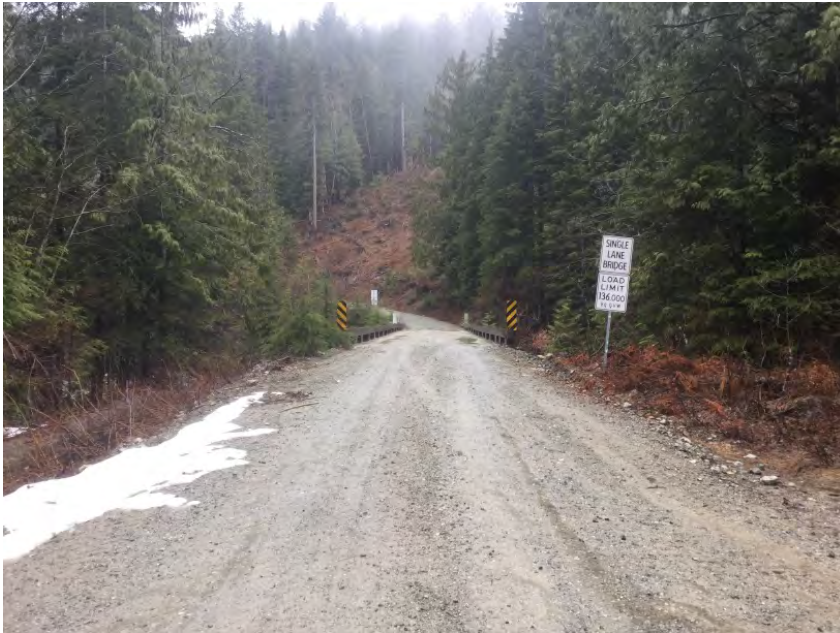
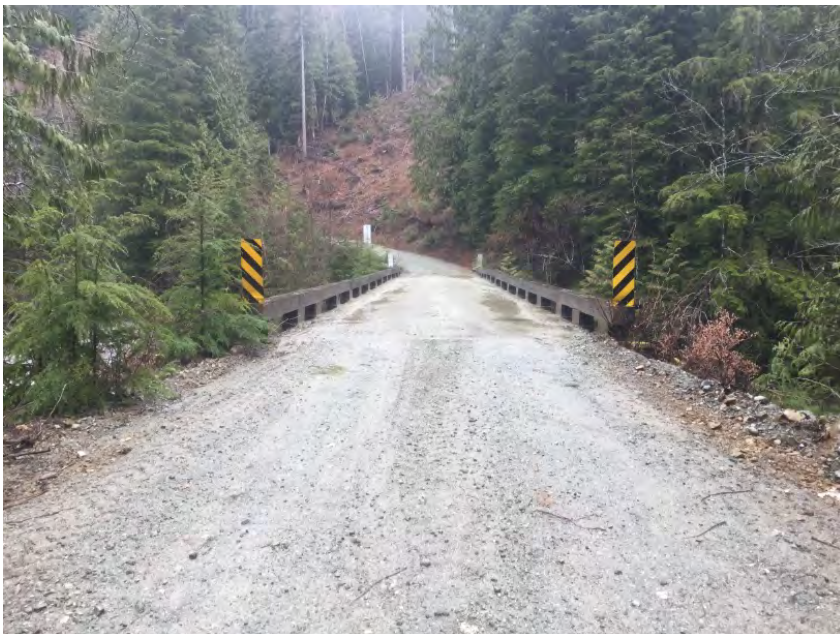
Approach from Right Bank when facing downstream

| Fender Condition | None | none at right approach |

| | 2 | Suggested | Medium | \$ | Place proper fender logs or concrete no post barriers at both approaches | | | | | |

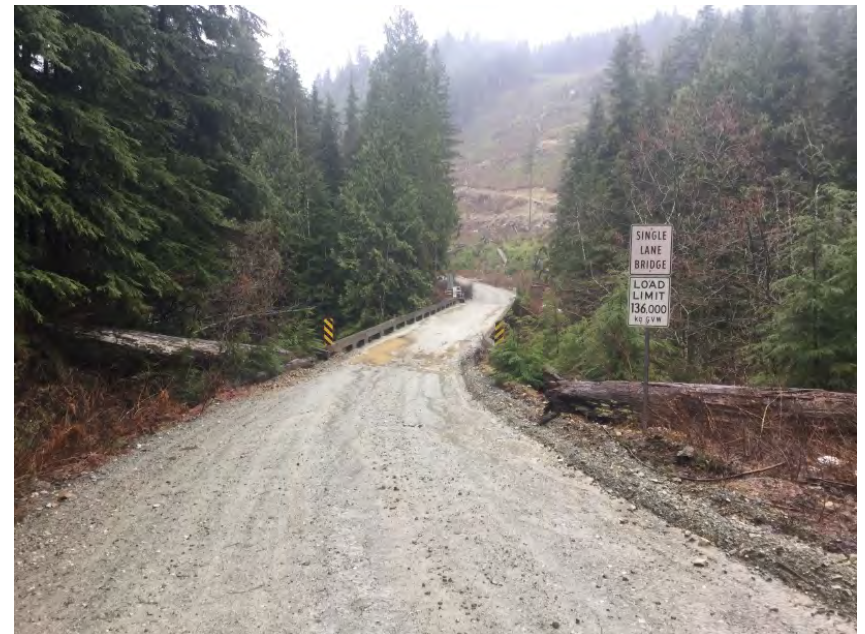
Approach from Left Bank when facing downstream

| Alignment | Fair | Good right approach, HC and VC left approach |

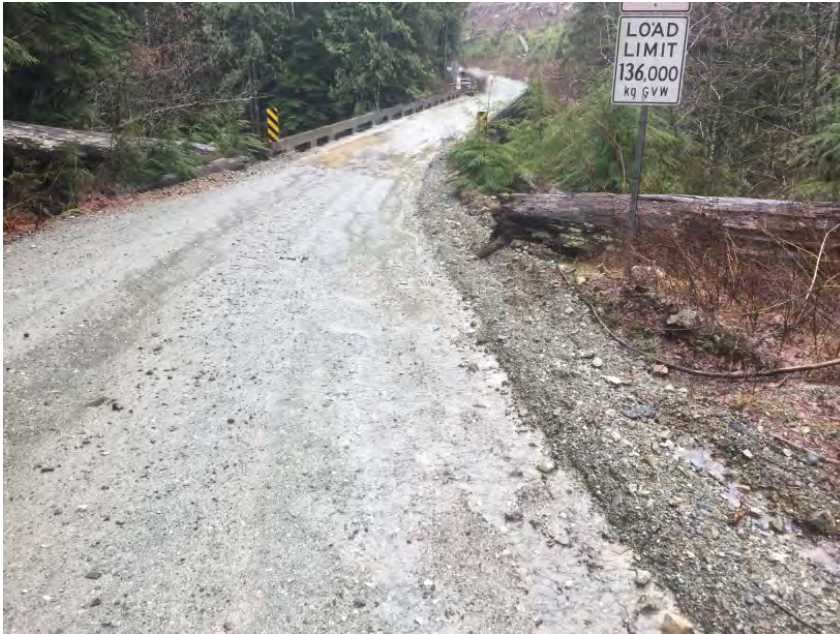
| GENERAL | Inspector's Comment: | Grader berm at left approach directly surface water down road and onto the bridge deck | | | | | | | | |

Grader berm directing surface water onto bridge deck

| | 1 | Suggested | Low | \$ | remove grader berm at left approach | | | | | |
| GENERAL | PEng's Comment: | Place fenders or concrete no post barriers at both approaches. Remove the grader berm at the left approach. Continue to monitor the condition of pier, the deck joints and the rubber bearing pad condition. Current load rating of L150 or 136 tonnes to continue. | | | | | | | | |

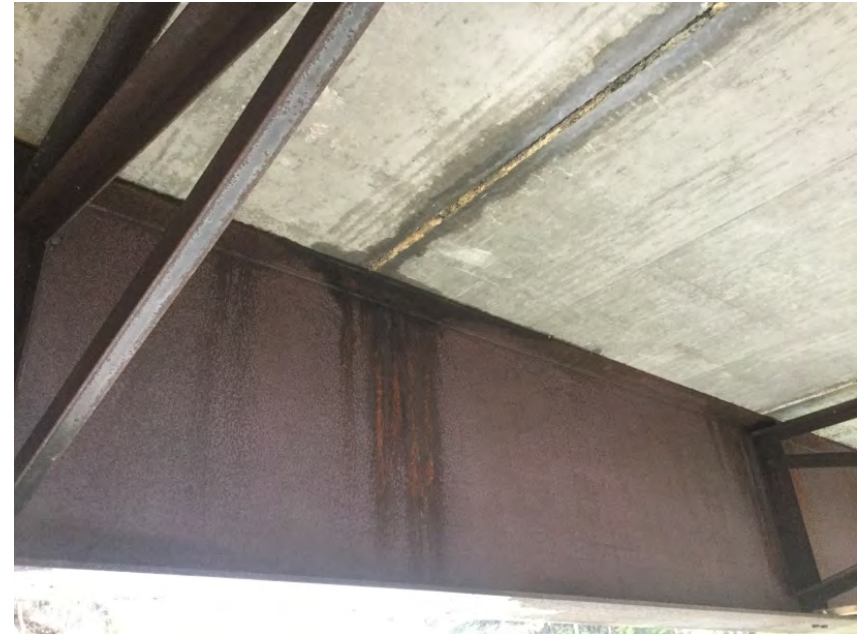
| Deck Joints | Fair | hairline cracks on the surface and evidence that water is getting through random joints | | | | | |

Indication of water leaking through random deck joints

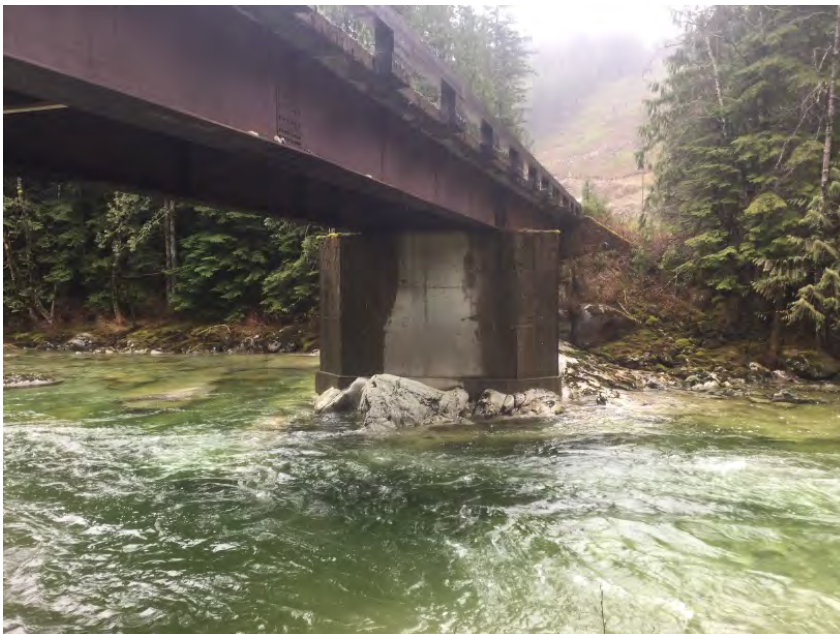
| Cribs | Fair | the Pier is actually concrete with hairline crack that doesn't appear to be getting any worse | | | | | |

| | 2 | hairline crack on the pier | | | | | | | | |

CIP pier

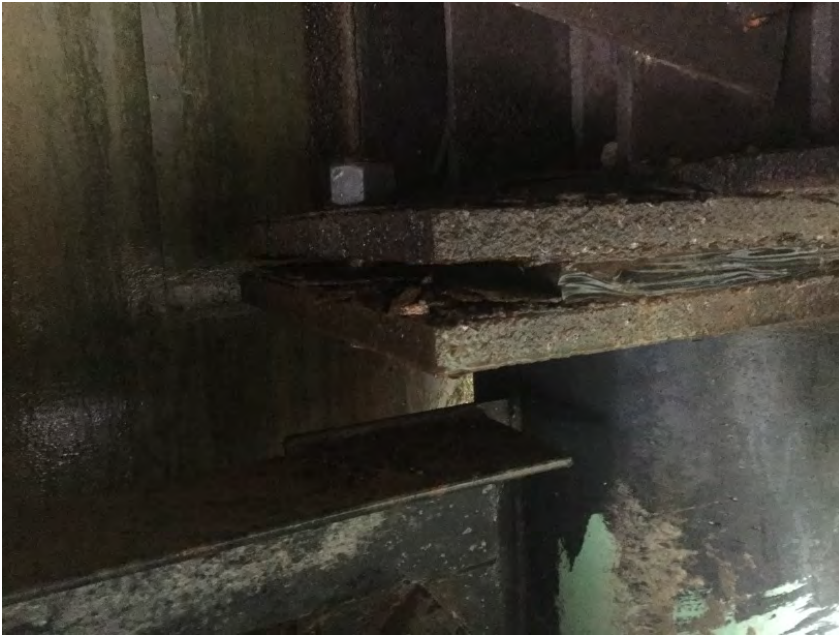
| | 1 | delaminating rubber bearing pads downstream left bank | | | | | | | | |

Minor delaminating of DS left bank bearing plates

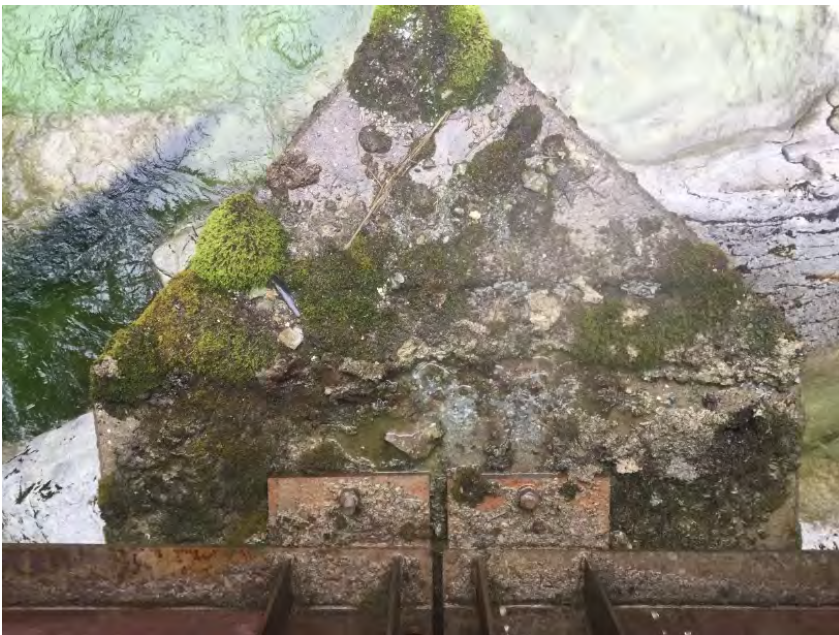
| Bearings | Unrated | difficult to completely assess but appear fair from deck | | | | | |

DS pier bearings

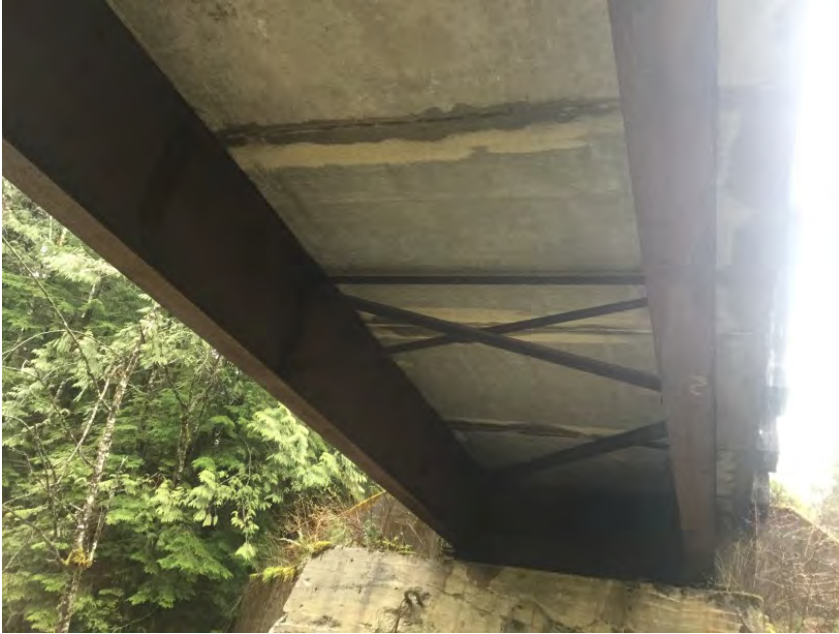
Jumpspan deck joints have evidence of water getting through
