CK-2037

STATLU 7300 3.7km

2018 Inspection

| Crossing Name | Towhead Creek | | |

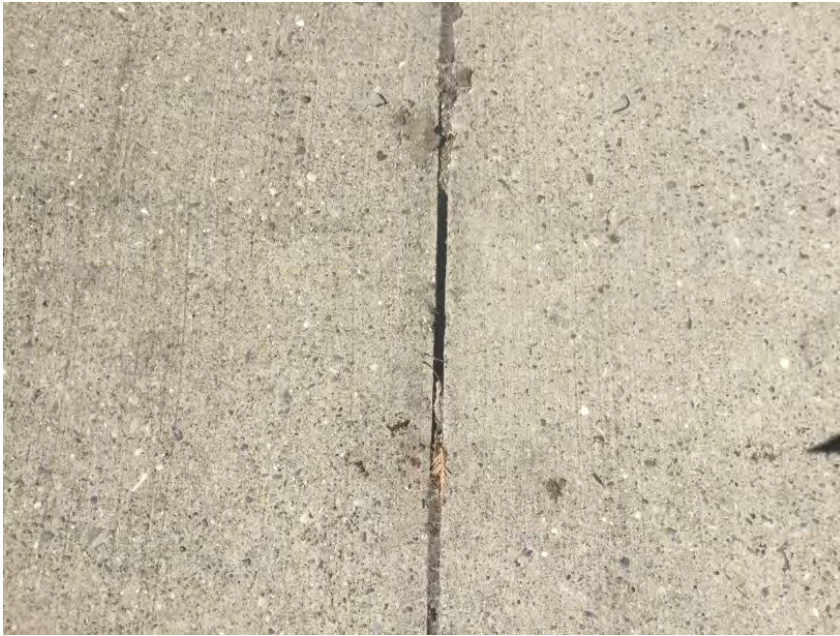
| Deck Joints | Fair | Worn in locations at surface |

Deck panel joints worn

Replace guardrail, risers and blocks. Brush approaches, replace missing delineators, and post bridge ahead signs. When the road is opened for industrial use monitor the deck joints, grout pockets and overall deck panel condition. Current load rating of L150 or 136 tonnes to continue.

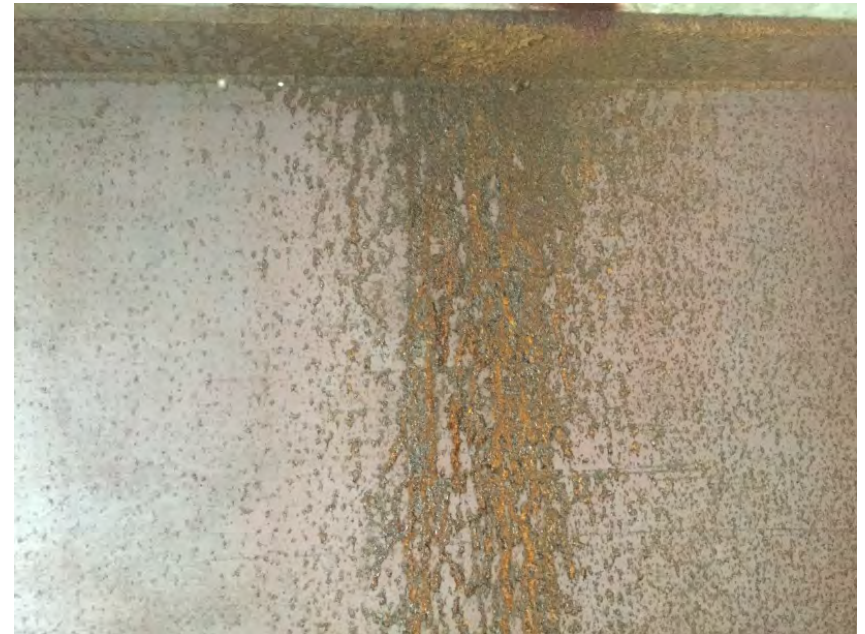
Girders Fair Pitting and flaking

Girders corrosion at deck joint and grout pocket locations

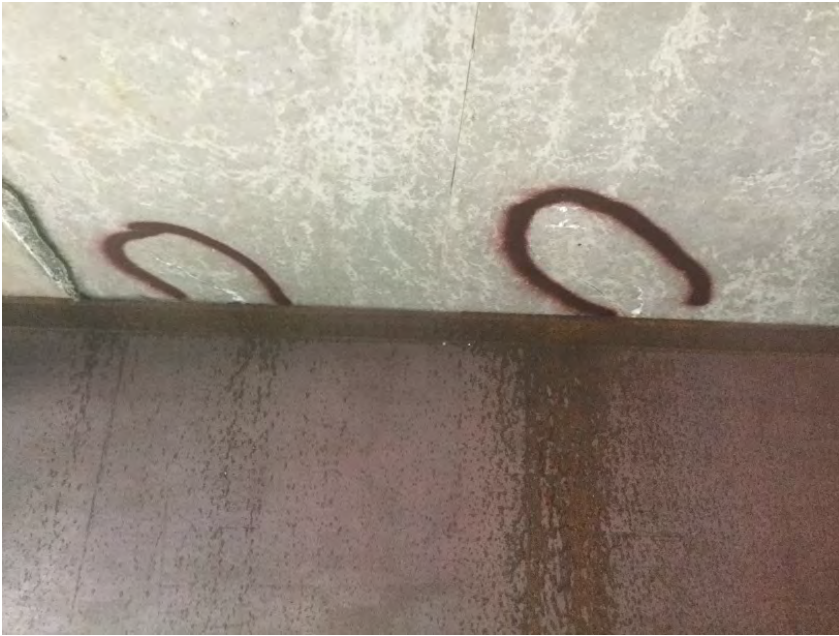
Cracking on underside of girders throughout

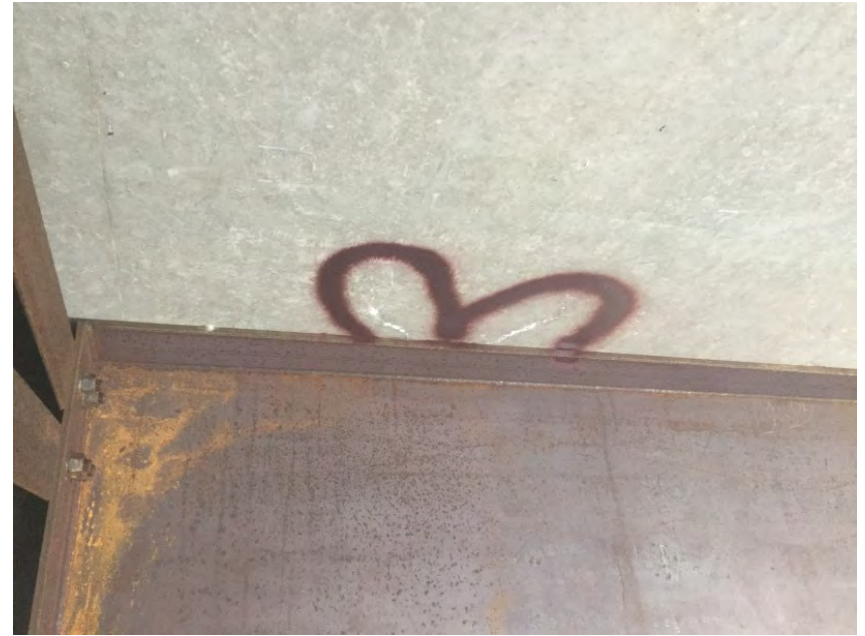
Deck panel cracks

| Item | Monitor Description | Frequency |
|---|---|---|
| 1 | Concrete deck condition | Routine Inspection |

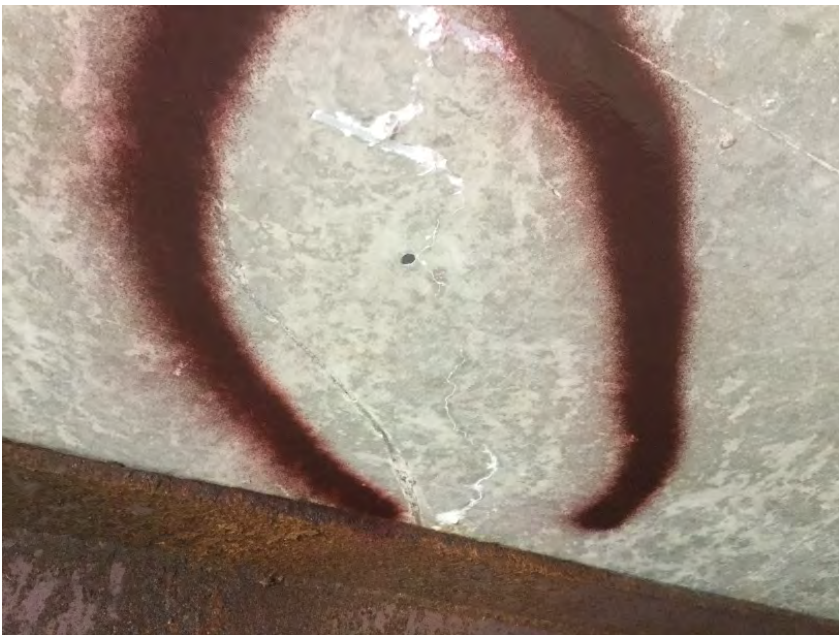
Deck panel cracks

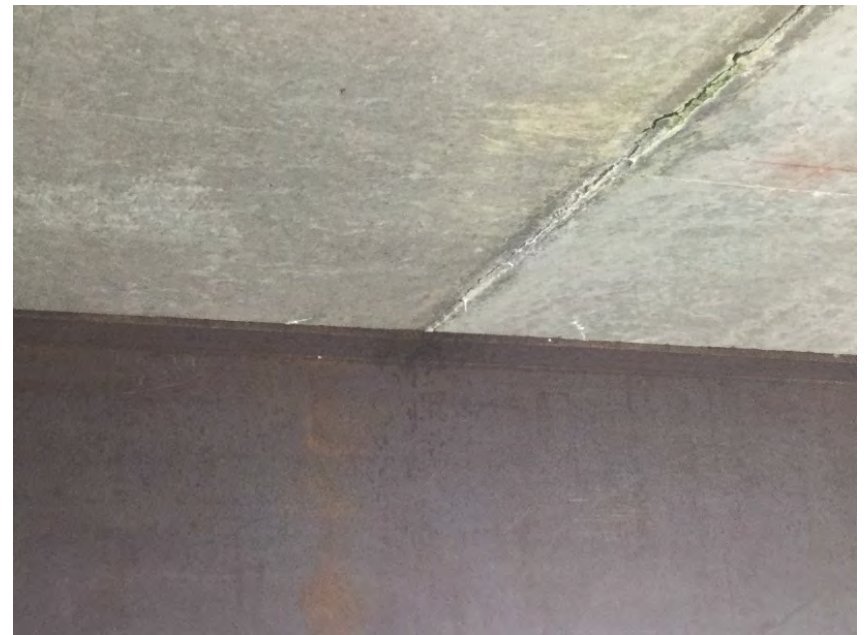
Deck joints cracks

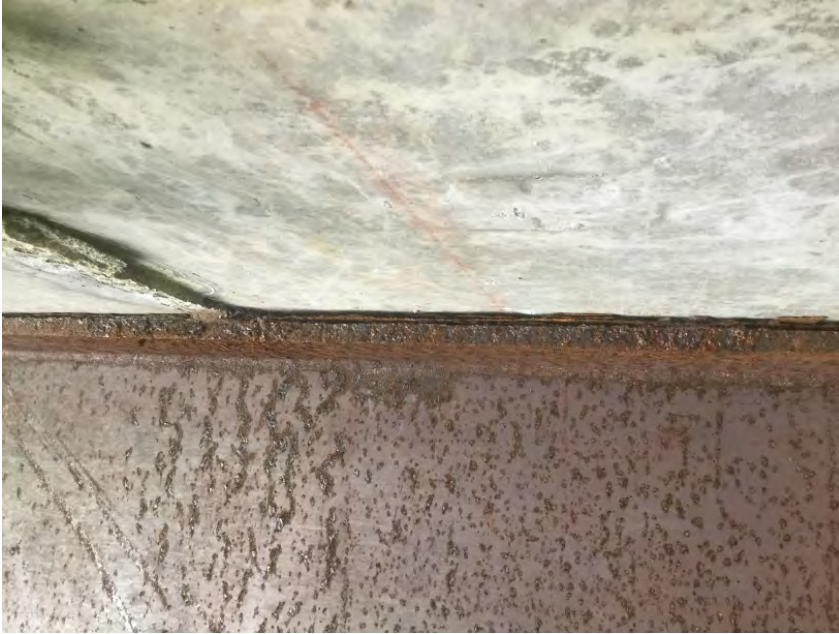
Panels being lifted due to rusting, typical throughout

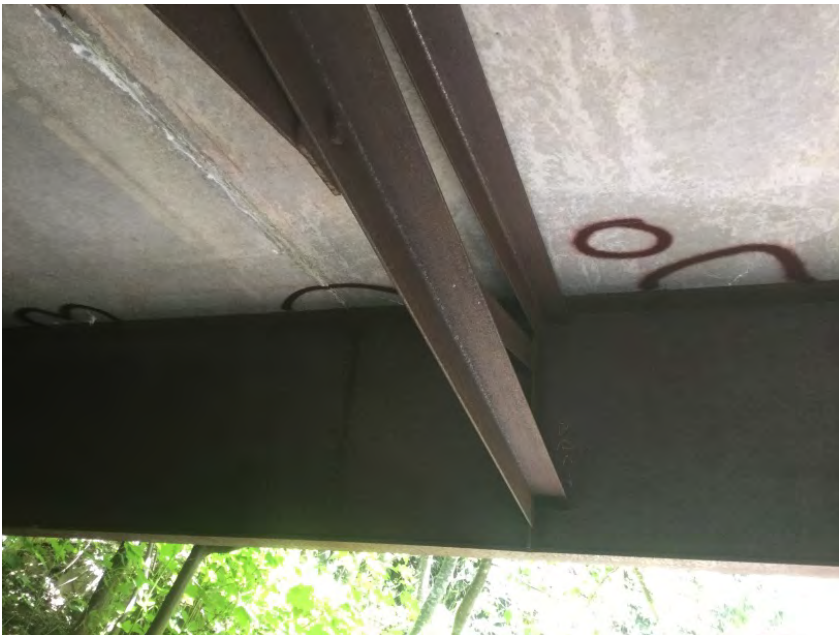
Deck panel cracks
