CK-2041

FLEETWOOD 3.7km

2018 Inspection

| Crossing Name | Chehalis River |

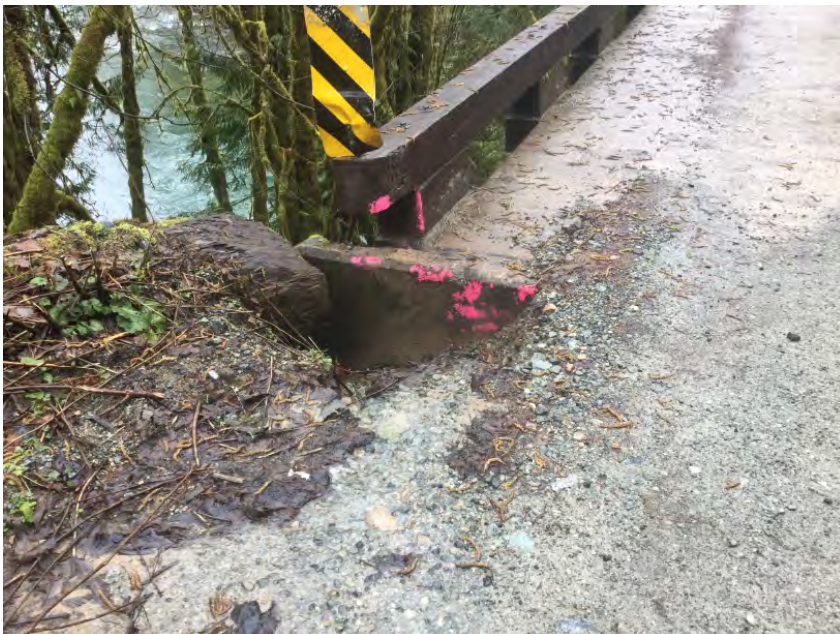
Fill Fair

Eroding at DS left approach

Eroding fill at DS left approach from surface runoff

Replace eroding fill at downstream left approach. Replace the missing/wrong delineators and replace the missing log fender. Present load rating of L150 or 136 tonnes to continue.

| Repair Item | Priority | Repair Description |
|---|---|---|
| 2 | High | Replace road fill at DS left approach prior to activity |

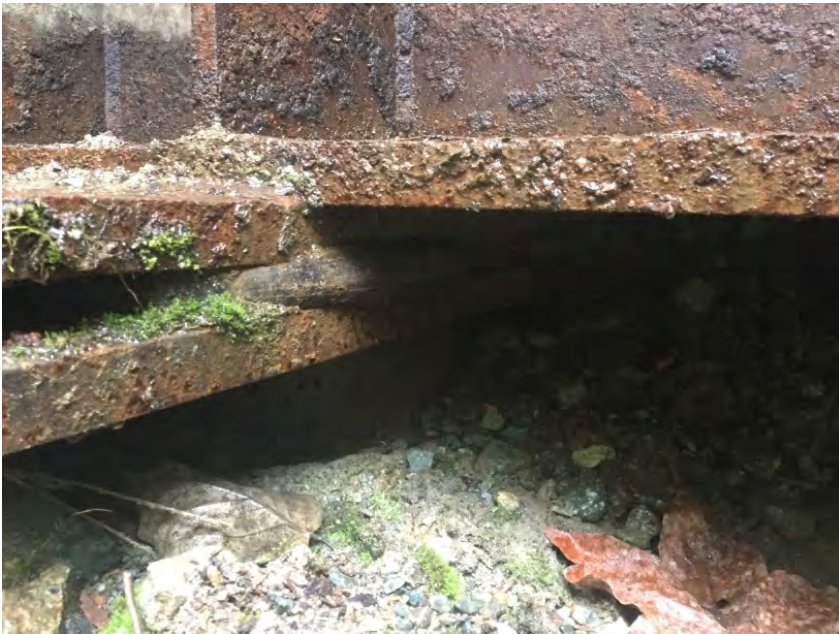
Bearings Fair

Bulging bearing pads at left bank
