CK-2044

CHEHALIS-MYSTERY 0.01km

2018 Inspection

| Crossing Name | Chehalis River |

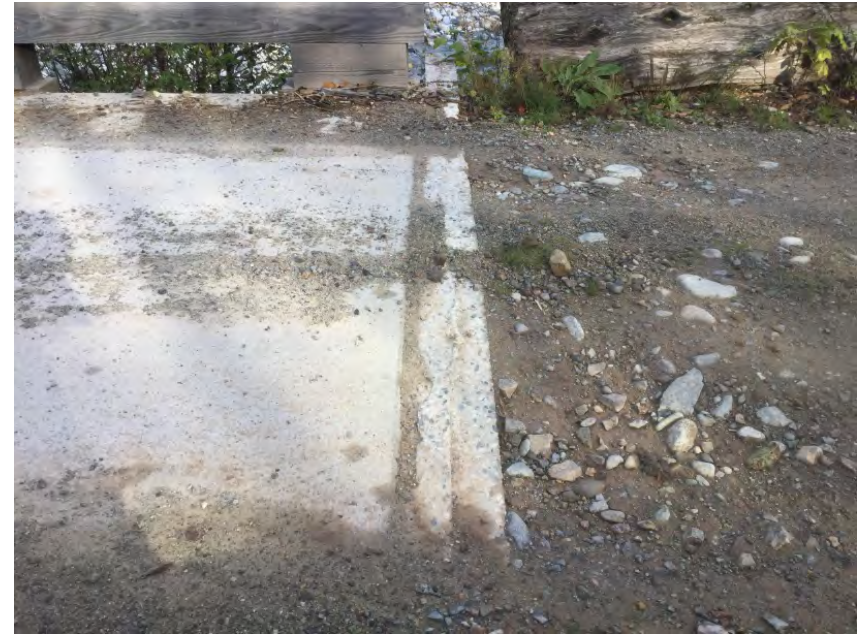
Left abutment ballast wall appears to have been cut

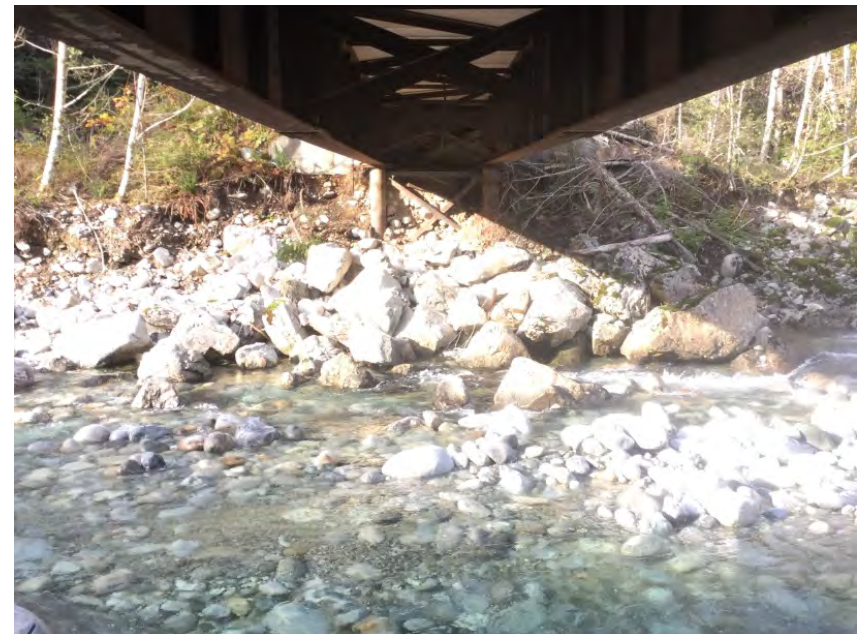
Right Bank Abutment when facing downstream

Fill Poor Fair at left bank but over steepened at right and will erode

| Item | Priority | Repair Description |
|---|---|---|
| 3 | Medium | Add riprap in front of right bank abutment for added protection and to help stabilize the fill |

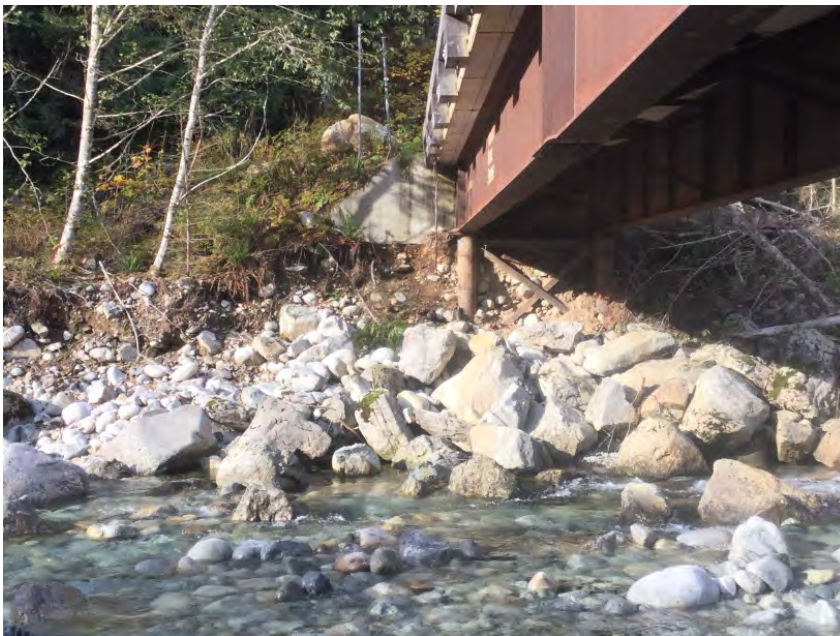
Comments    Fill at right bank appears to have been eroded, check previous inspections

Fill at right bank is over steepened

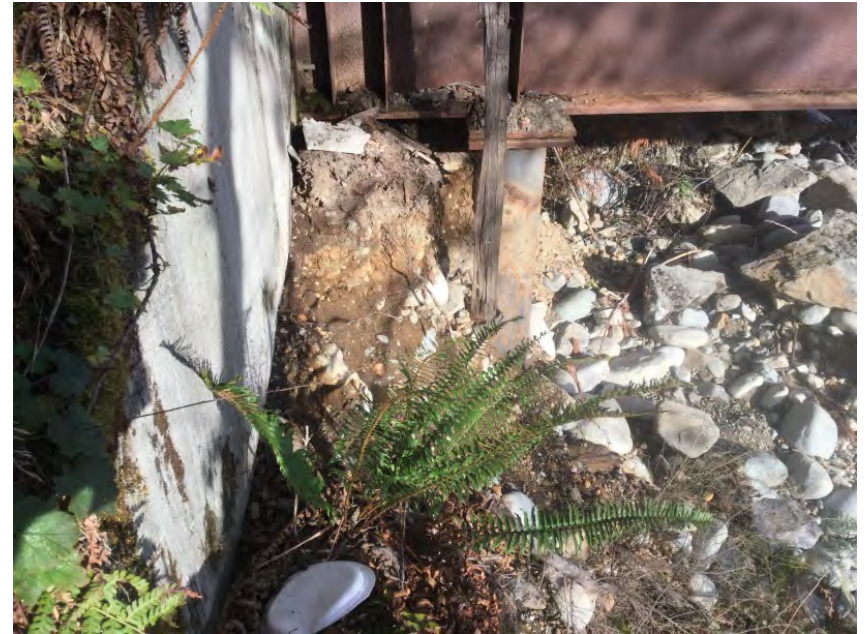
Over steepened fill behind ballast wall at right bank

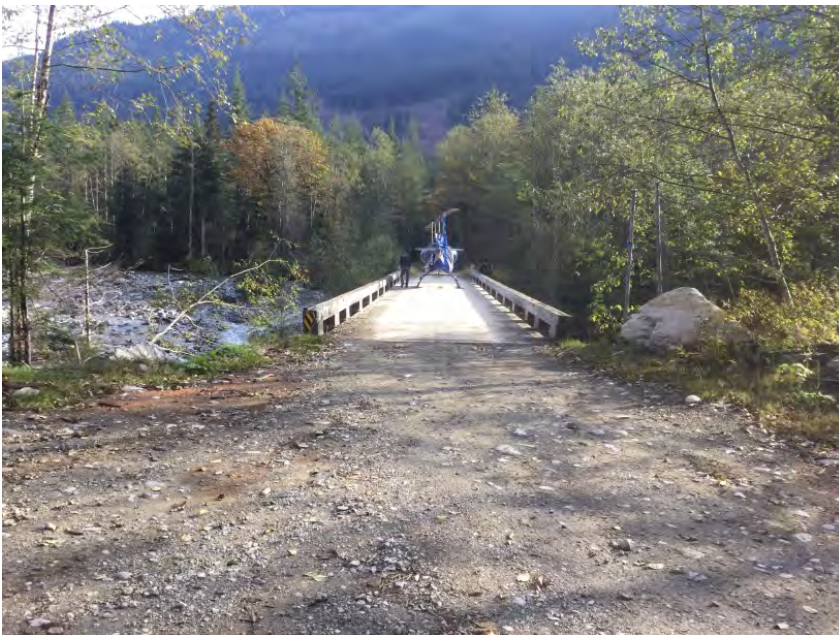
Approach from Right Bank when facing downstream

Missing upstream right approach

| Item | Priority | Repair Description |
|---|---|---|
| 2 | Medium | Replace missing fender log at upstream right approach |

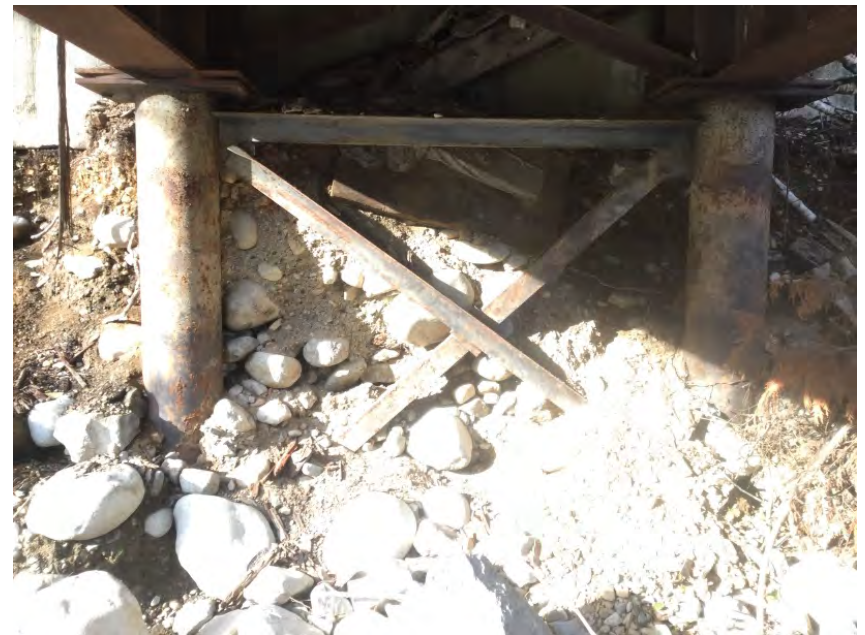
Over steepened fill behind right bank abutment

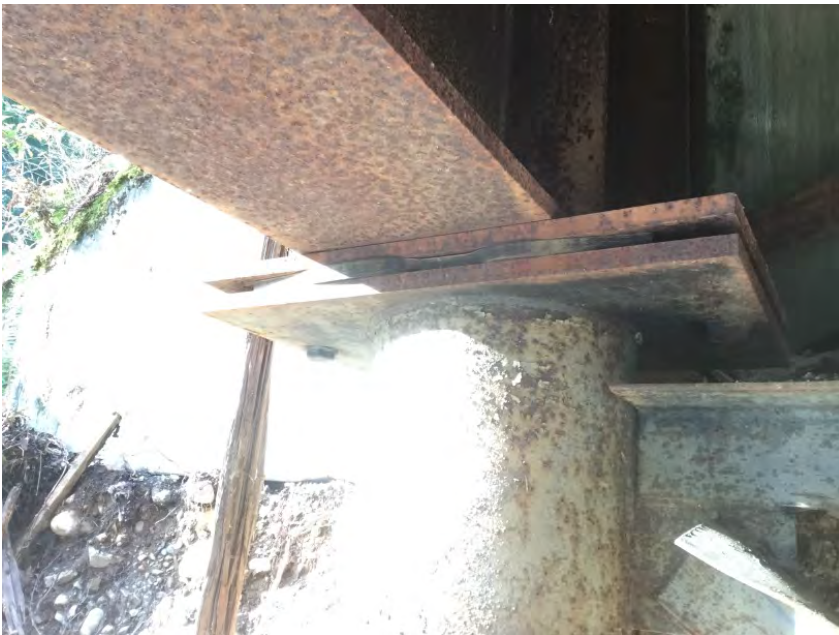
Bearing pads at right bank
