CK-2047

CHEHALIS-MYSTERY 11.9km

2018 Inspection

Crossing Name Mystery Creek

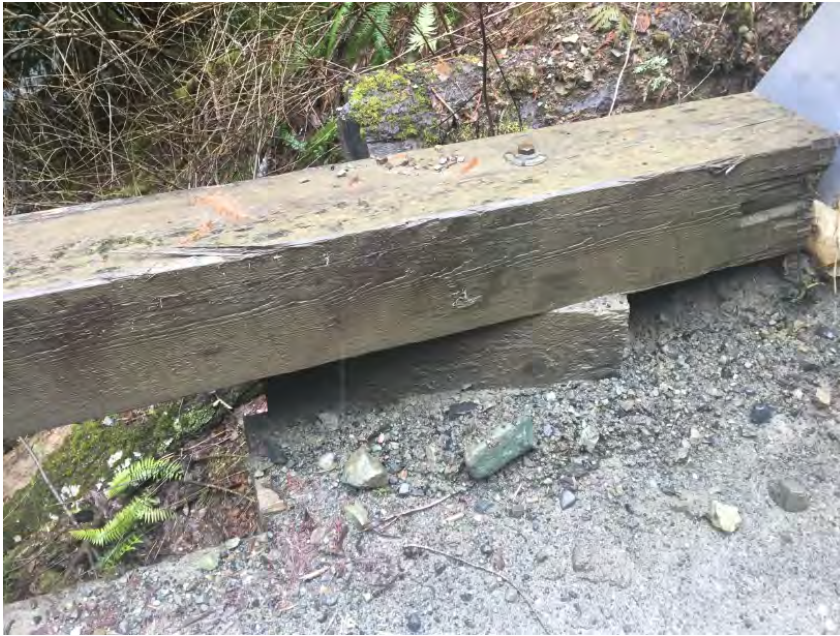
Hardware Poor Loose rail bolts and some missing

Missing bolt on guardrail

| 2 | Medium | Replace guardrail, risers and blocks |

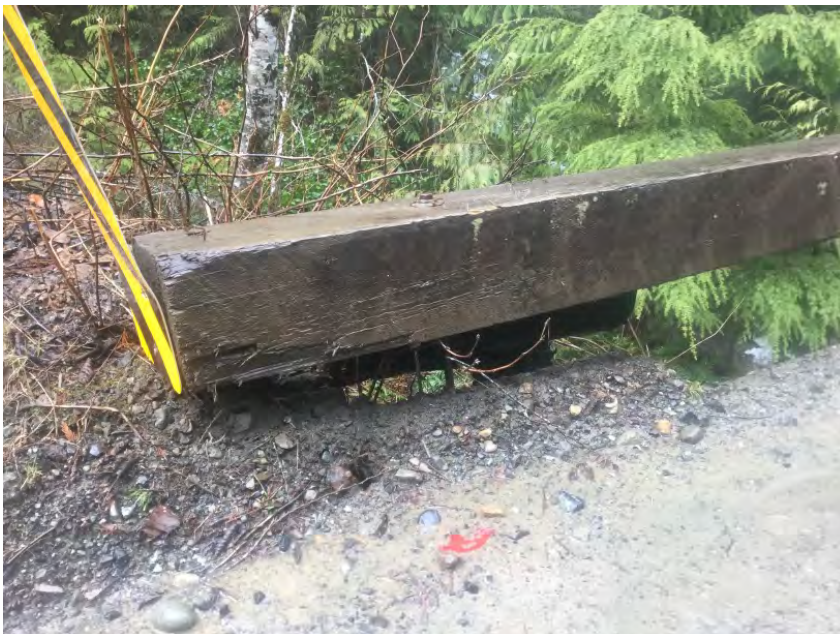
Missing riser and only 1 bolt

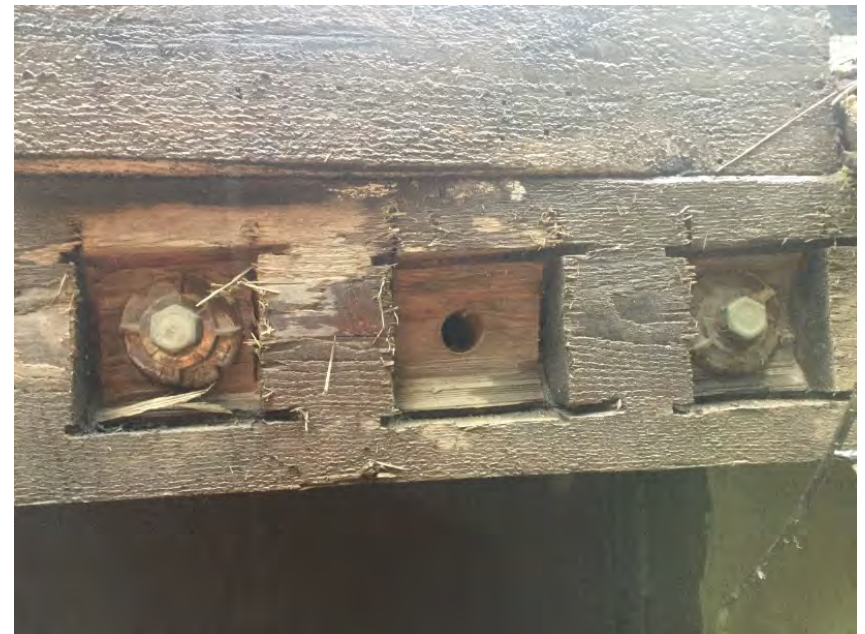
Curb Rail/Blocks/Posts Poor Cored random blocks and all over 50% rotten - replace all

Missing block bolt and rotting

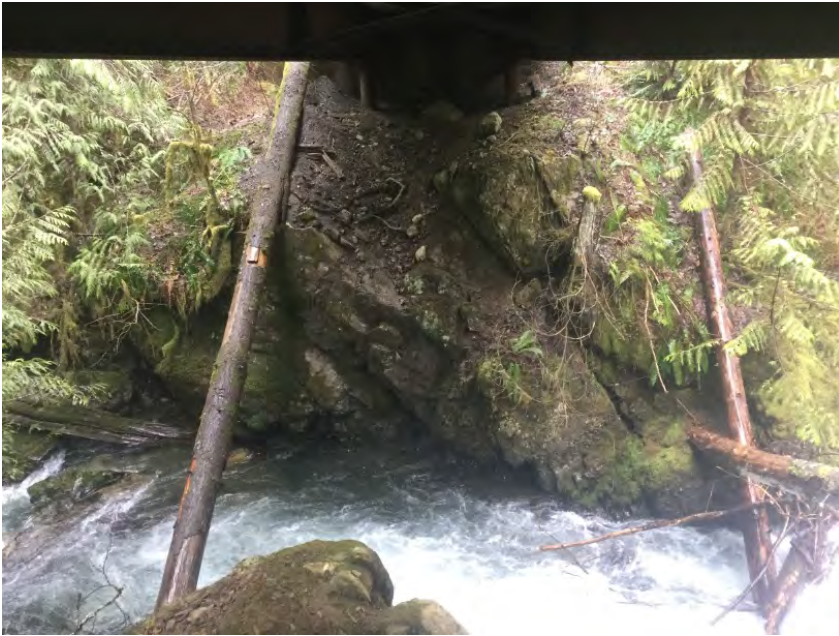
Right Bank Abutment when facing downstream

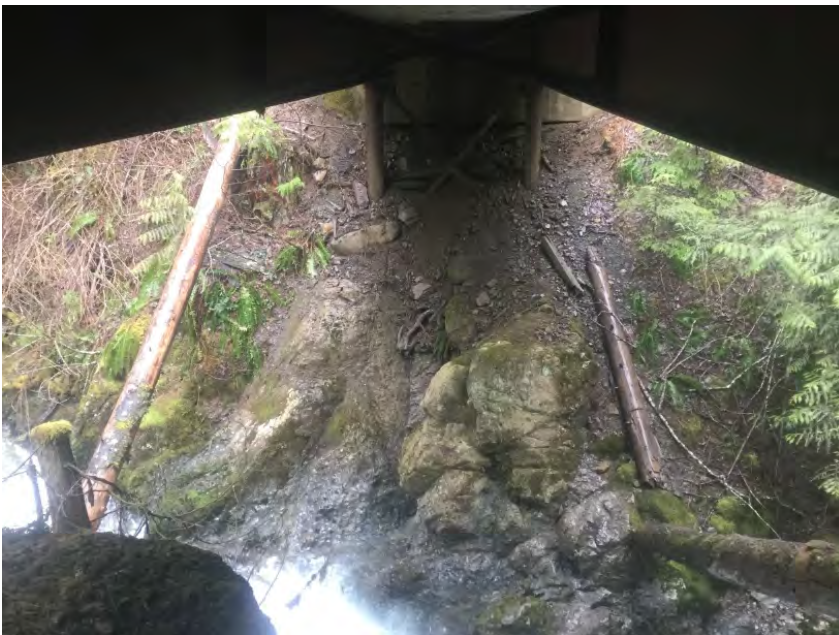
Only 1 bay at left bank and appears steep

Left Bank Abutment when facing downstream
